Corrosion of copper after 20 years exposure in the bentonite field tests LOT S2 and A3

SVENSK KÄRNBRÄNSLEHANTERING AB

SKB TR-20-14

September 2020

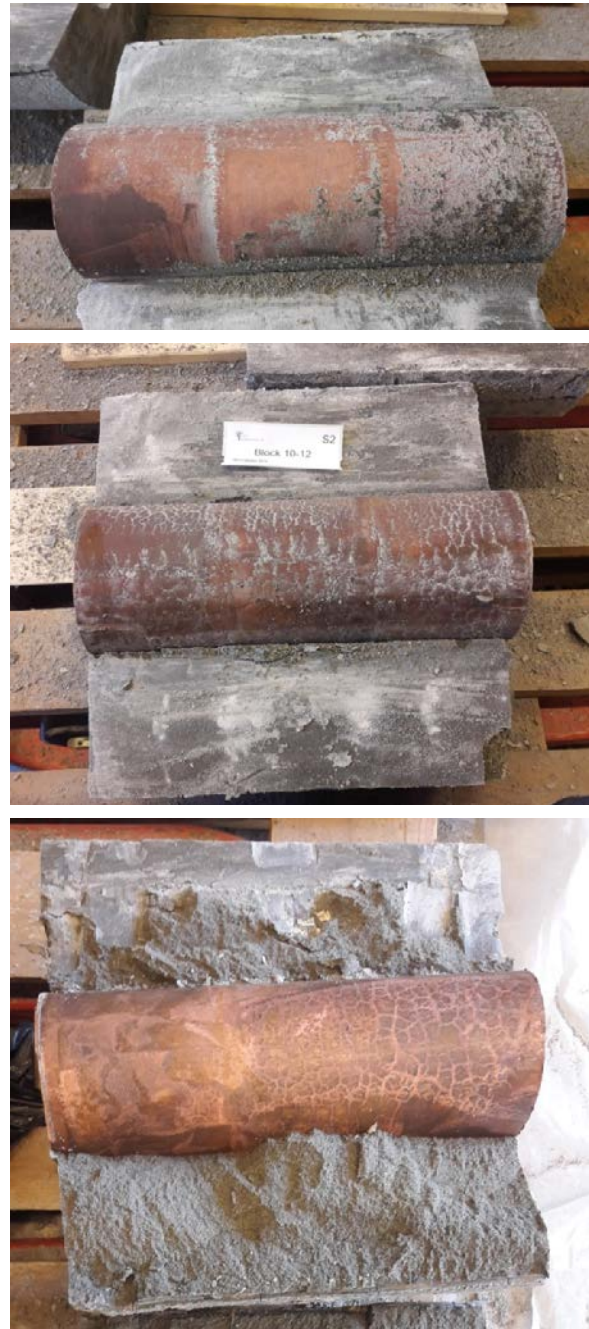
Figure 3-3. Appearance of the copper pipes in LOT A3 and S2 immediately after uncovering the pipes.

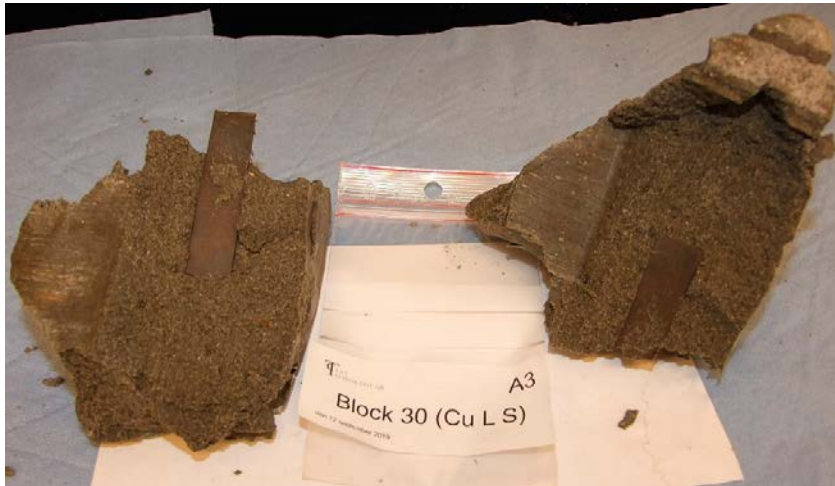
Figure 3-5. Corrosion coupon A3/L with surrounding bentonite clay.

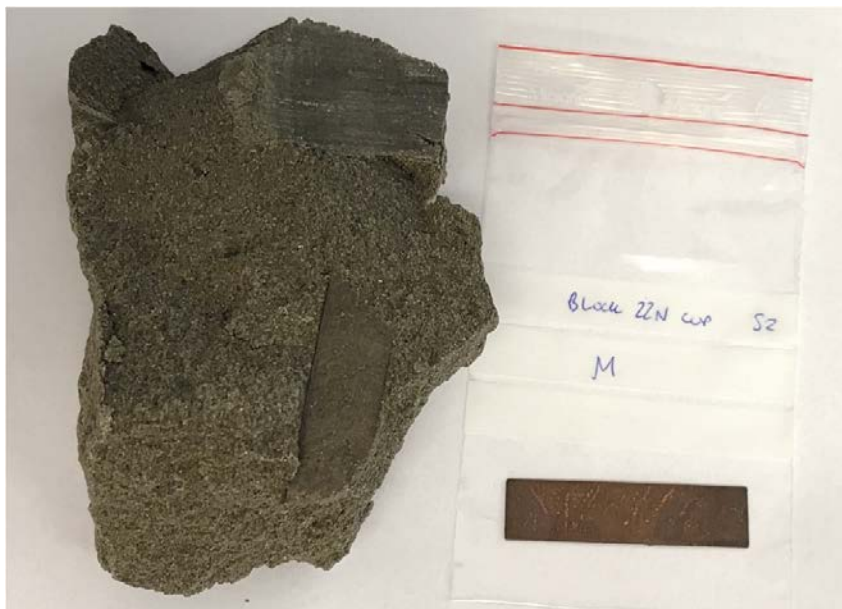
Figure 3-6. Corrosion coupon S2/M with surrounding bentonite clay.

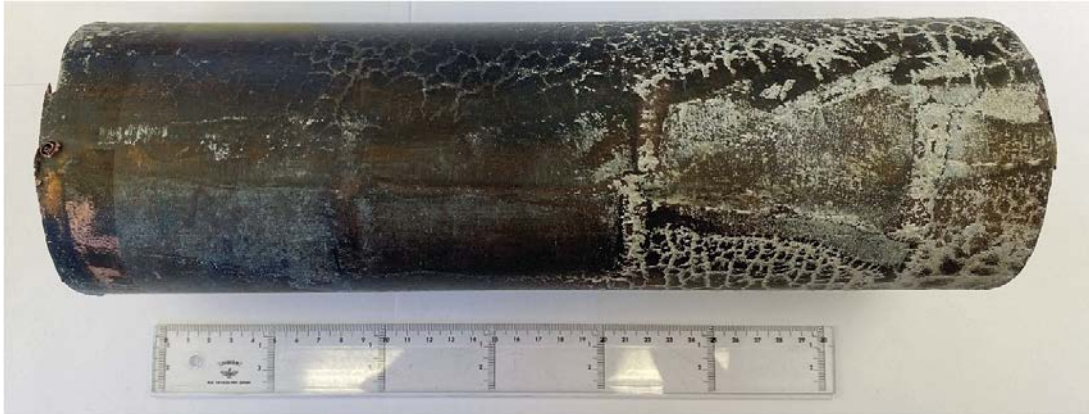
Two pipe samples from blocks 21–23 of test parcels A3 and S2 were also delivered to RISE KIMAB in sealed aluminium bags and were photographed in as-received condition prior to analyses. The pipes were partially covered with a thin layer of bentonite clay, and it could be seen that the surfaces varied in appearance with some areas apparently having a thicker or more dense oxide layer than others (Figures 3-7, 3-8 and Appendix A).

Figure 3-7. Pipe sample A3 in as-received condition.

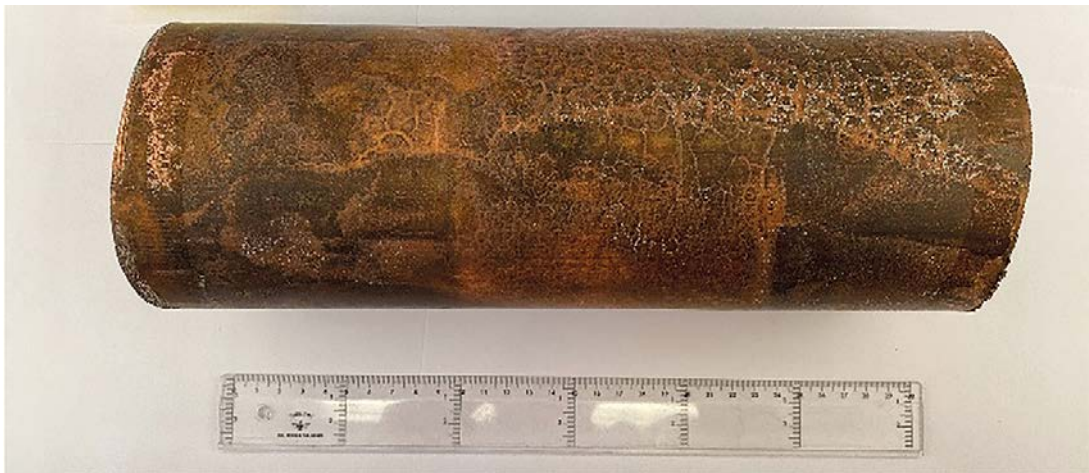
Figure 3-8. Pipe sample S2 in as-received condition.

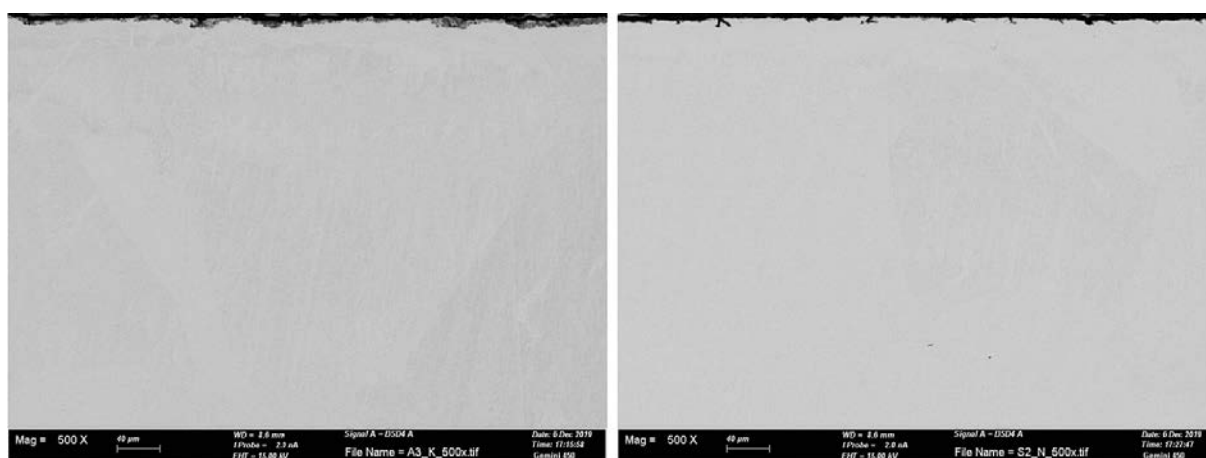
Figure 3-11. SEM image of cross-section of coupons A3/K (left) and S2/N (right), magnification $\times 500$.

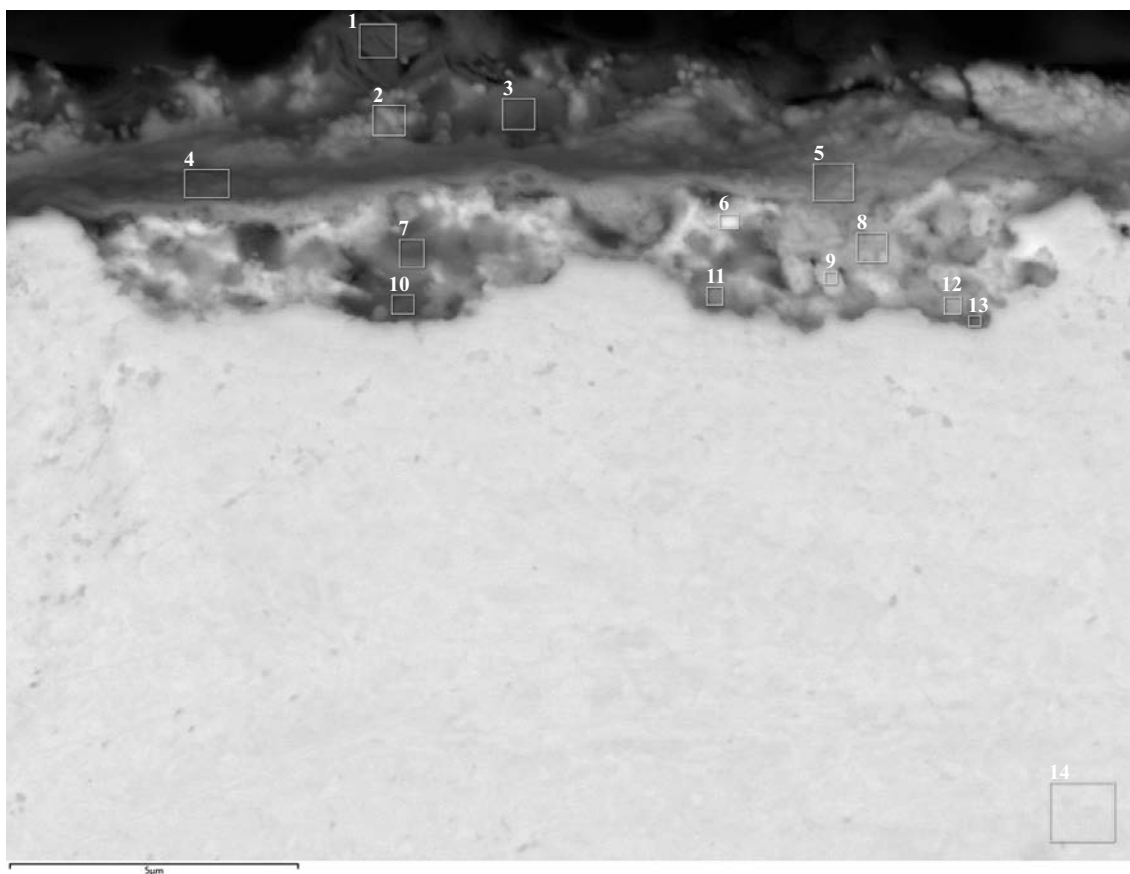
Figure 3-12. SEM image of corrosion coupon A3/K in cross section, magnification $\times 14\,000$, with associated EDS analysis results.

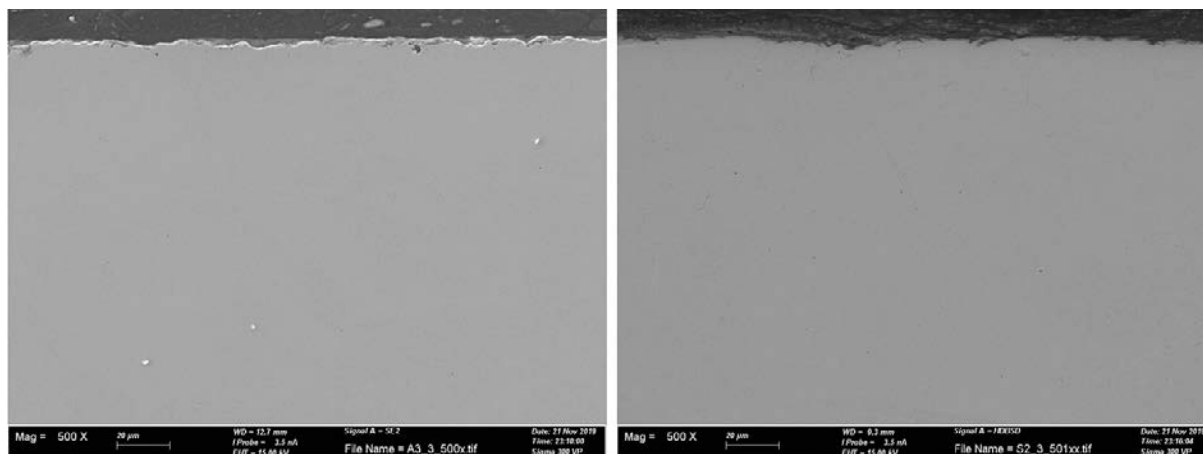
Cross-sectioned samples of the copper pipe surfaces appeared generally rough with frequently occurring pits or defects densely distributed over the observed interfaces, see Figures 3-17 to 3-20. The pits were generally wide and shallow, and the deepest pit found was ca 25 μm (Appendix F). The surface deposits on the pipe samples contained high levels of O, likely from both the corrosion product Cu_2O and from bentonite clay, as indicated by a generally high content of Si. The content of S was generally low (from < 1 at% up to a few at%), but a few observations of enhanced S levels were made. On the pipe sample from S2, an enhanced level of S (12 at%) was found on the surface, however, the same spot also had an enhanced level of Ca (11 at%), indicating that the deposit was CaSO_4 from the bentonite clay (Figure G-52). EDS data from spots nearby showed lower levels of both S and Ca, which however also seemed to match with CaSO_4 . Another observation of enhanced S was made inside a shallow pit found on the sample from S2 (Figure 3-20). Here, the level of S was 16 to 26 at% and the levels of O and Si were both lower than what was generally found. Since there was no correlation of S with either Ca (CaSO_4) or Fe (FeS_2), this observation suggests the formation of a Cu-S phase. Many of the cross-sections were very low in S (< 3 at%) and only occasionally high levels (> 10 at%) were detected. Due to the low levels of S, the presence of bentonite, and significant levels of Ca (precipitation of CaSO_4) it was difficult to analyse the distribution of Cu-S phases in the corrosion products. Full details of the EDS analyses are included in Appendix G, and images of the cross-sections are reported in Appendix F.

Figure 3-17. SEM images of cross-sections of samples from pipes A3 (left) and S2 (right). Magnification $\times 500$.

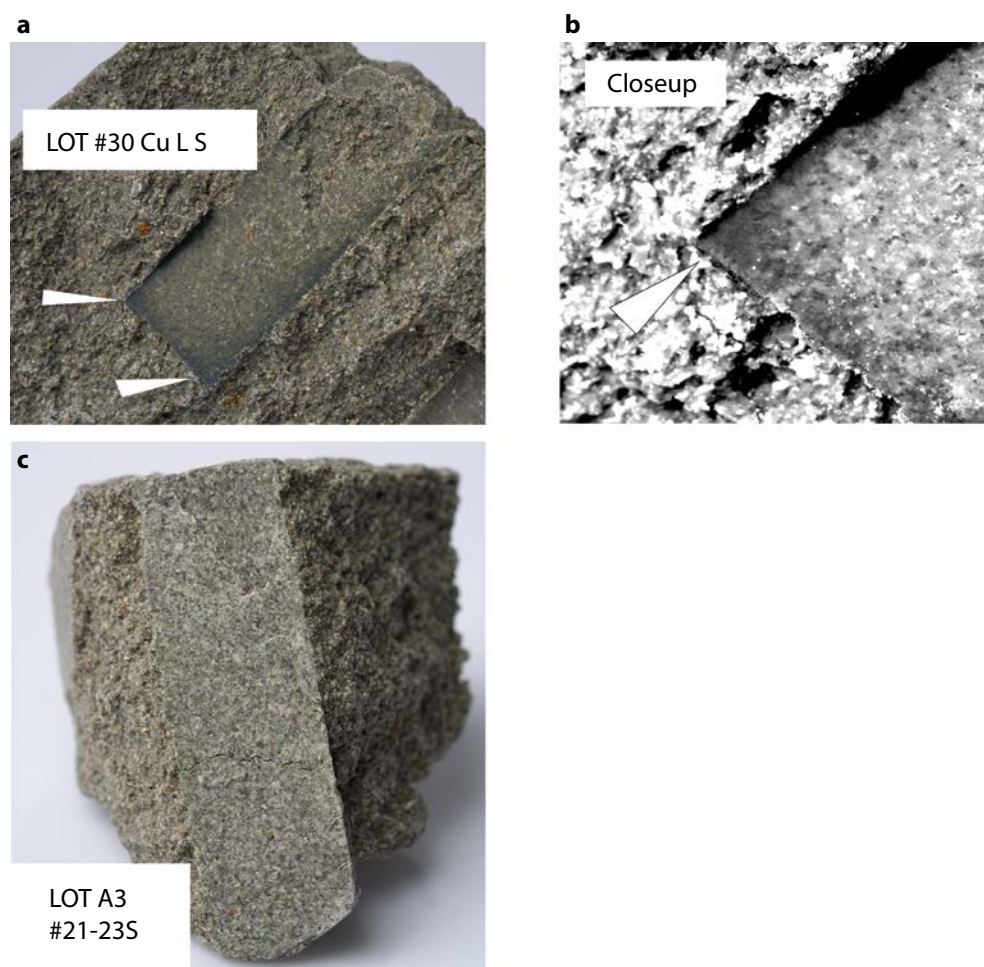
Some of the bentonite surfaces that had been in contact with the copper coupons had visible unevenly distributed corrosion products, primarily located in the corners, while others had no visible corrosion products (Figure 3-24).

Figure 3-24. (a) Example of bentonite with visible unevenly distributed corrosion products, primarily located in the corners. (b) Closeup of (a). (c) Example of bentonite with no visible corrosion products.

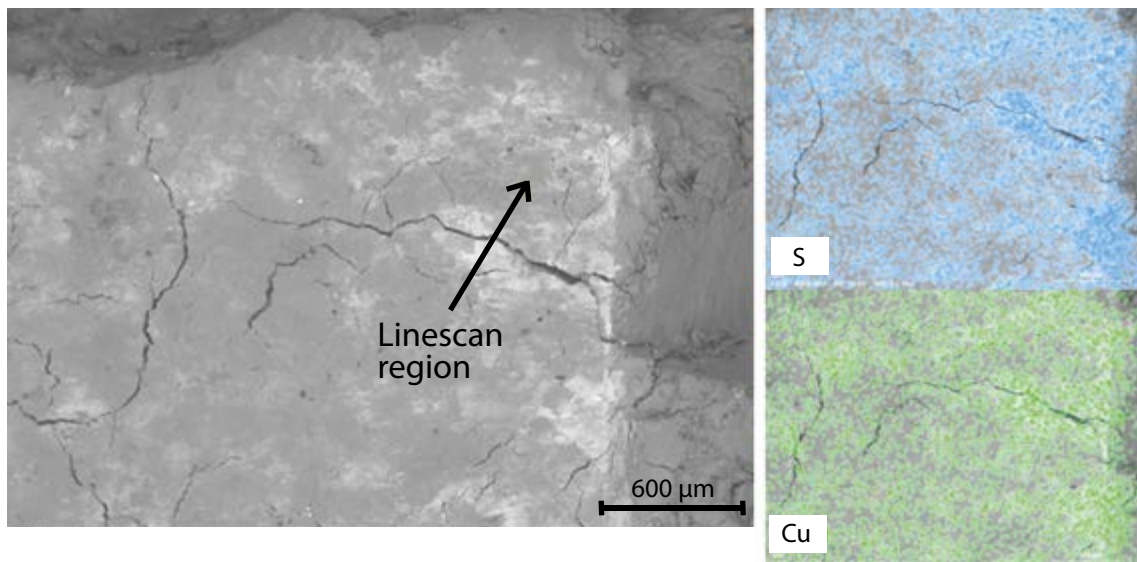
The investigated sample that had been in contact with coupon L from the A3 parcel, is shown in Figure 3-26 (denoted “#30 Cu L S”). One corner visually rich in dark corrosion products in the bentonite was selected. The edge that looked dark visually in the sample looked very bright in backscatter mode in the SEM, indicating the presence of heavy atoms (Figure 3-27).

Figure 3-27. Sample of bentonite (“30 Cu L S”) from contact with a corner of coupon L from LOT A3. Left: BSE micrograph showing bright high scattering regions with elements of relatively higher atomic number. Upper right: EDS-map showing sulfur (S). Lower right: EDS-map showing copper (Cu).

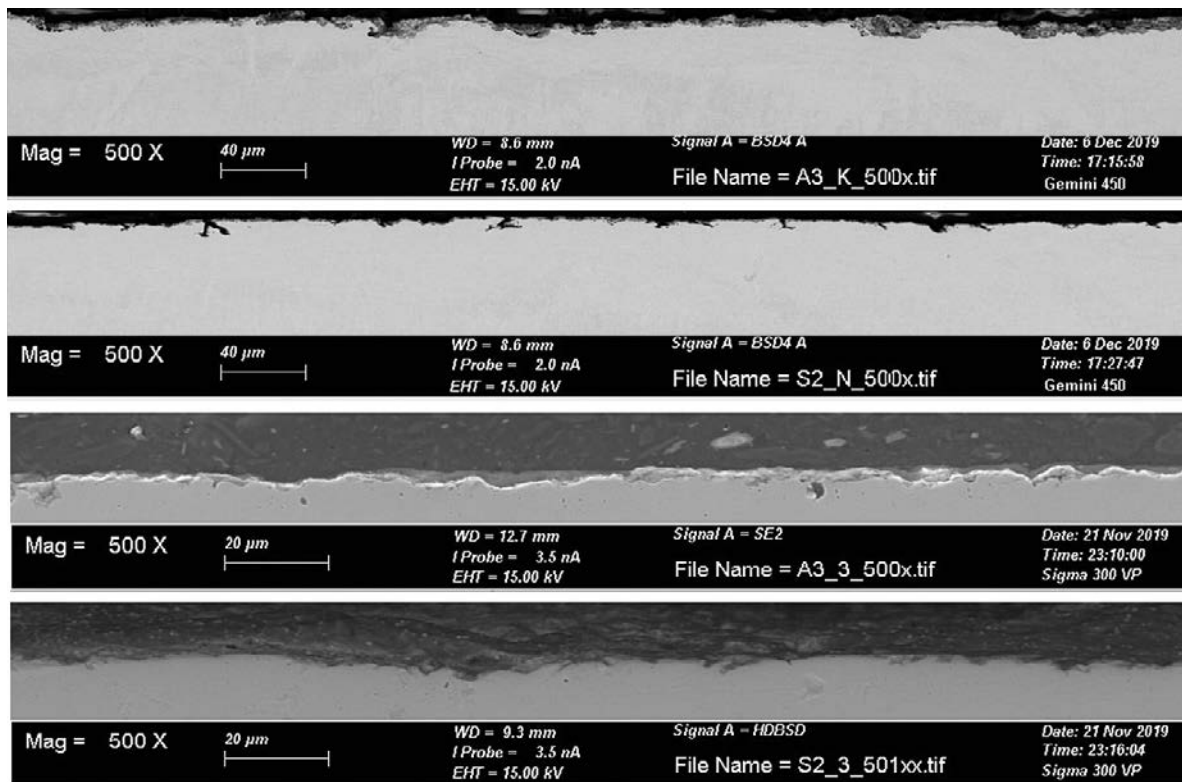
Figure 4-2. Micrographs of cross-sectioned samples of coupon A3/K (top), coupon S2/N (second from top), pipe from A3 (third from top), and pipe from S2 (bottom).

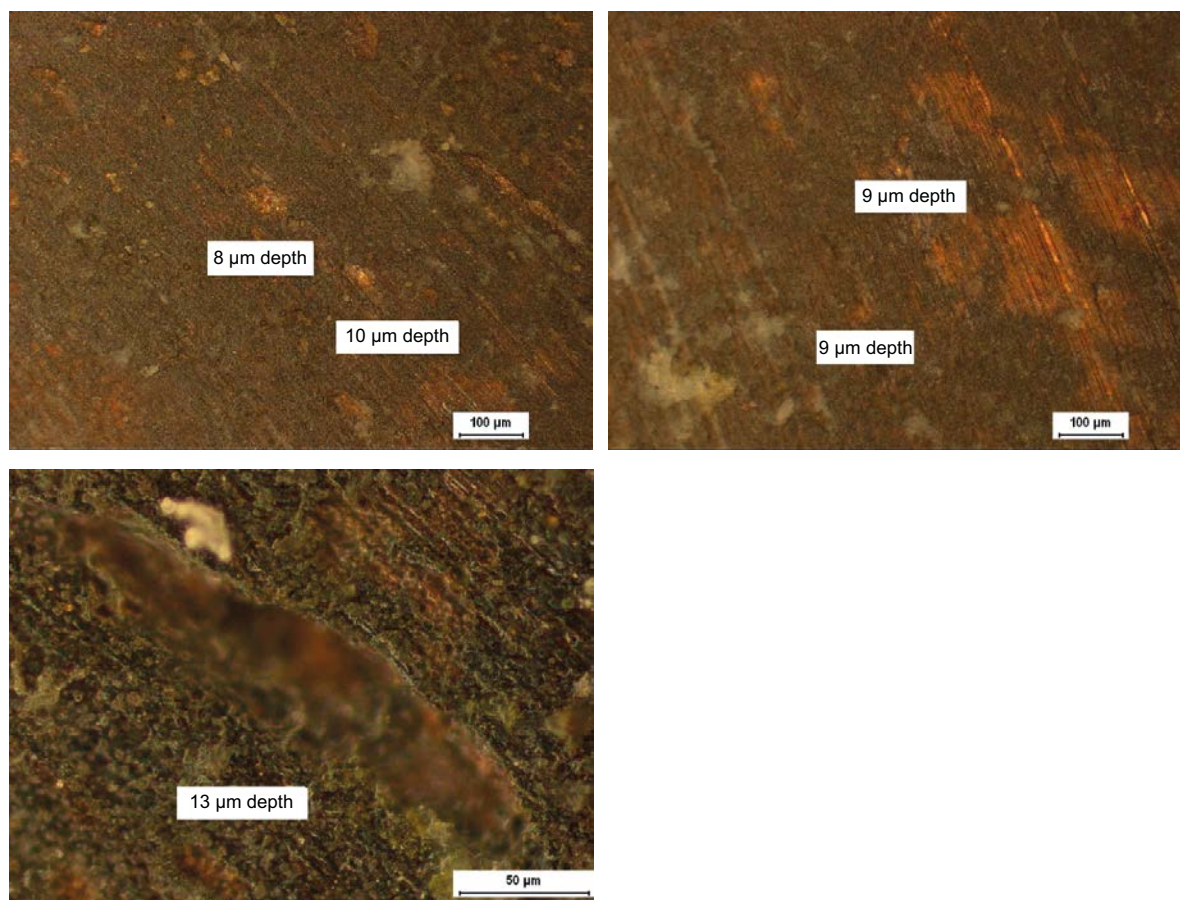
Figure E-1. Microscope images of the deepest defects found on coupon A3/I before pickling.

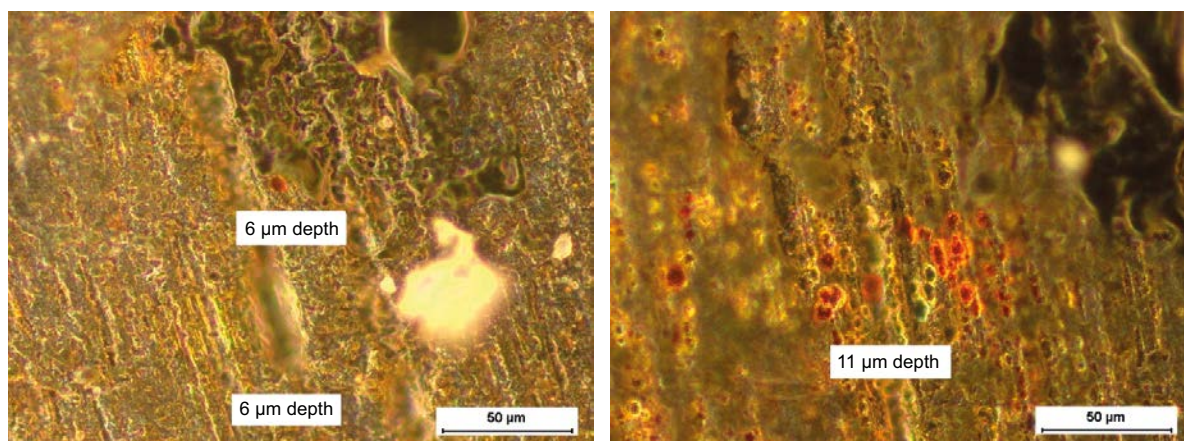
Figure E-3. Microscope images of the deepest defects found on coupon A3/K before pickling.

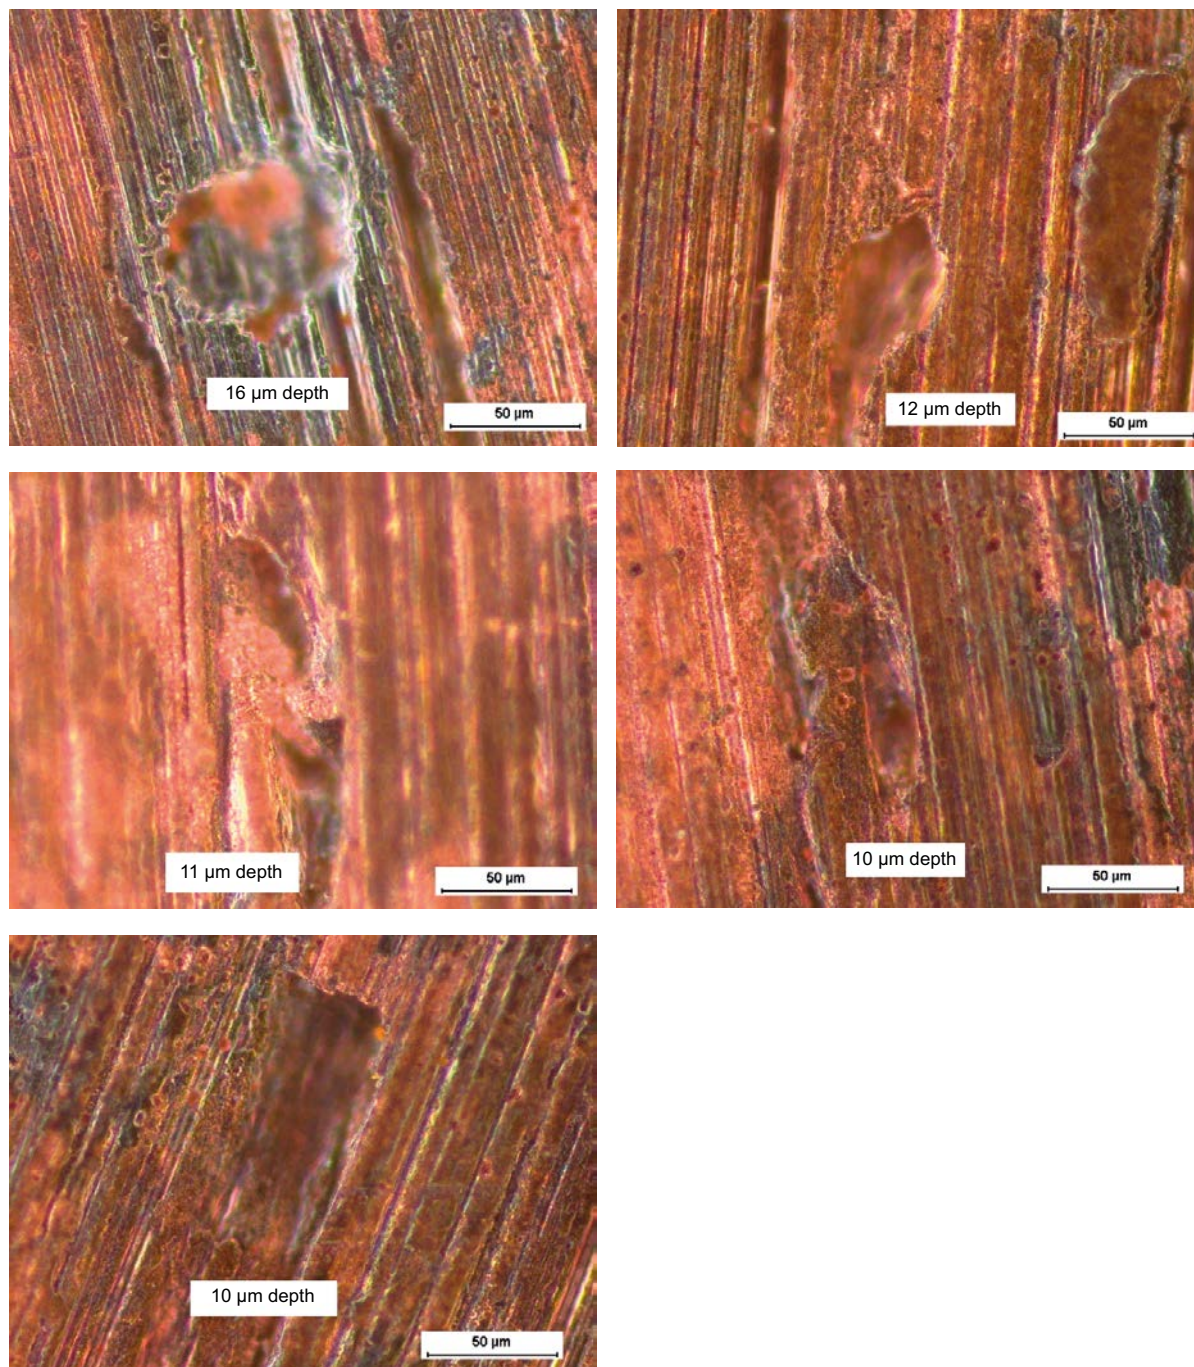
Figure E-11. Microscope images of the deepest defects found on coupon A3/I after pickling.

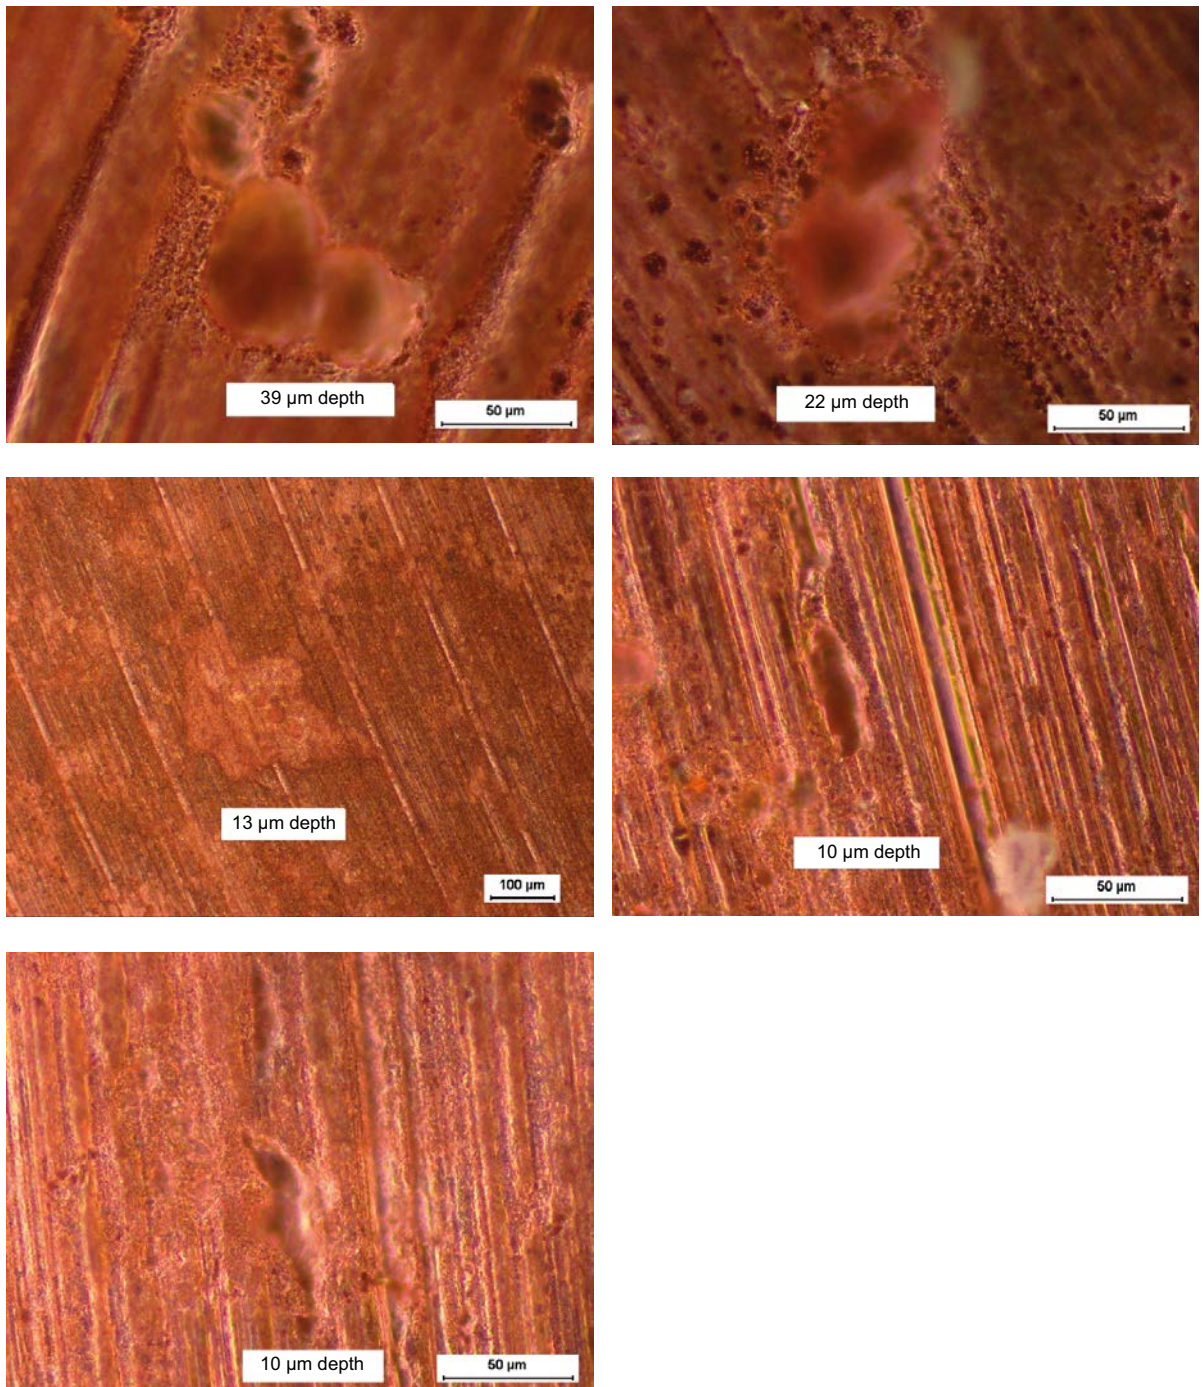
Figure E-12. Microscope images of the deepest defects found on coupon A3/J after pickling.

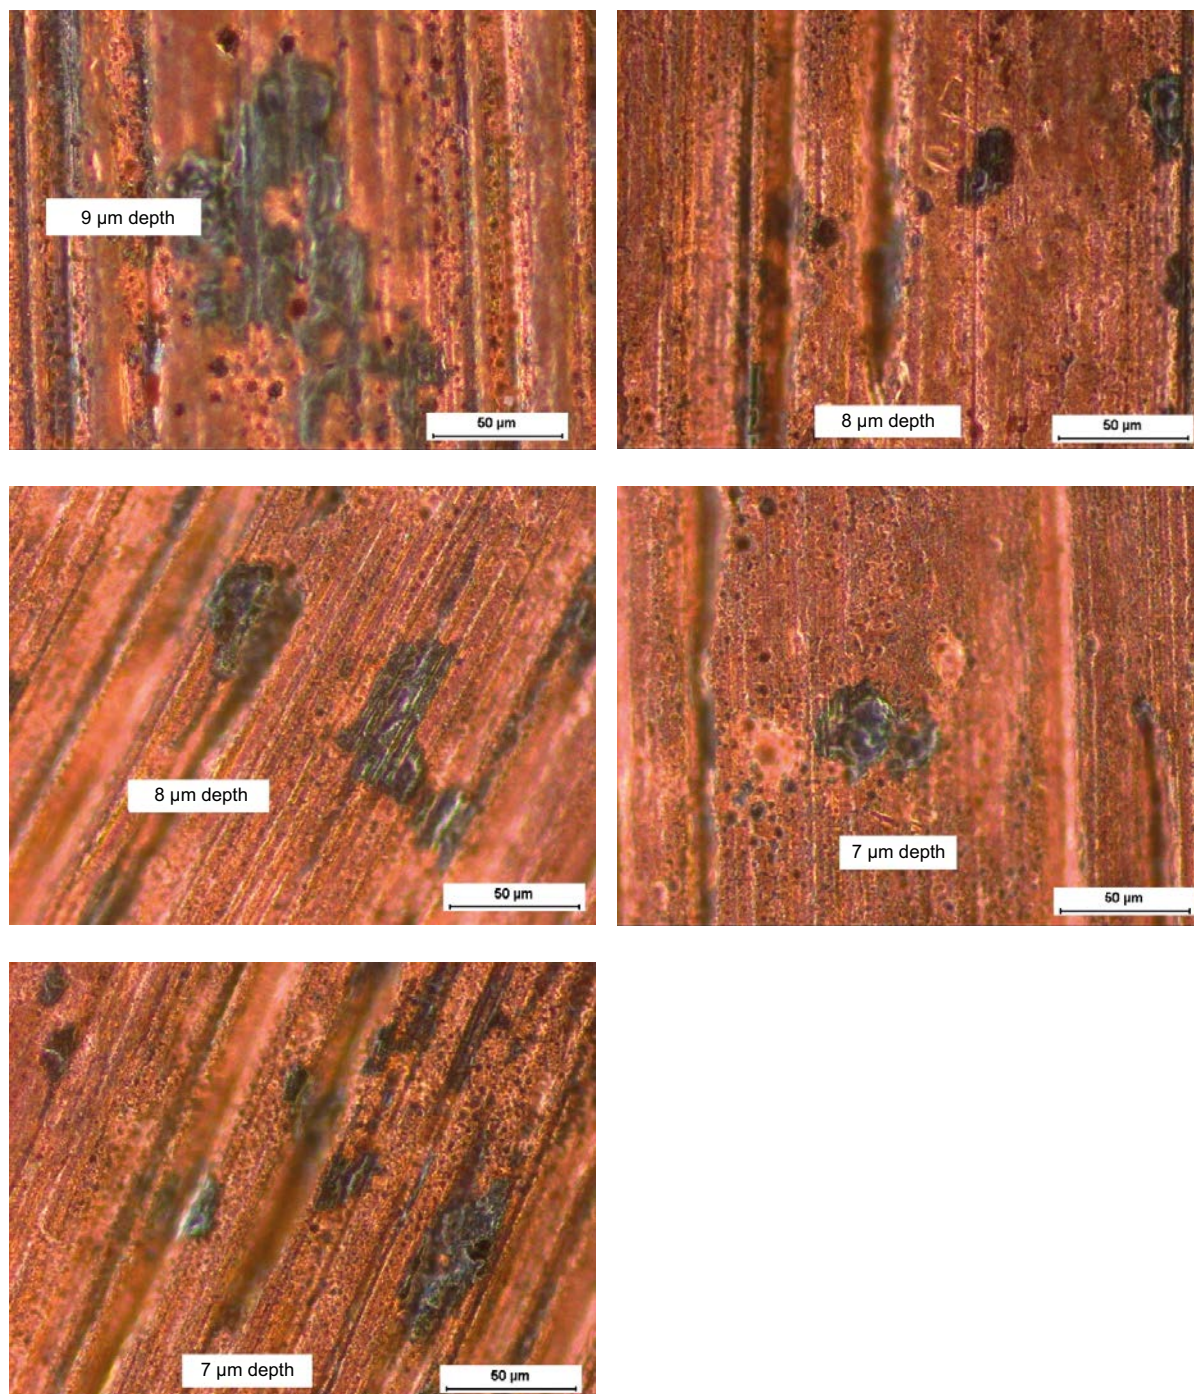
Figure E-13. Microscope images of the deepest defects found on coupon A3/L after pickling.

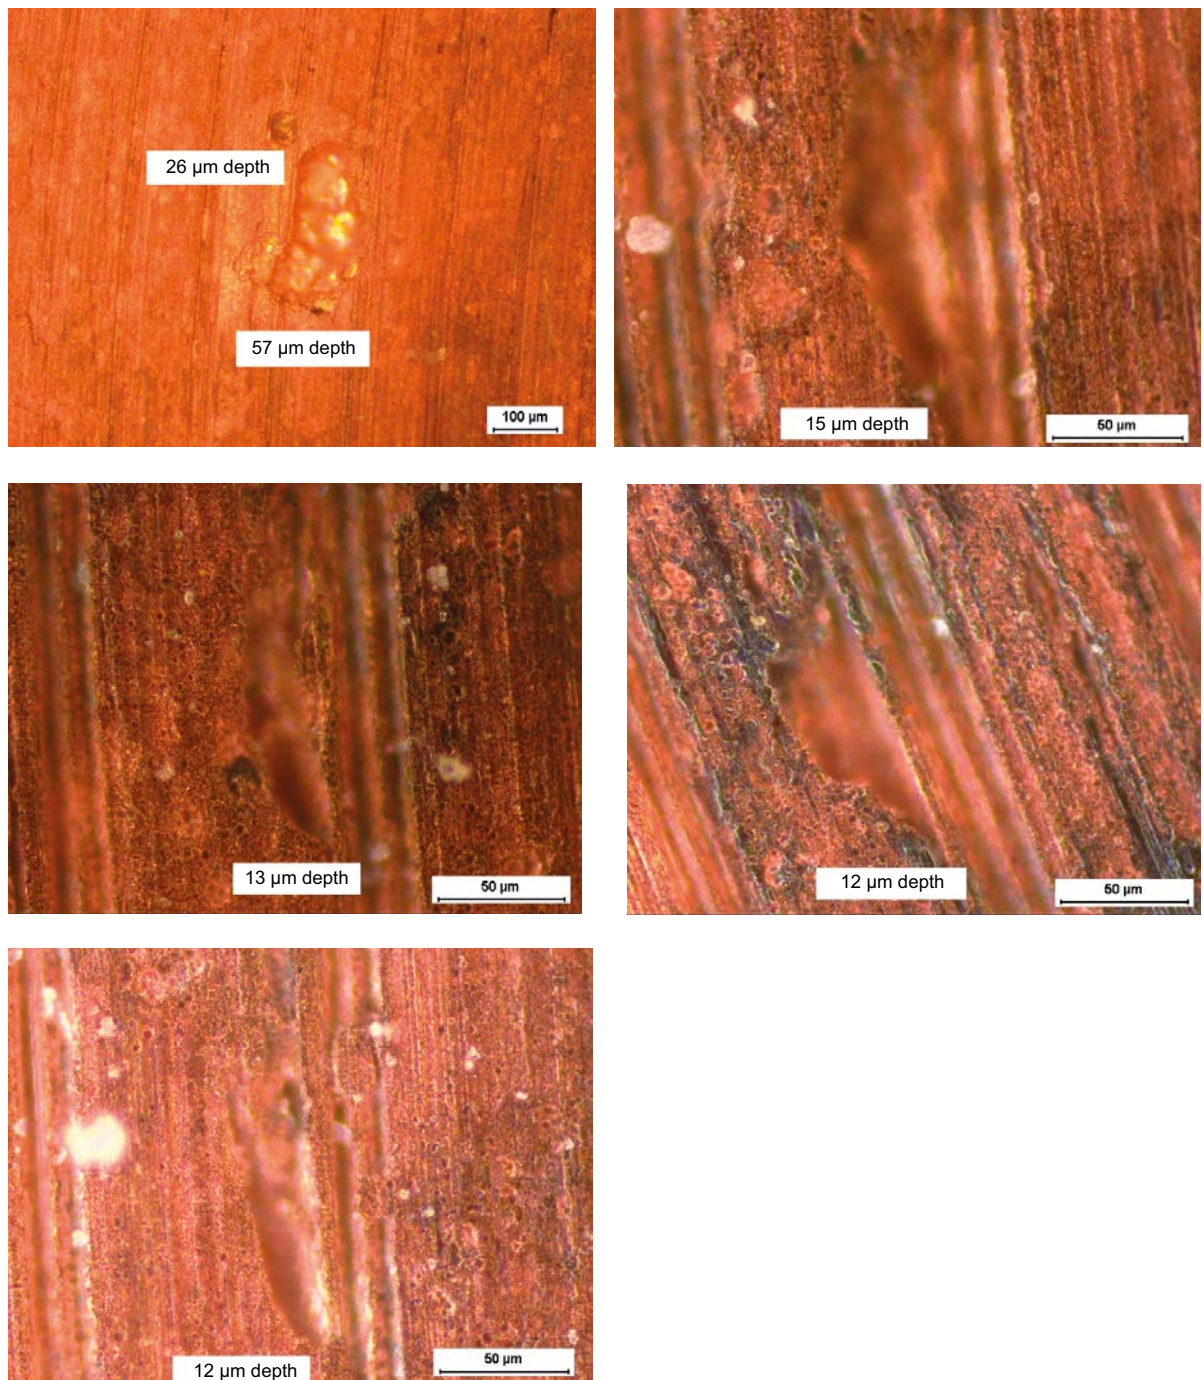
Figure E-14. Microscope images of the deepest defects found on coupon S2/M after pickling.

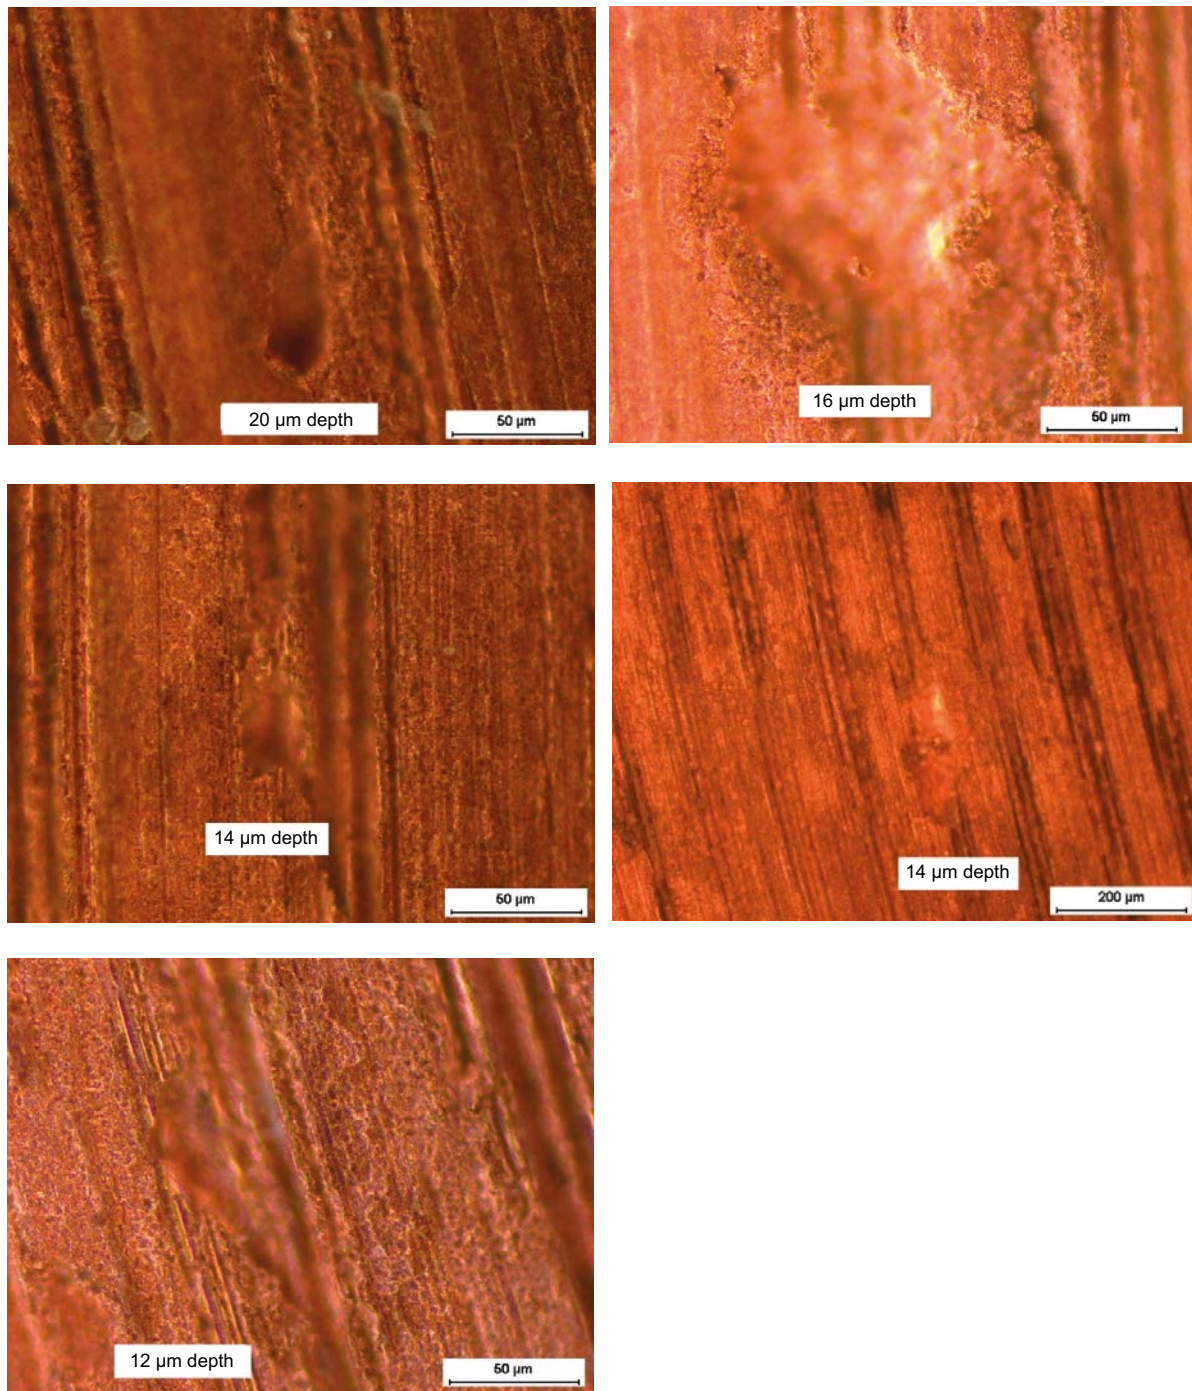
Figure E-15. Microscope images of the deepest defects found on coupon S2/O after pickling.

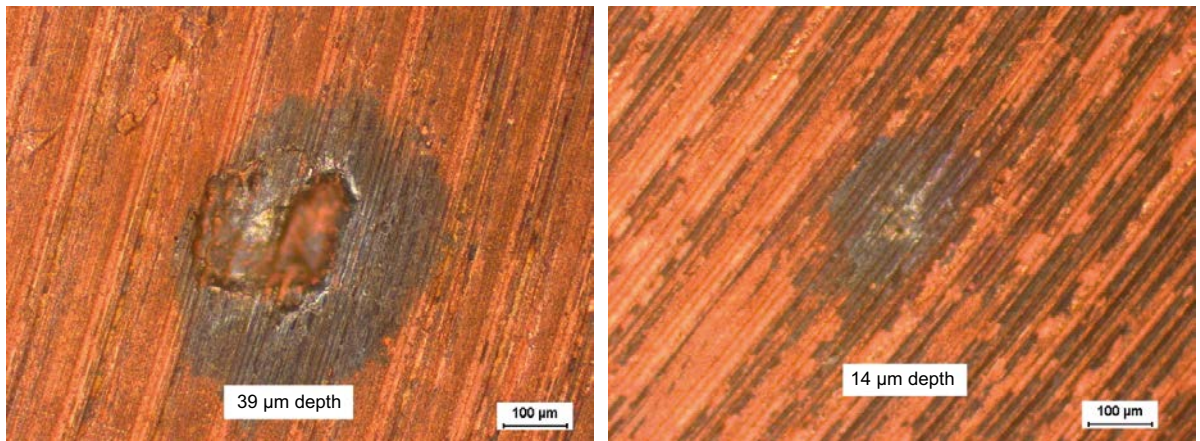
Figure E-16. Microscope images of the deepest defects found on coupon S2/P after pickling.
