R-15-11

Further metallographic analysis of MiniCan SCC test specimens

SVENSK KÄRNBRÄNSLEHANTERING AB

Suzanne Aggarwal, Venugopal Addepalli, Nicholas Smart
Amec Foster Wheeler

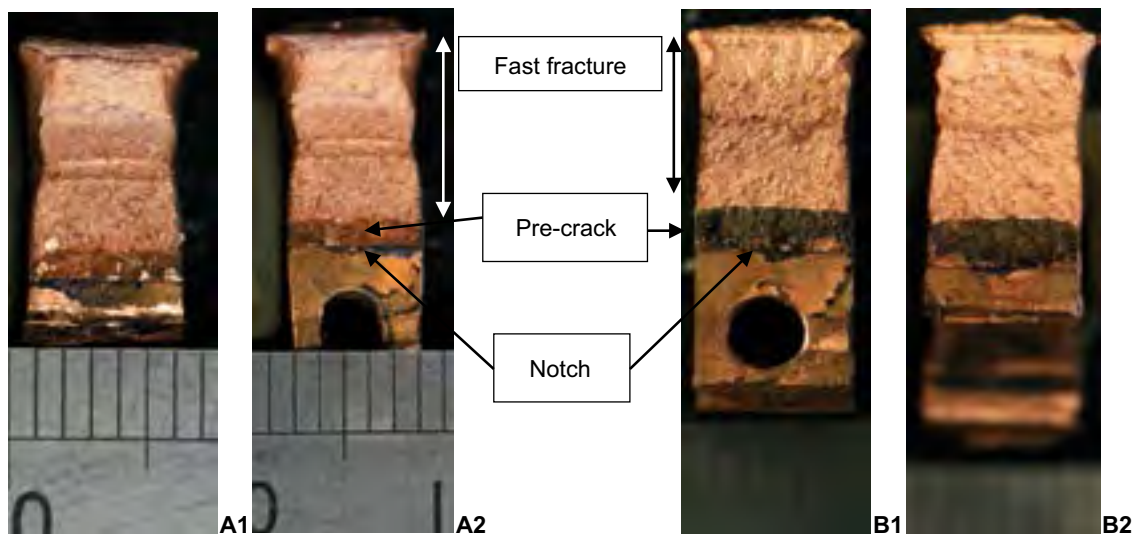
Figure 3-1 shows the WOL specimens before they were removed from the Bakelite mounts and Figure 3-2 shows the opened WOL specimens; there was a range of discoloration on the notch and pre-crack area, along with fresh shiny surfaces on the fast fracture areas. The pre-crack region is evident from the thumbnail shapes emanating from the notch created in the WOLs. WOL B sections appear to have a much darker deposit on the surface of the pre-crack region.

Figure 3-2. Photographic images of WOL A1 and A2, WOL B1 and B2 fracture faces post fatigue and fast fracture (scale 1 mm bars).

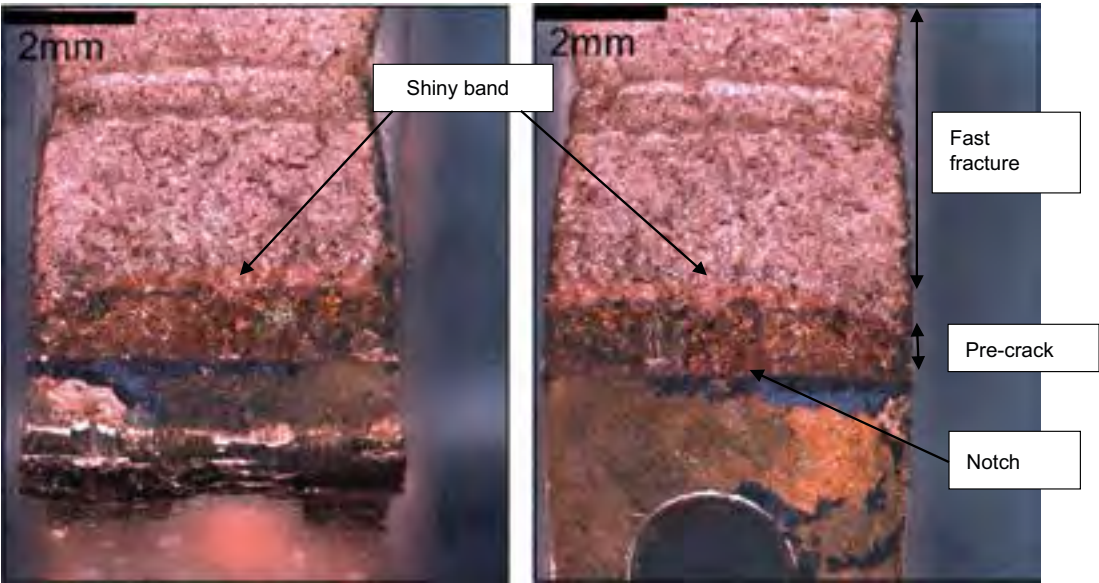
Figure 3-3. WOL A1 (LHS) and A2 fracture faces (RHS).

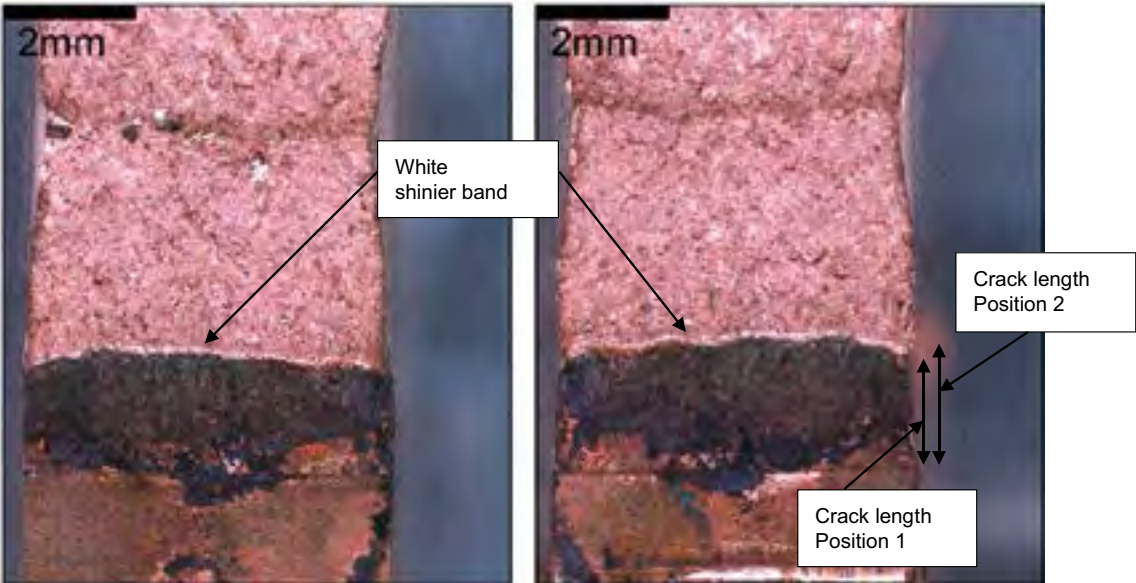
Figure 3-4. WOL B1 (LHS) and B2 (RHS) fracture faces.

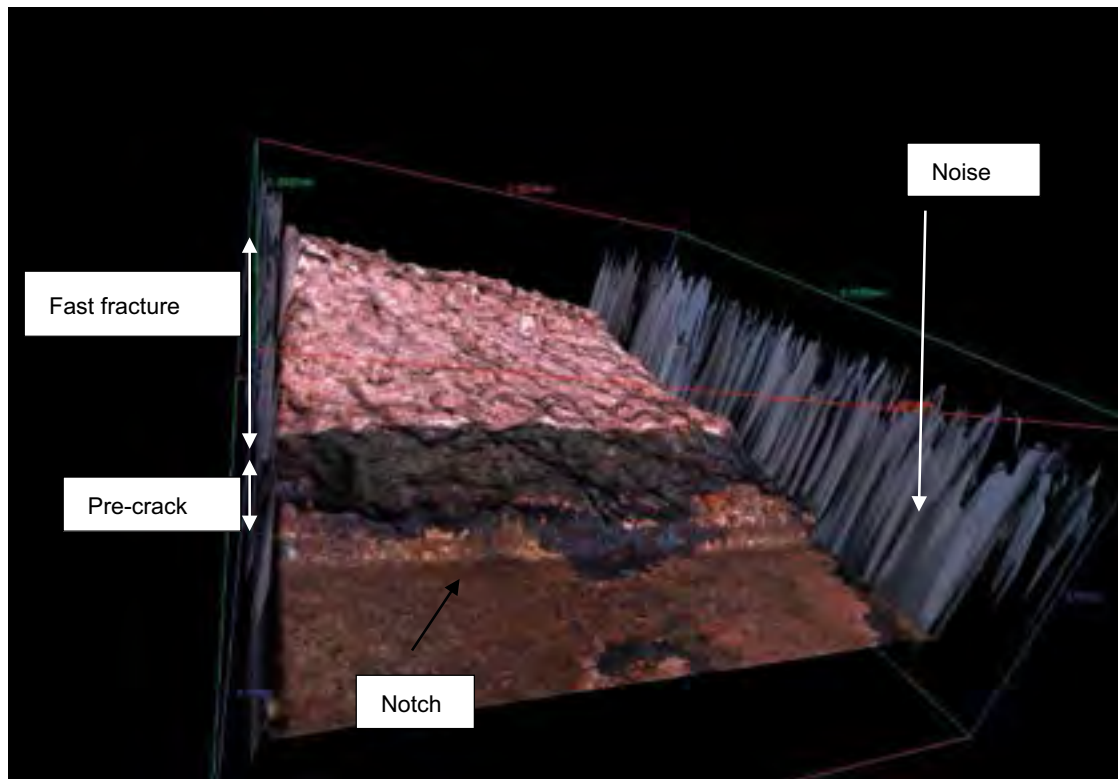
Figure 3-5 is an example of the tilted 3D profile that the Alicona microscope is able to produce of an imaged surface. It shows that the dark deposition on the pre-cracked region had also deposited above the notch of the specimen. There is no evidence from the Alicona microscope images of any dark deposition on any other region past the pre-cracked region.

Figure 3-5. 3D image of WOL B1 fracture surface.

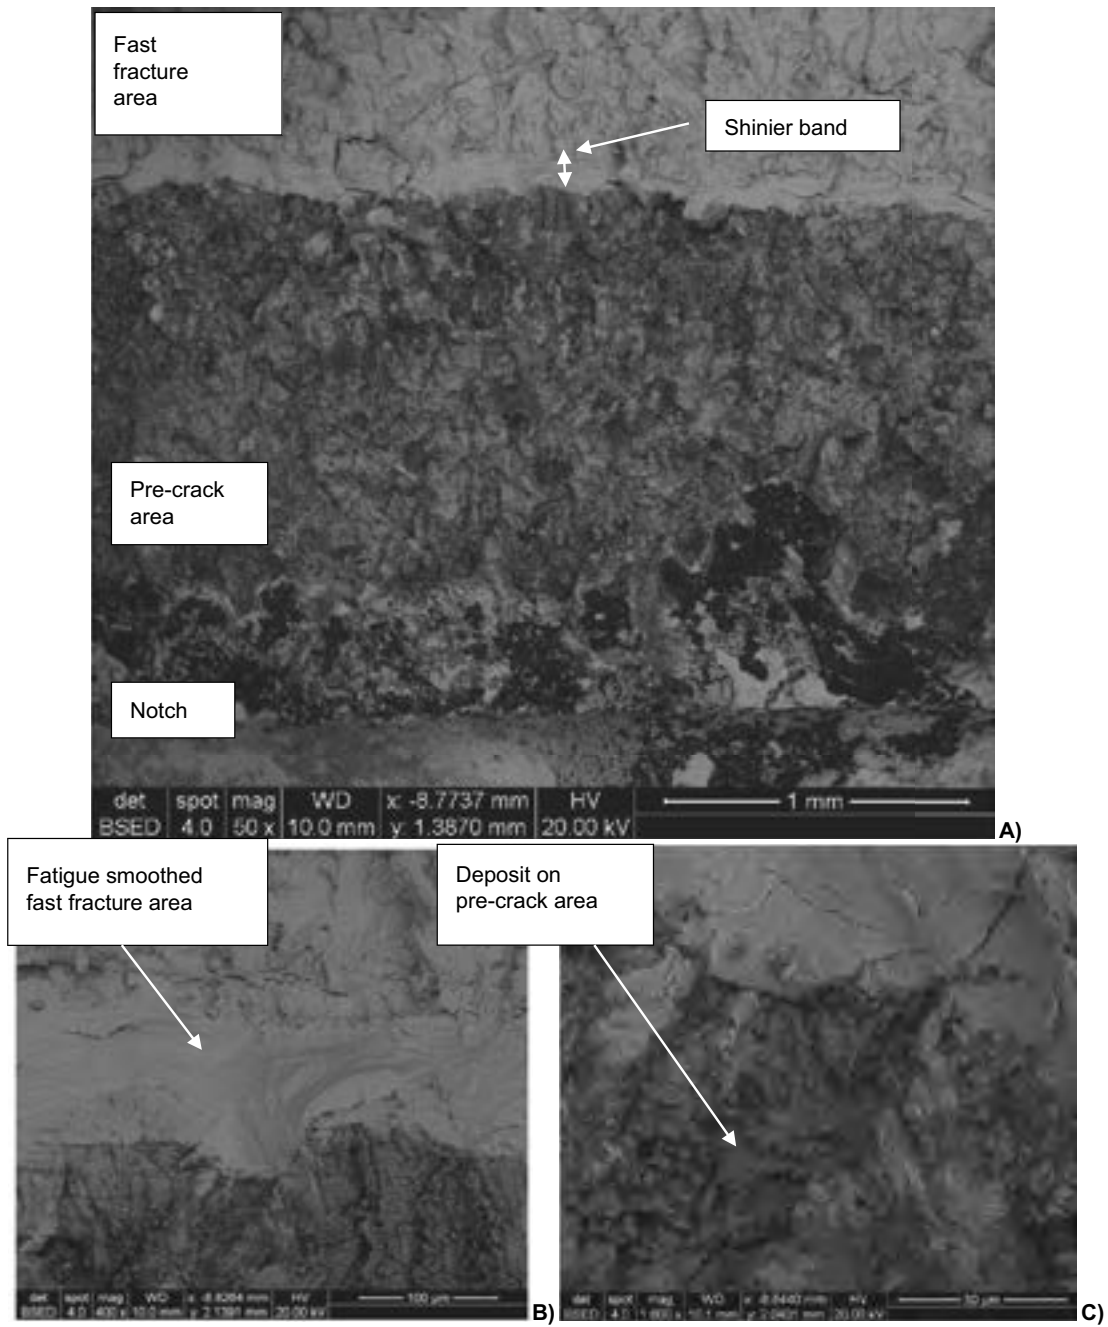
Higher magnification images (Figure 3-10 to Figure 3-12) of WOL B1 and B2 show the location of the shinier band, as seen on the Alicona images in the previous section. The shinier band consists of fatigue lines and smoothed regions, where the initial stages of pulling open the WOLs occurred. This initial smoothing of the fast fracture region is due to the technique required to open the specimens. This shinier band is an artifact that was not caused by the test conditions. There is no evidence of any crack growth that could be attributed to SCC from the pre-crack. The presence of the dark deposit on the surface of each pre-crack surface partially hindered a full analysis. EDX (energy dispersive X-ray spectroscopy) of the pre-crack and fast fracture regions as shown in Figure 3-13, Figure 3-14 and Table 3-2 show that there is evidence of an oxygen-containing deposit being present on the pre-crack area and negligible oxide being present on the fast fracture region. Table 3-2 also indicates the presence of some carbon in the deposit. Due to the limited sensitivity of the EDX technique it can only be speculated that the carbon is present as an organic deposit or as carbonate (when taking into consideration the EDX results for the U-bend specimens, Section 3.2.3). Therefore, although visual evidence of a deposit on fracture faces A1 and A2 is limited to SEM images, the EDX analysis supports the conclusion from the Alicona images of there being an oxygen-rich deposit present only on the pre-crack area and no further.

Figure 3-10. SEM image of WOL B1 (near to borehole flange), end of pre-crack, A) $\times 50$, B) $\times 400$ and C) $\times 1600$ magnification.

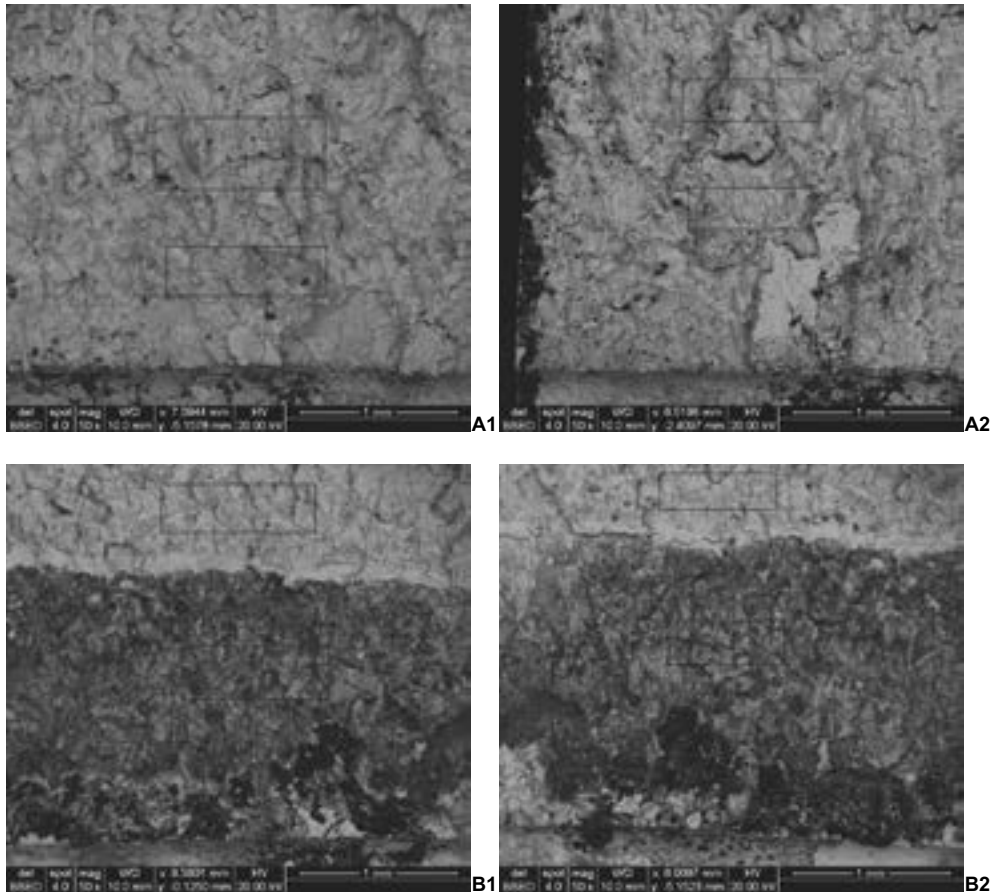
Figure 3-13. Backscattered electron detector (BSED) images of pre-crack and fast fracture regions showing positions of EDX analysis for oxygen (oxide) determination on WOL A (top row) and WOL B (bottom row) surfaces.

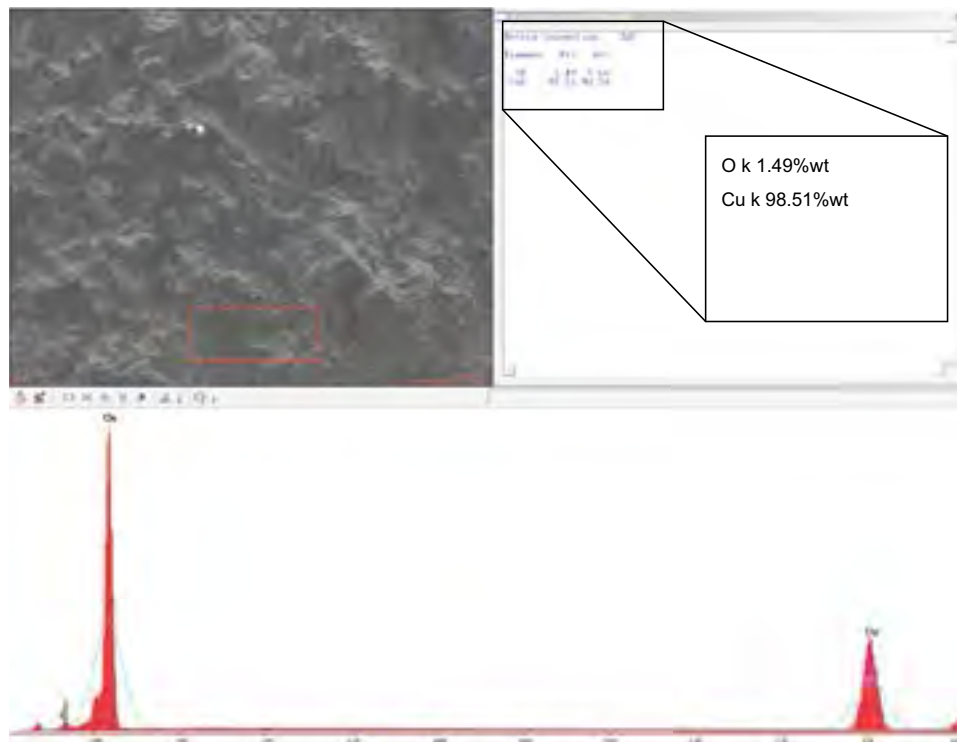
Figure 3-14. Example of EDX analysis for pre-crack region of WOL specimen A1.

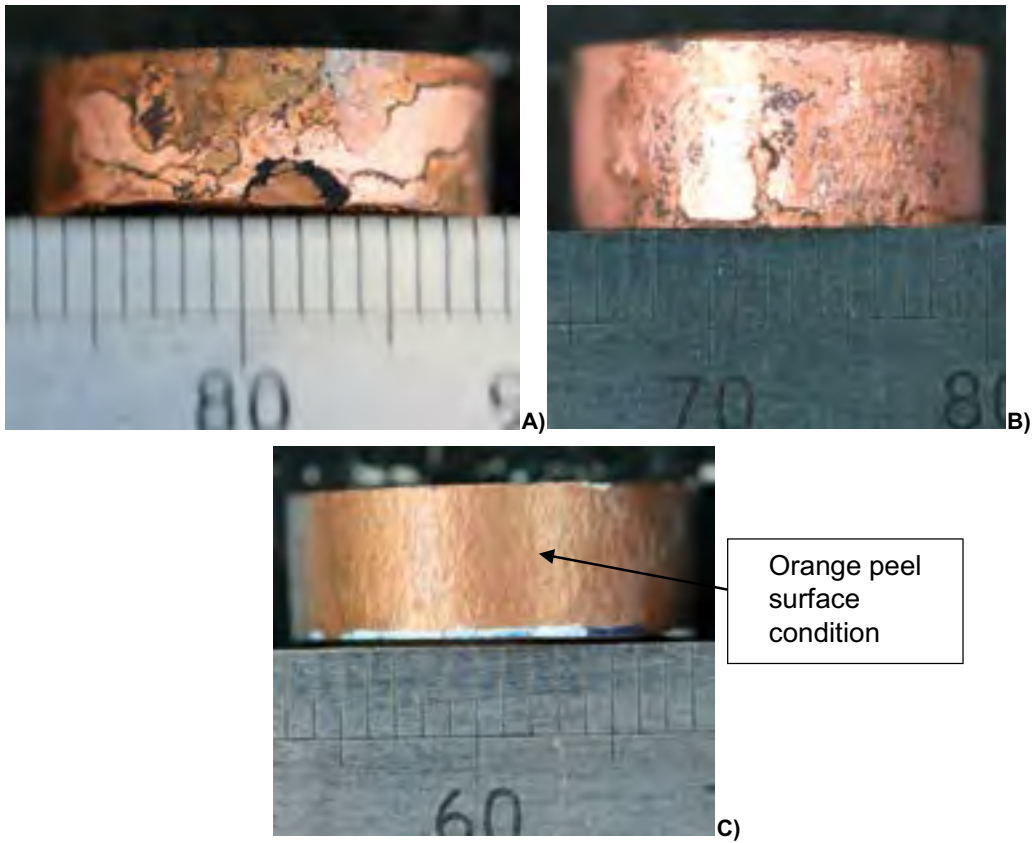
Figure 3-16. Surface condition of previously mounted slices A) bottom slice B) top slice and C) unmounted slice of 95UG (near to borehole flange).

In Figure 3-16 and Figure 3-17, showing the tested U-bends, there appears to be a residue or deposit on the surface of the U-bends. This is located on the inner, outer and flat end surfaces of the U-bends. The patchiness of the residue or deposit on the previously mounted sections / slices (top and bottom) is attributed to the removal of the Bakelite to re-evaluate the surface features of the U-bends. This is confirmed by the shininess of the patchy regions where fresh copper surfaces had been exposed.

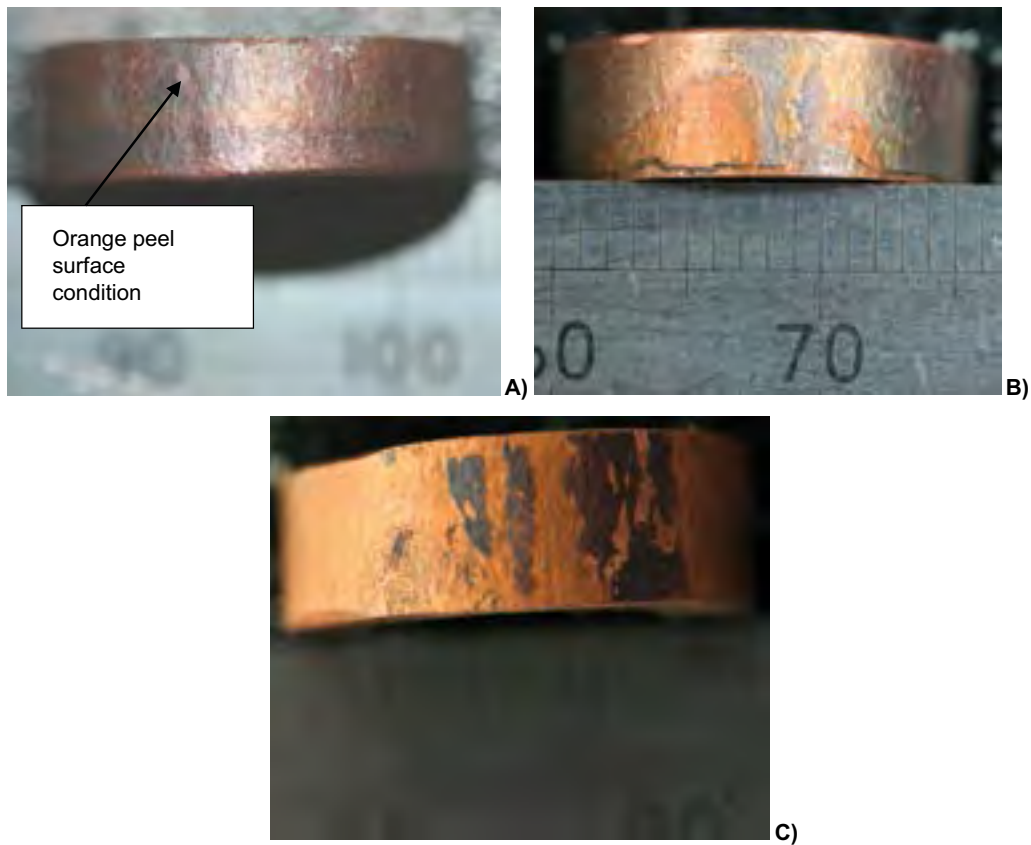
Figure 3-17. Surface condition of previously mounted slices A) bottom slice B) top slice and C) unmounted slice of 94UG (near to cage).

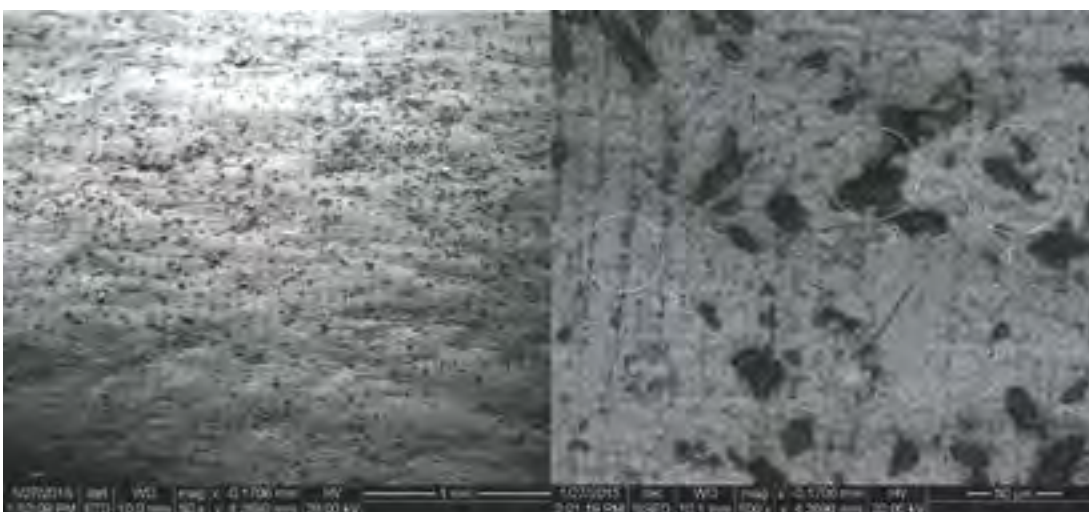
Figure 3-29 to Figure 3-38 are SEM images of the tested U-bends, all showing evidence of surface deposition. Table 3-4 and Figure 3-29 show the results of EDX analyses at three different positions on the surface of a tested U-bend specimen whose elemental composition was characterised using EDX. All three positions showed the presence of carbon, oxygen, calcium and copper in varying proportions. This suggests that there was a general surface deposit that was oxygen-rich, possibly a calcium-copper carbonate. The pit size range seen on the surface was up to a maximum of ~20 μm diameter.

Figure 3-29. $\times 50$ and $\times 500$ magnification SEM images of 94UG unmounted section slice with curvature of U-bend from top of image to bottom. The results of EDX spot analyses of the features marked as 1, 2 and 3 are given in Table 3-4.

Element	Position 1	Position 2	Position 3
Carbon	34	39	39
Oxygen	38	14	9
Molybdenum	1	1	1.8
Calcium	23	2	0.4
Copper	4	41	49
Other elements	–	3	0.7

When compared with the untested U-bend, Specimen 94 UG shows evidence of pitting on the surface of the material. There appear to be striations of pits (i.e. selective attack), along the machine tool marks, as well as generally dispersed pits not associated with any machine tool marks. No significant difference in the EDX analysis of the pits was noted between the two types of corrosion (i.e. general corrosion and selective corrosion).

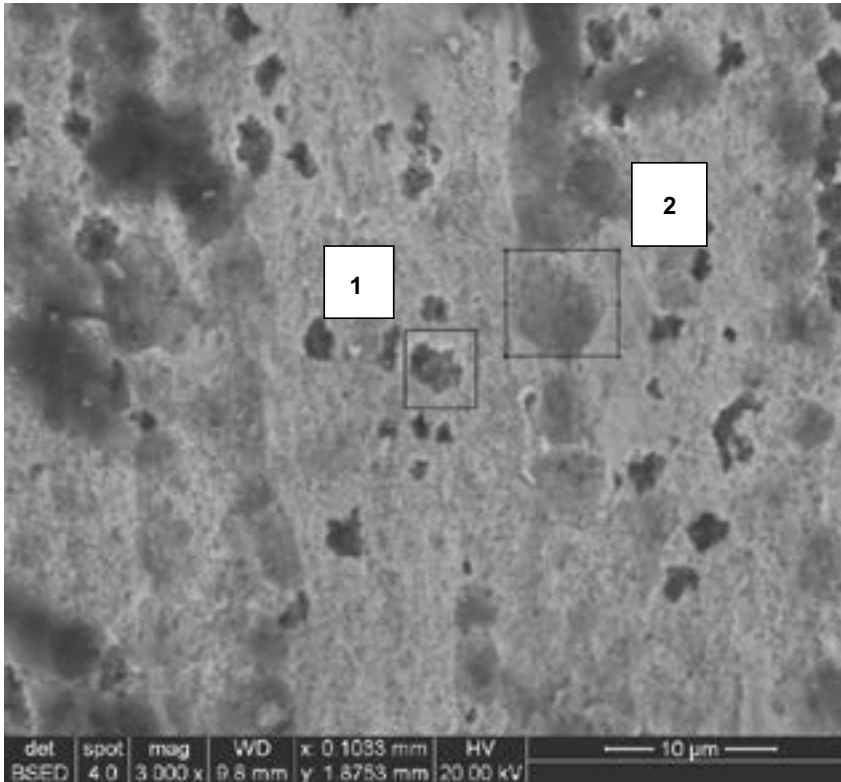
Element	Position 1	Position 2
Carbon	34	43
Oxygen	8	6
Copper	55	51
Other elements	3	-

Figure 3-31. EDX analysis of pit 1 (general corrosion) and 2 (selective corrosion) of 94UG unmounted section.

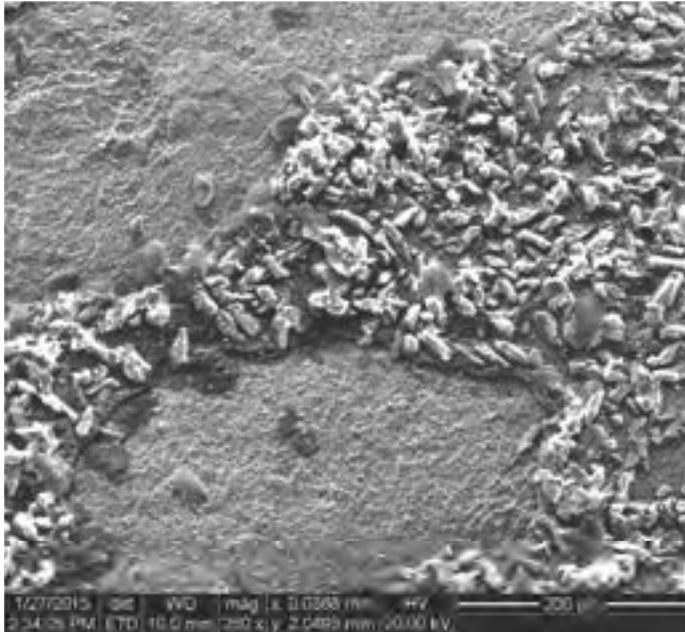
Element	
Carbon	49
Oxygen	14
Iron	7
Calcium	6
Manganese	0.1
Copper	18
Other elements	5.9

Figure 3-35. ×250 magnification SEM image and elemental analysis (EDX) of surface deposit 95UG unmounted slice.

95UG appears to have a considerable carbon- and oxygen-rich deposit on the surface of the material. This is shown in Figure 3-35, along with EDX data in the neighbouring table. This data further supports the possibility of calcium-copper carbonate being present on the surface of the tested U-bend specimens.

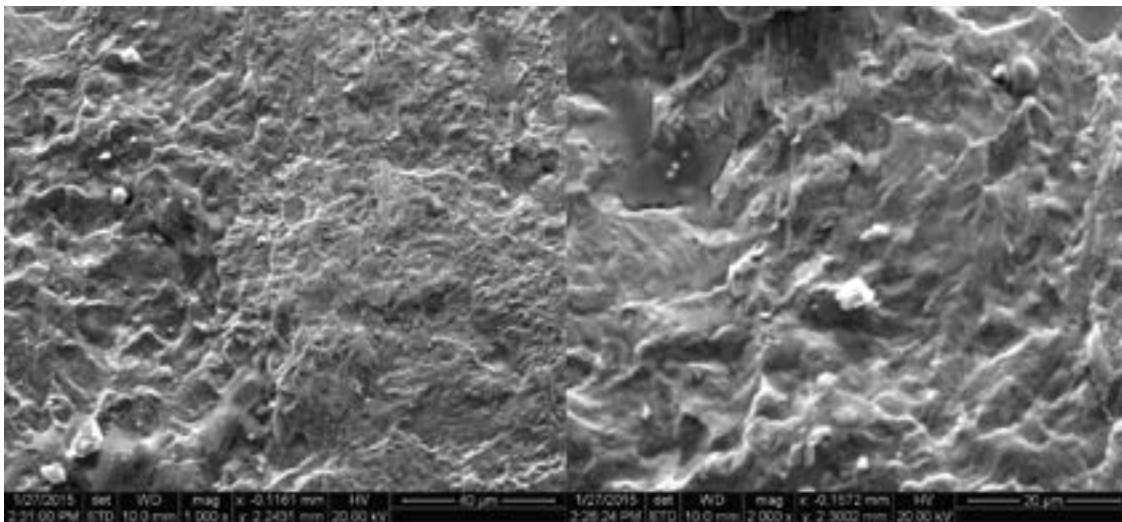
Figure 3-36. ×1000 and ×2000 magnification SEM images of 95UG unmounted slice U bend with curvature from top of image to bottom showing general surface corrosion.

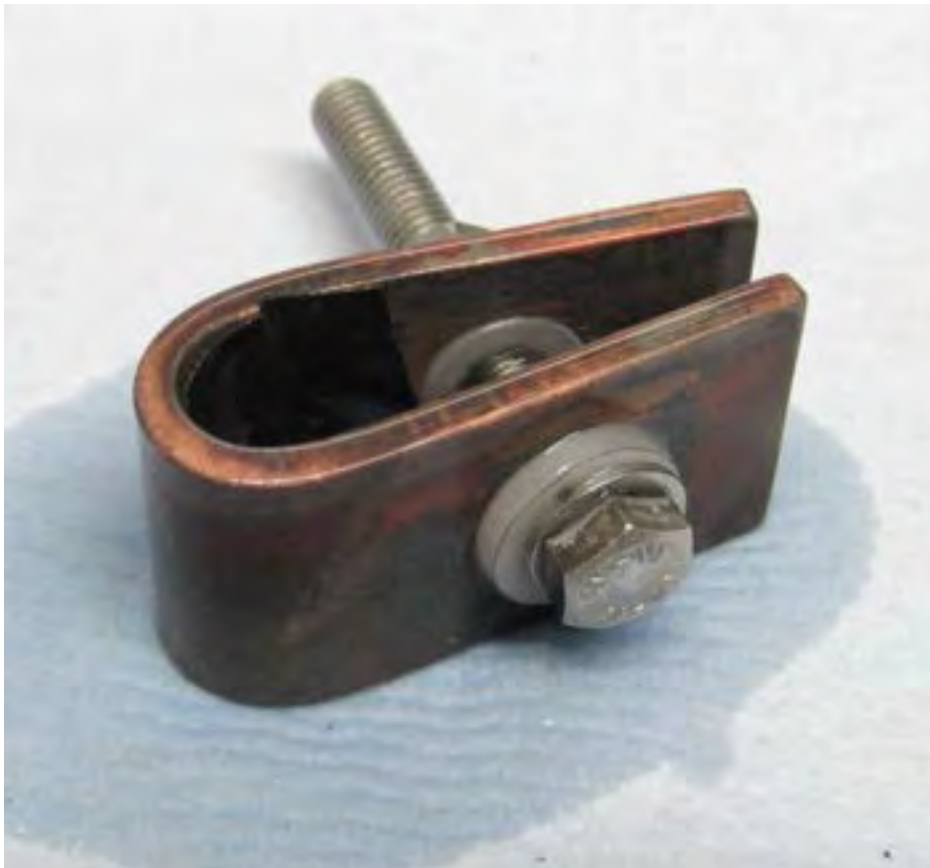
Figure 3-39. U-bend specimen 94UG immediately after removal from the water-filled transfer flask when the specimens were transported to the UK for analysis (Smart et al. 2012).

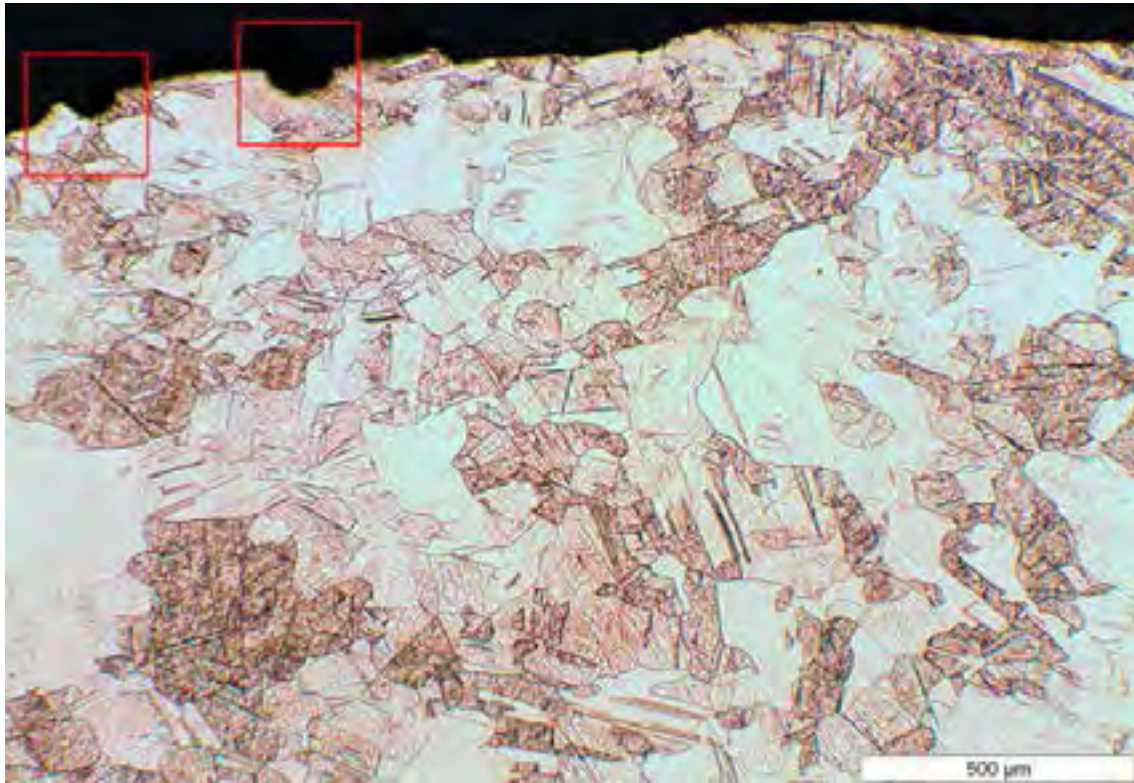
Figure A3-1. Optical micrograph of the outside cross-section of U-bend specimen 2 (near borehole flange), highlighting areas of surface roughness.
