Febex Project Post-mortem Analysis: Corrosion Study

V. Madina, I. Azkarate
INASMET

AITEMIN requested the INASMET Foundation to carry out the tasks laid down in quotation Ref. 73.1707.2, consisting of a study of the corrosion suffered by different components of the “in situ” test of the FEBEX Project being carried out by AITEMIN in Grimsel (Switzerland).

The test began in July 1996 and, after approximately six years, one of the heaters, a section of guide tube (liner), samples and four sensors were extracted in June 2002. These elements were the object of the study, the aim of which was to evaluate the behaviour of the above-mentioned elements in relation to the corrosion phenomena suffered in the same conditions as those predicted for deep geological disposal in a granitic formation.

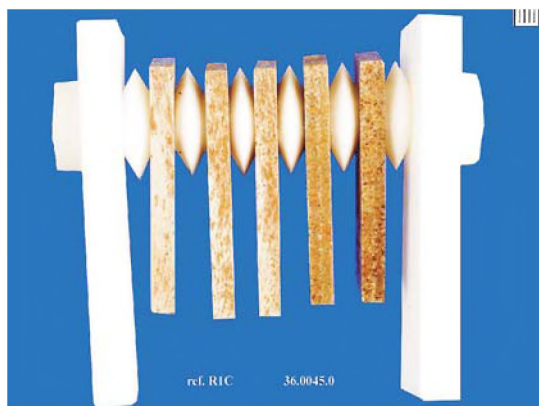
This rack consisted of 5 carbon steel coupons: 2 base material coupons, identified as 1C1 and 1C2, and 3 test coupons with welded joints, 1C3 (EBW), 1C4 (FCAW) and 1C5 (MAG). Visual analysis revealed very superficial corrosion of the carbon steel coupons, even with shiny uncorroded zones being observed, [Figures 31 and 32](#).

Figure 31: Reception rack ref. R1C (TStE355 steel).

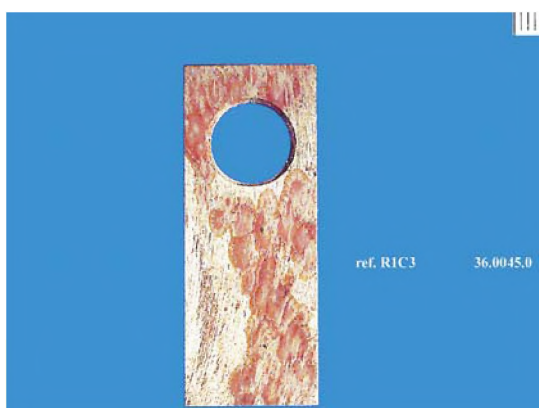
Figure 32: Corrosion coupon Ref. R1C3.

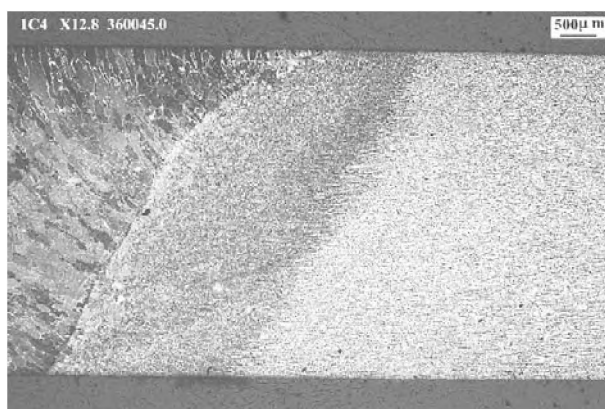
Metallographic study of tested coupons shows little penetration of the corrosion, with no differences in the extent of the corrosion being noted between the base and welded materials, [Figures 33 and 34](#). Scanning electron microscope (SEM) analysis of the surface of these coupons reveals a poorly adherent and discontinuous layer of oxide, [Figure 35](#). EDS analysis of this oxide, [Figure 36](#), reveals the majority presence of iron and oxygen, with a small amount of chlorine. The XRD spectrum of the sample only detects the substrate (Fe), given the lack of thickness of the oxide layer generated on the surface of the test sample.

Figure 33: FCAW welded joint, coupon Ref. R1C4.

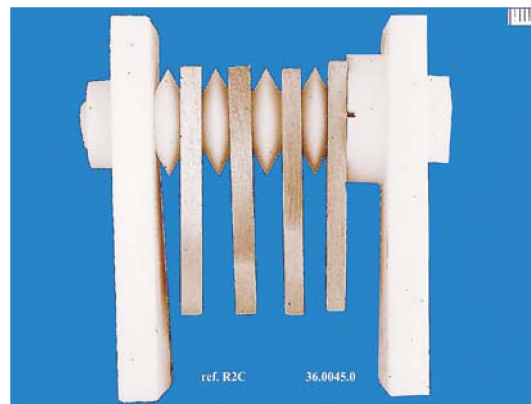
test pieces tested, which presented the same appearance as they did before beginning the “in situ” test, [Figures 37 and 38](#). Only one of the coupons, identified as R2C3, showed some small marks, [Figure 39](#). Scanning electron microscopy examination revealed that said zones were characterised by stains or colour changes on the surface of the metal, with no corrosion penetration of the material being observed, [Figure 40](#).

Figure 37: Reception rack Ref. R2C (316L steel).

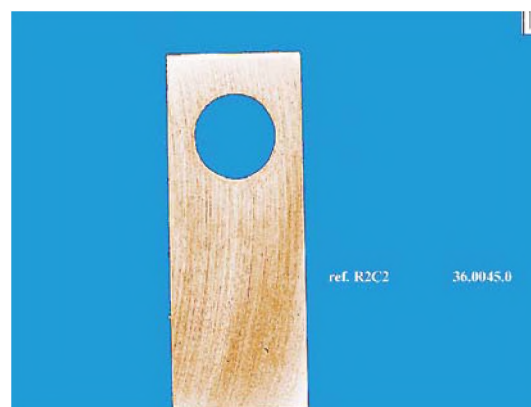
Figure 38: Corrosion coupon Ref. R2C2.

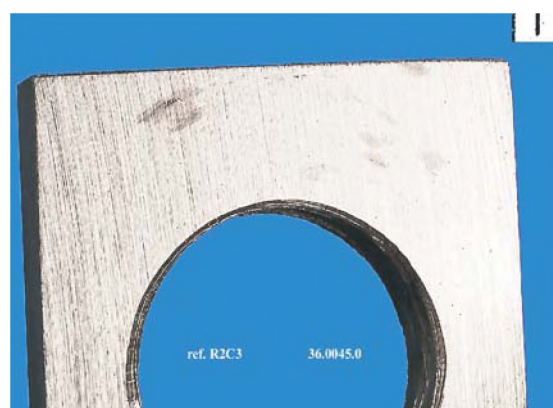
Figure 39: Corrosion coupon Ref. R2C3.

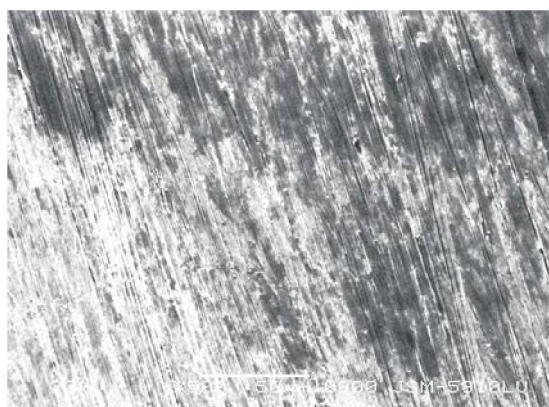
Figure 40: SEM micrograph of surface of R2C3.

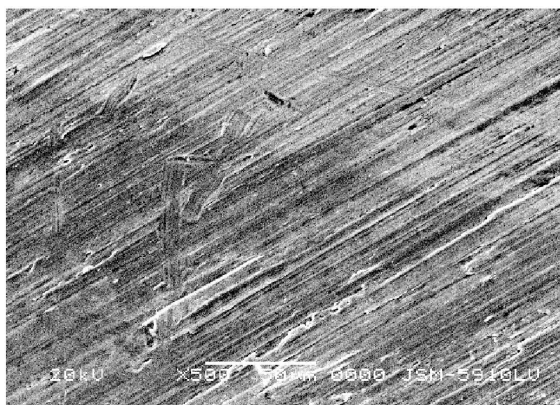
This rack consisted of 8 coupons: Ti Gr 2 base (3C1), Ti Gr 2 EBW (3C2), Ti Gr 7 base (3C3 and 3C4), Ti Gr 7 EBW (3C5), Ti Gr 7 PAW (3C6), Ti Gr 12 base (3C7) and Ti Gr 12 EBW (3C8). No corrosion at all was observed of the titanium coupons examined, neither generalised nor localised, [Figures 41 to 44](#). However, on all test pieces there were observed the traces left by the Teflon crevice device used with the titanium test pieces. SEM analysis of these zones revealed that, in all cases analysed, they were strips slightly darker than the rest of the metal, with no beginnings of corrosion due to overlapping or crevice being observed, [Figure 44](#).

Figure 44: SEM micrograph of surface of R3C2 (Ti 6r-2).

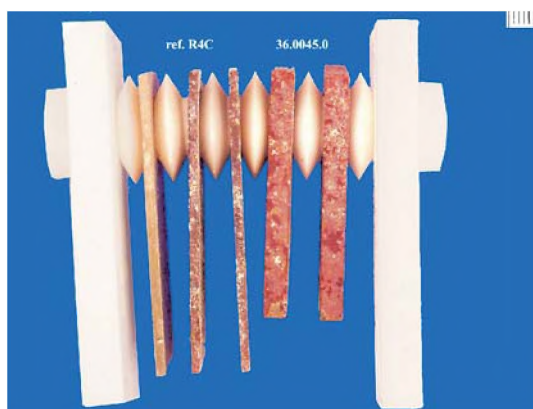
and 4C4) and 1 of Cu30Ni cupronickel (4C5). This rack showed the greatest amount of corrosion of the test pieces making it up, Figure 45. The Cu-ETP coupons showed a dense and not very adherent oxide layer, Figure 46. The EDS and XRD analyses, shown in Figures 50 and 51, respectively, reveal that this oxide corresponds to the molecular cuprite Cu_2O , with other minerals proceeding from the bentonite being detected. A small chlorine peak was also observed.

Figure 45: Reception rack ref. R4C (coppers).

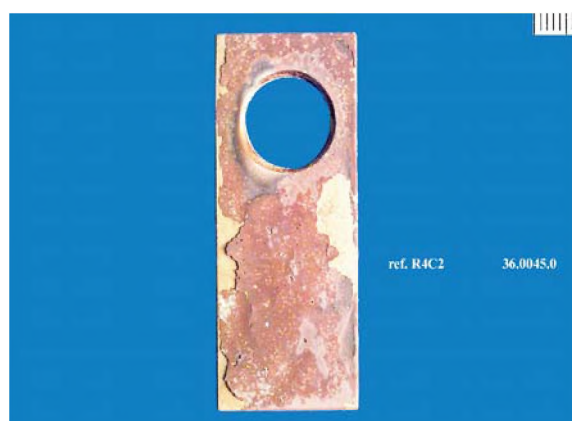
Figure 46: Corrosion coupon Ref. R4C2 (Cu-ETP).

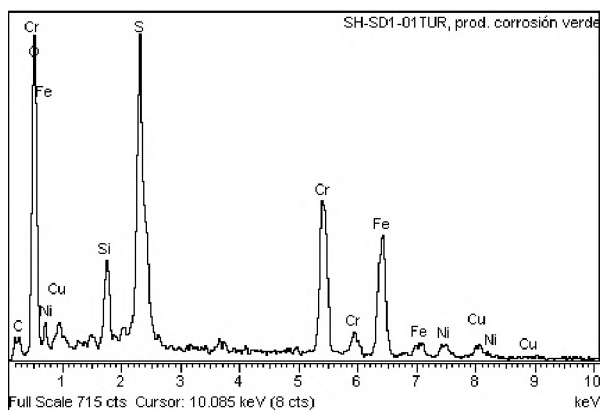
The EDS analyses carried out on the green corrosion products show the presence of sulphur, sometimes predominant, [Figures 85, 89 and 92](#). Analysis of the reddish corrosion products shows them to be enriched with the element iron, [Figures 88 and 93](#). A significant fact is that analysis of the corrosion products beneath pustules shows calcium enrichment as well as sulphur, [Figure 90](#).

Figure 85: EDS spectrum of green corrosion products on sensor SH-SD1-01, close to the rock.

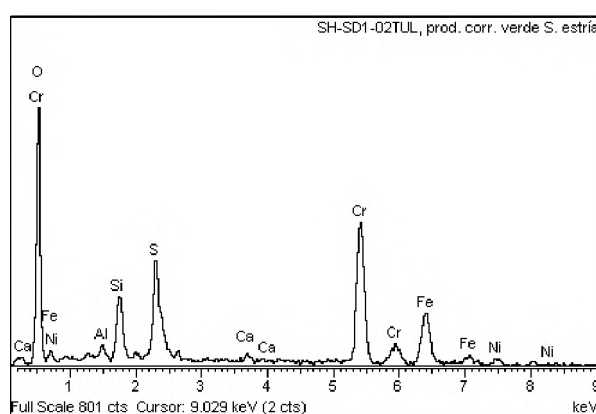
Figure 89: EDS spectrum of green corrosion products on sensor SH-SD1-02, close to the rock.

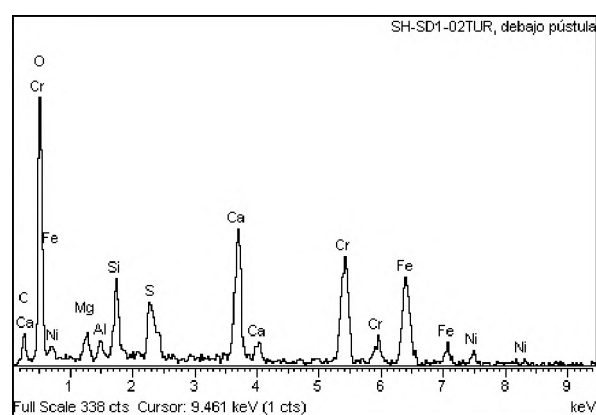
Figure 90: EDS spectrum of corrosion products/deposits under pustules on sensor SH-SD1-02, close to the liner.

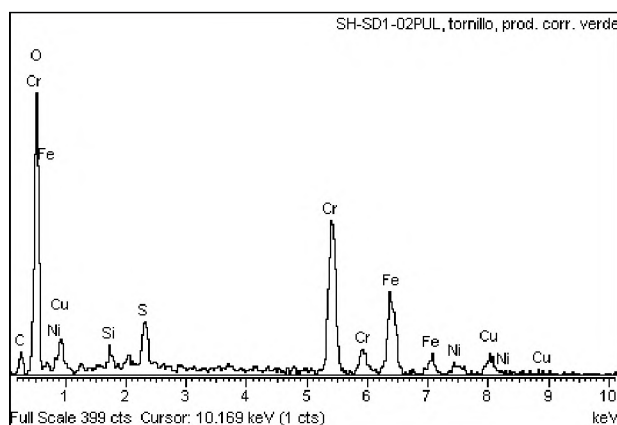
Figure 92: EDS spectrum of green corrosion products on the screw fixing sensor SH-SD1-02 to the liner.

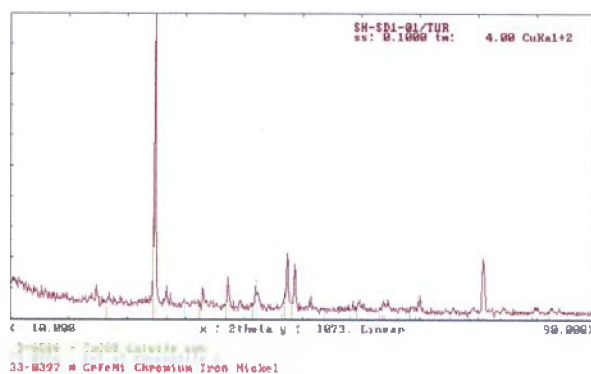
Figure 96 shows the spectrum obtained from analysis of the green corrosion products observed on the surface of the sensor SH-SD1-01. As well as calcite, CaCO_3 , analysis also detected iron sulphide Pyrrhotite, Fe_{1-x}S . XRD analysis carried out on one of the pustules, Figure 97, associates the peaks with calcite.

Figure 96: XRD spectrum of green corrosion products on sensor SH-SD1-01, close to the rock.

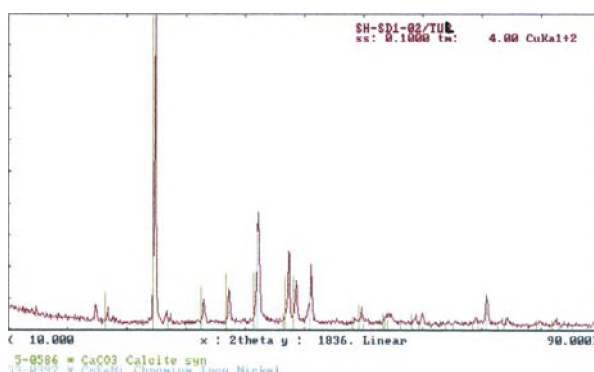
Figure 97: XRD spectrum of corrosion products on sensor SH-SD1-02, close to the liner.

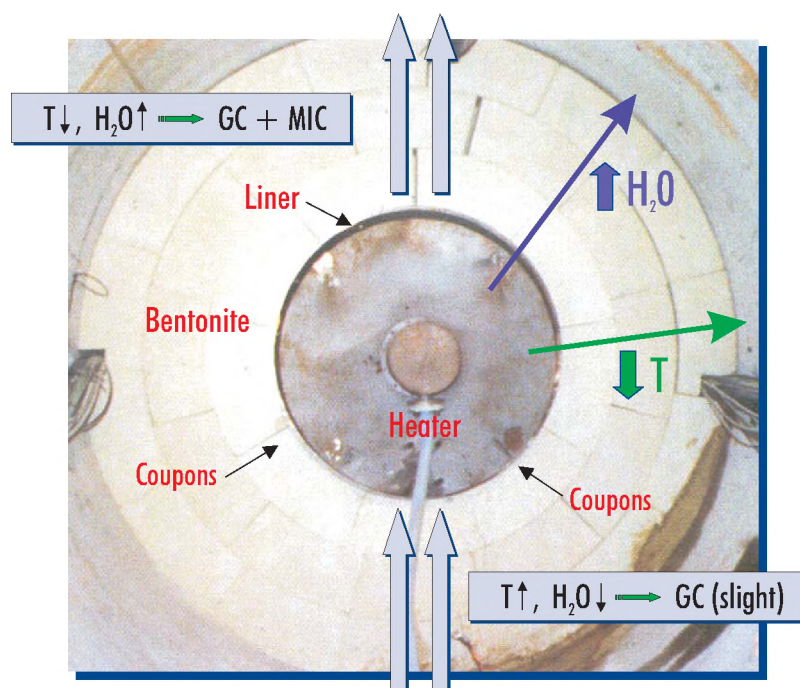
After analysing the results we obtain in [Figure 133](#) to explain the evolution of the corrosion suffered by the different components, in function of the temperature and humidity of the “in situ” test.

Figure 133. Evolution of the corrosion suffered by the different components, in function of the temperature and humidity of the “in situ” test. GC: Generalised Corrosion. MIC: Microbiologically Induced Corrosion
