Post-test examination of copper coupons from LOT test parcel A2 regarding corrosion

Bo Rosborg
Rosborg Consulting and Stockholm University

Report compiled by Bo Rosborg based upon experimental work performed at Clay Technology AB, Stockholm University and Studsvik Nuclear AB.

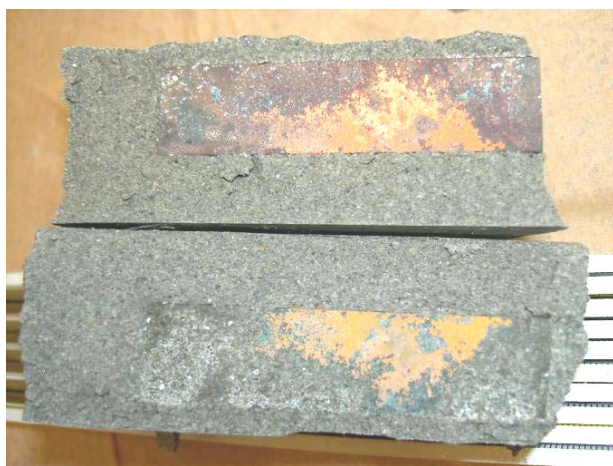
After breaking loose a copper coupon from the bentonite, corrosion products could as found before (5-6) be seen on parts of the bentonite surfaces facing the copper coupon, see Figure 1.1, thus revealing a better adherence to the bentonite on part of the surface. A brownish corrosion product layer with blue-green corrosion products here and there on top of it covered most of the copper coupons, see Figure 1.2. However, apparently bare copper surface was also seen. The blue-green corrosion products revealed the presence of bivalent copper.

Figure 1.1 Corrosion products seen on the adjacent bentonite after breaking loose copper coupon A230H. (The copper coupon is in place in the upper bentonite piece.)

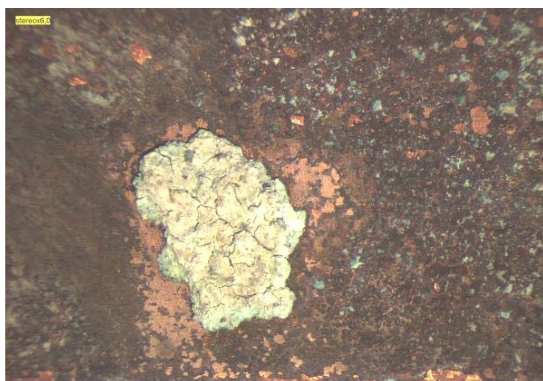
The blue-green corrosion products were not only unevenly distributed on the copper coupons, but also in between them. Copper coupon A230G contained the most, see Figure 1.2 through 1.5. (It showed also the maximum weight loss, see Appendix E.) The EDS data revealed that the blue-green corrosion products penetrated into the bentonite.

Figure 1.3 Part of Figure 1.2 with the blue-green “crust”.

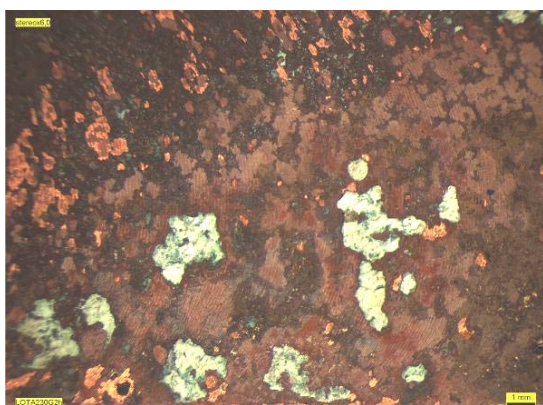
Figure 1.5 Part of Figure 1.4 with the blue-green corrosion products.

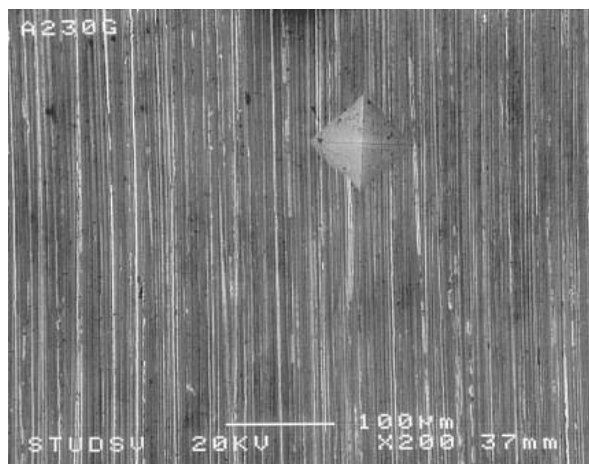
Figure 2.1 The micro hardness indentation mark (a Vickers pyramid indent) in the centre of the slightly polished side 1 of copper coupon A230G before exposure.

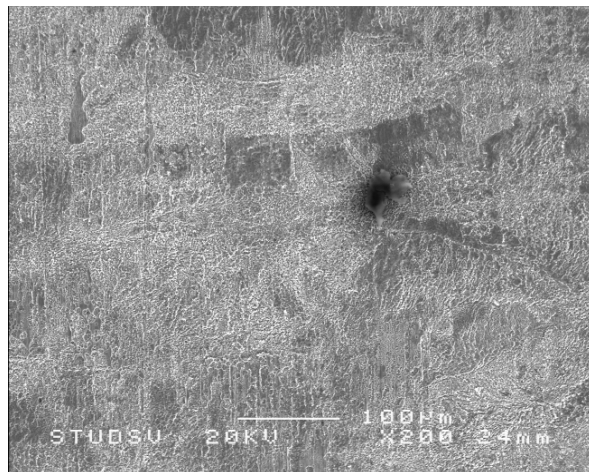
As before (6) the micro hardness indentation marks on the polished side of coupons A222E and A230G made before exposure, as shown in Figure 2.1, were not found after exposure, in spite of the fact that the identification, the milling cutter and the polishing marks are clearly seen (and that the average corrosion rate is estimated to be less than $0.5 \mu\text{m}/\text{year}$, see Appendix E).

Figure 2.2 The centre of the slightly polished side 1 of copper coupon A230G after exposure. (The intention was to find the indentation mark shown in Figure 2.1 after exposure and take a picture of the very same area. However, the mark was not found.)

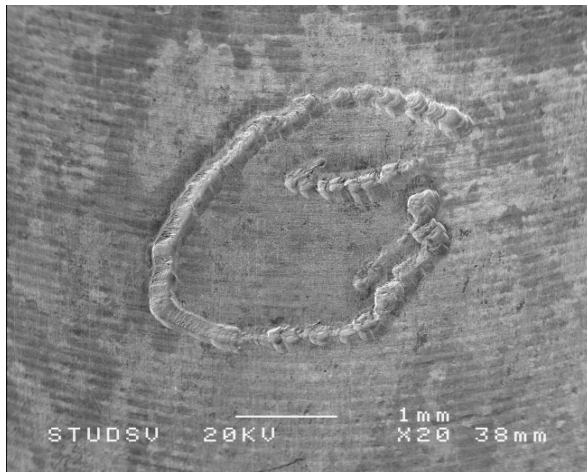
Figure 2.3 The identification mark (the letter G) on side 1 of copper coupon A230G after exposure. (Do observe that the milling cutter marks, but not the polishing marks, are clearly seen.)

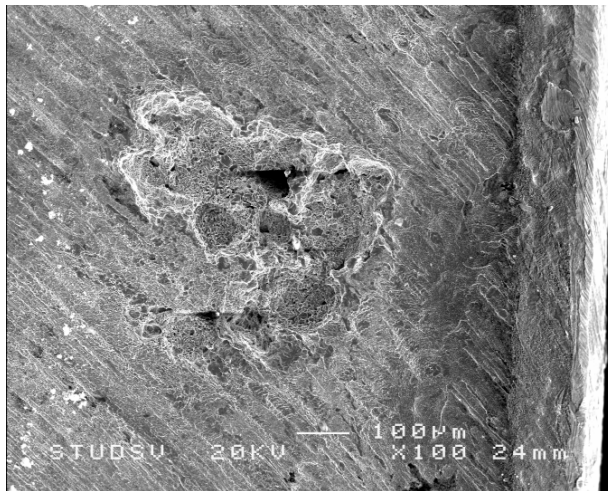
A number of surface defects of the kind shown in Figure 2.4 were, however, found in the copper coupons. They are believed to originate from the manufacturing rather than being a result of corrosion. Any signs of active pits could not be found.

Figure 2.4 Surface defect found in copper coupon A230G close to one edge.

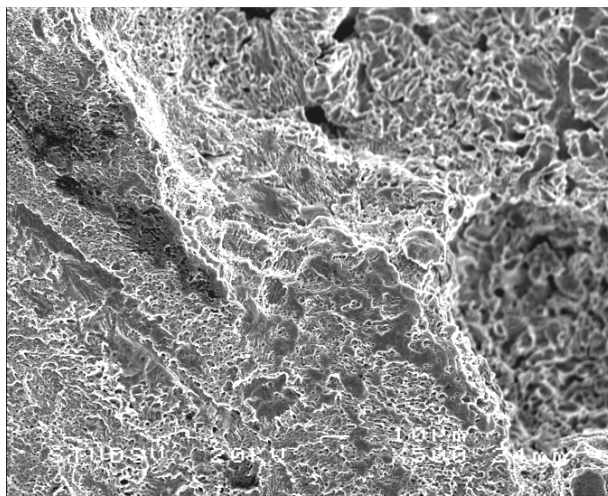
Figure 2.5 Detail of Figure 2.4.

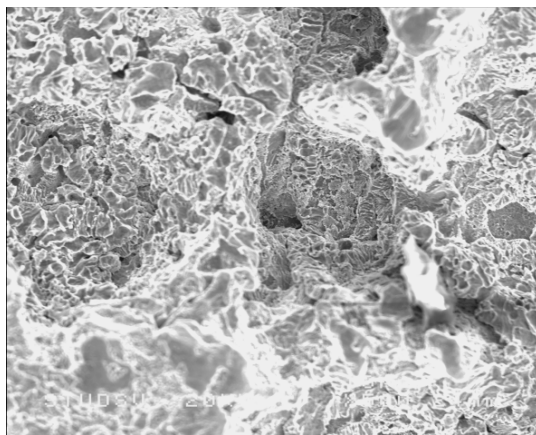
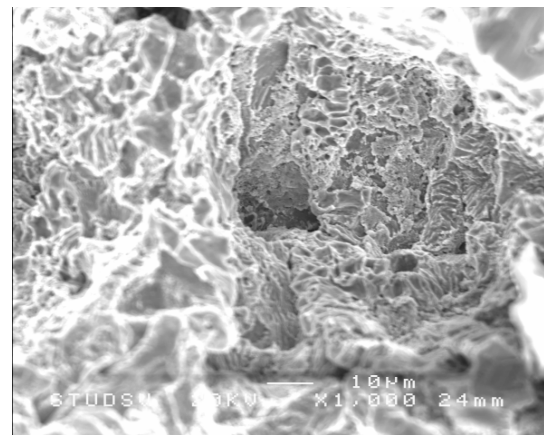
Figure 2.6 Another detail of Figure 2.4 in two magnifications.

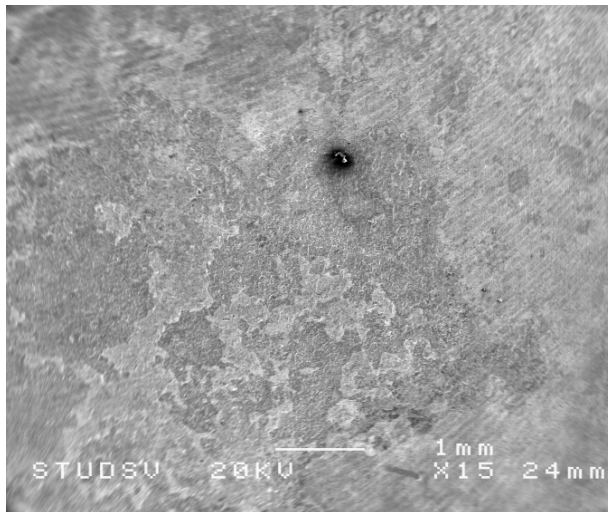
Figures 2.7 through 2.9 show the area below and next to the crust in Figure 1.2 after descaling. The amount of corrosion is somewhat higher at the crust. However, any unambiguous signs of pitting are not obvious.

Figure 2.7 The area at the crust in Figure 1.2 after descaling.

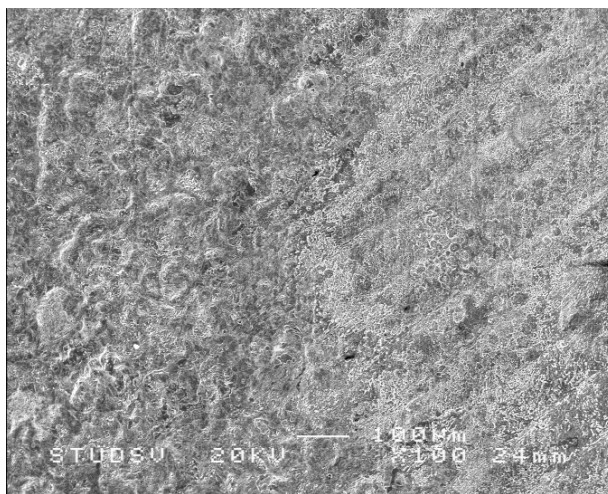
Figure 2.8 Detail of Figure 2.7 showing the boundary between more corroded and less corroded area (the latter to the right where the milling cutter marks are clearly seen).

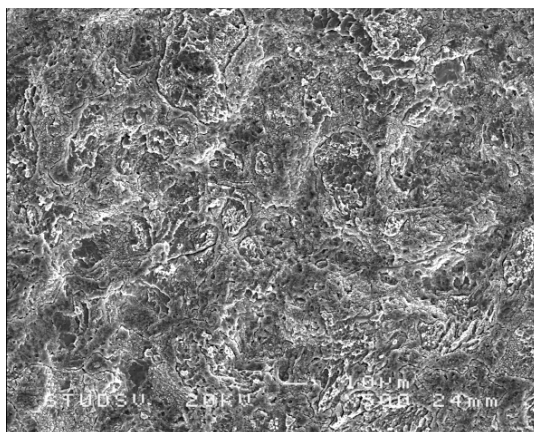
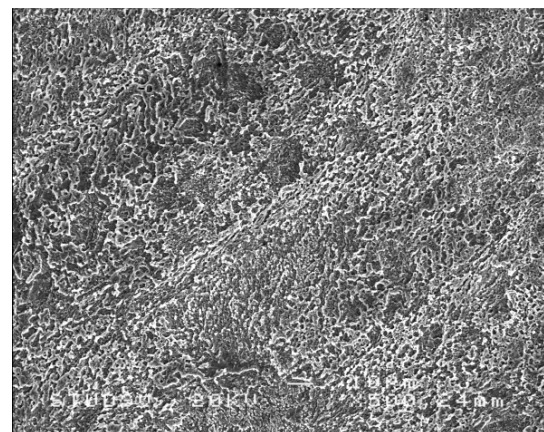
Figure 2.9 The more corroded area (to the left) and the less corroded area (to the right) in higher magnification.

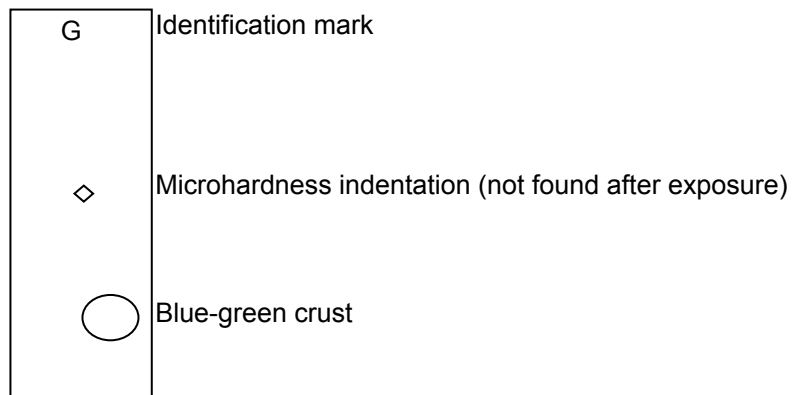
Copper coupon A230G side 1

The blue-green corrosion products were unevenly distributed on the copper coupon; spots and a "crust" (on A230G side 1).

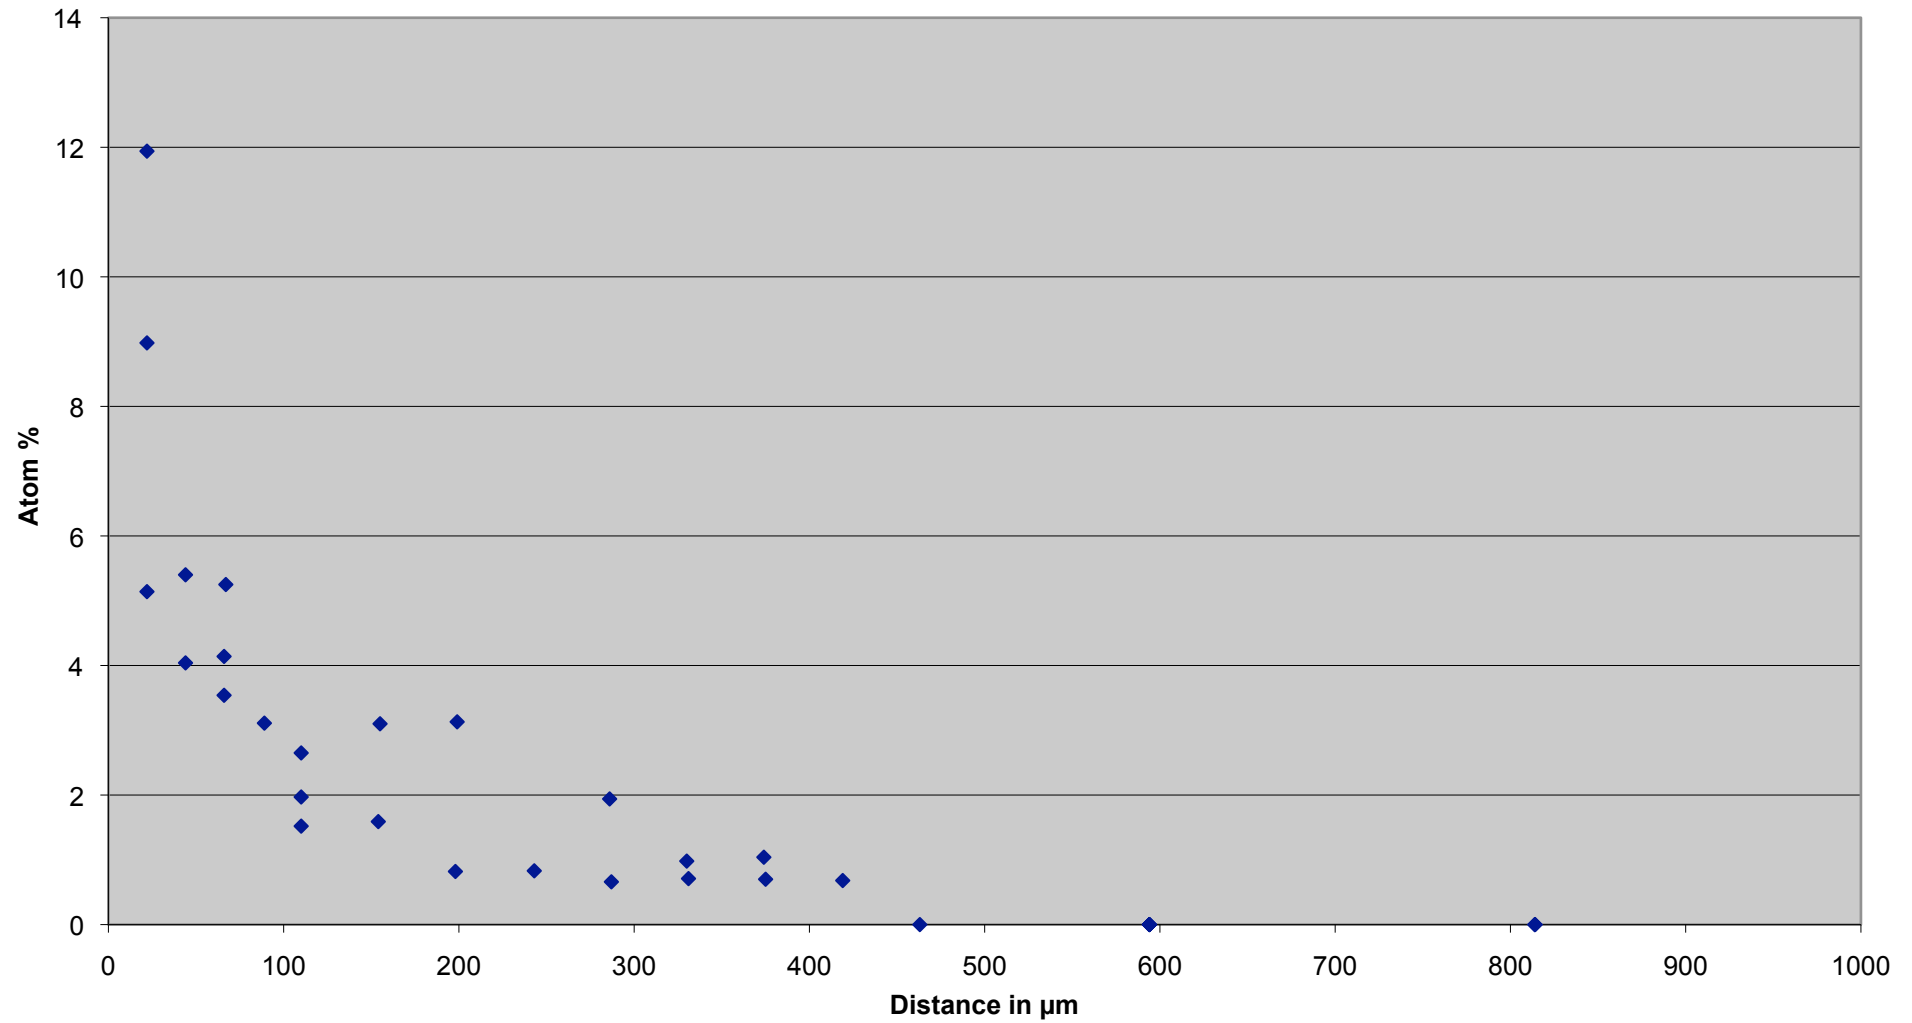
Copper profile in bentonite next to copper coupon A230H

Copper was found to penetrate 500 μm into the bentonite.
