Exposure of Copper in Äspö Groundwaters

Summary

This report describes an exposure that Korrosionsinstitutet performed at SKB's hard rock laboratory at Äspö. Copper coupons were exposed to groundwater at two different depths.

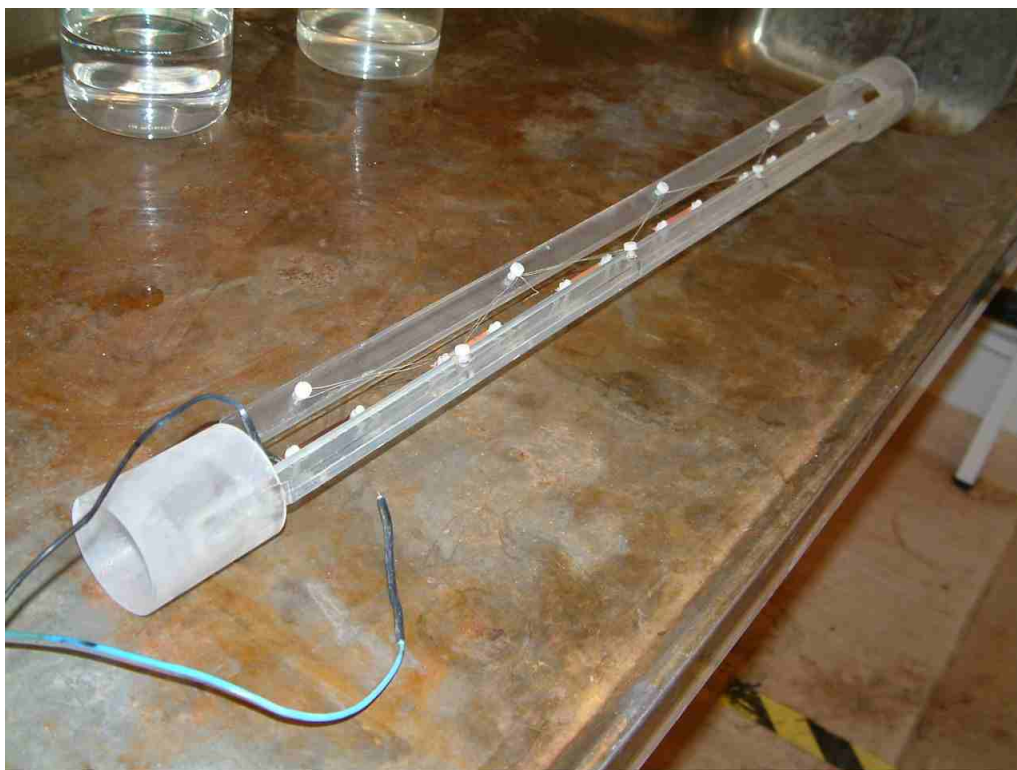
Figures 3 and 4 show photographs from the when the equipment was disassembled. The equipment in figure 3 was exposed in the chloride rich water and the equipment in figure 4 in the sulphide rich water. As figure 3 shows the coupons from the chloride rich water are bright and shiny whereas the coupons from the sulphide rich water (figure 4) are covered with a black substance that easily falls off in flakes.

Figure 3. Dismounting the equipment exposed in the chloride rich water at site SA 2880A.

Copper coupons exposed in the chloride rich water in bore hole 2880 show, to the naked eye, no signs of corrosion. During the exposure period a large amount of ground water has passed through the container with the copper coupons. Assuming a constant flow of 1 litre per minute, approximately 1.3×10^6 litres have passed the copper coupons during the whole exposure period. The average corrosion corresponds to about 6.9 mg Cu per coupon. With 6 coupons in the container, the average copper concentration in the outgoing water would be about $6 \times 6.9 / 1.3 \times 10^6 = 3.2 \times 10^{-5}$ mg Cu per litre. In molar units, the average concentration of copper would be 5×10^{-10} M. With the strong complex forming capacity of the chloride contents of the local ground water, $\sim 13\,000$ mg Cl/litre, the activity of the free Cu^+ ion is so low that the results are consistent with reducing conditions. Thus, the mass loss is consistent with reducing conditions. But there was a mass increase observed after exposure but before pickling. Can the observed mass increase be consistent with reducing conditions? The mass increase could indicate solid corrosion products. Solid corrosion products such as Cu_2O and CuCl would explain the mass increase but their formation is not consistent with reducing conditions and they are so soluble that their presence at the surface does not seem to be consistent with the very low copper concentration in the water. It is possible that the mass increase is due to deposits or sediments from the ground water that has nothing to do with copper corrosion. However, the microscope image in figure 5 shows some rainbow coloured patterns on the copper coupon that are similar to the patterns that can be observed in figure 4 for the coupon exposed in sulphide rich water. The local ground water in bore hole SA2880A is nominally free of sulphide as shown in table AII in appendix I. The measurement uncertainty is given as 0.1 mg/litre. The composition of the sulphide rich water in bore hole SA1420A in table AI in appendix I shows that the sulphide concentration varies from one analysis to another. The variations are very high in relative terms. In absolute terms and in relation to the measurement uncertainty, the sulphide concentrations may be considered low. The reported values are in several instances lower than the measurement uncertainty. Yet we conclude that the sulphide contents in the water from bore hole SA1420A is responsible for the corrosion of the copper coupons exposed to this water. It would be consistent with observations if sulphide present, in the water from bore hole SA2880A, at concentrations below reporting level, is the cause for the observed corrosion of the copper coupons exposed to this water.

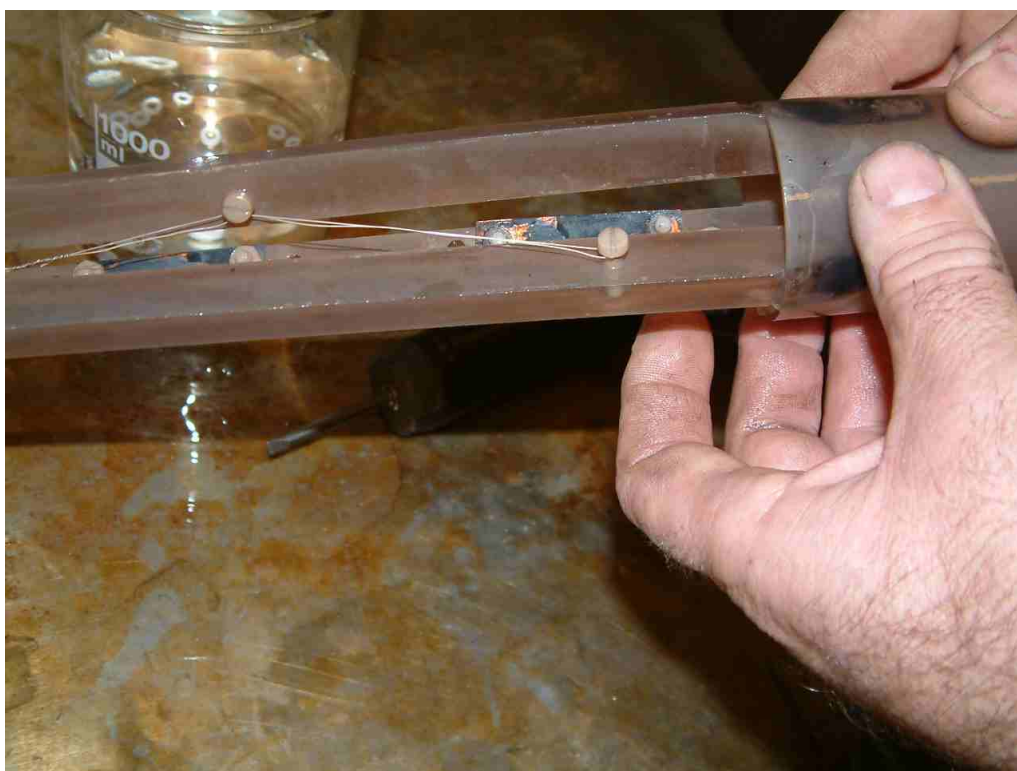
Figure 4. Dismounting the equipment exposed in the sulphide rich water at site SA 1420A.

Copper coupons exposed to the sulphide rich water in bore hole 1420 show characteristics normally associated with this type of corrosion. A black deposit of insoluble corrosion products at the copper surface seems to be present in figures 4 and 6. The uneven coverage of the copper coupon, visible in both figures, also indicates that the deposit easily cracks and falls off the underlying metal. It seems likely that the relatively thick and more or less adherent corrosion products have provided some degree of barrier between the underlying copper metal and free sulphide in the water, during the exposure. This barrier may have been a limiting factor for the corrosion of the copper coupons exposed at bore hole 1420.

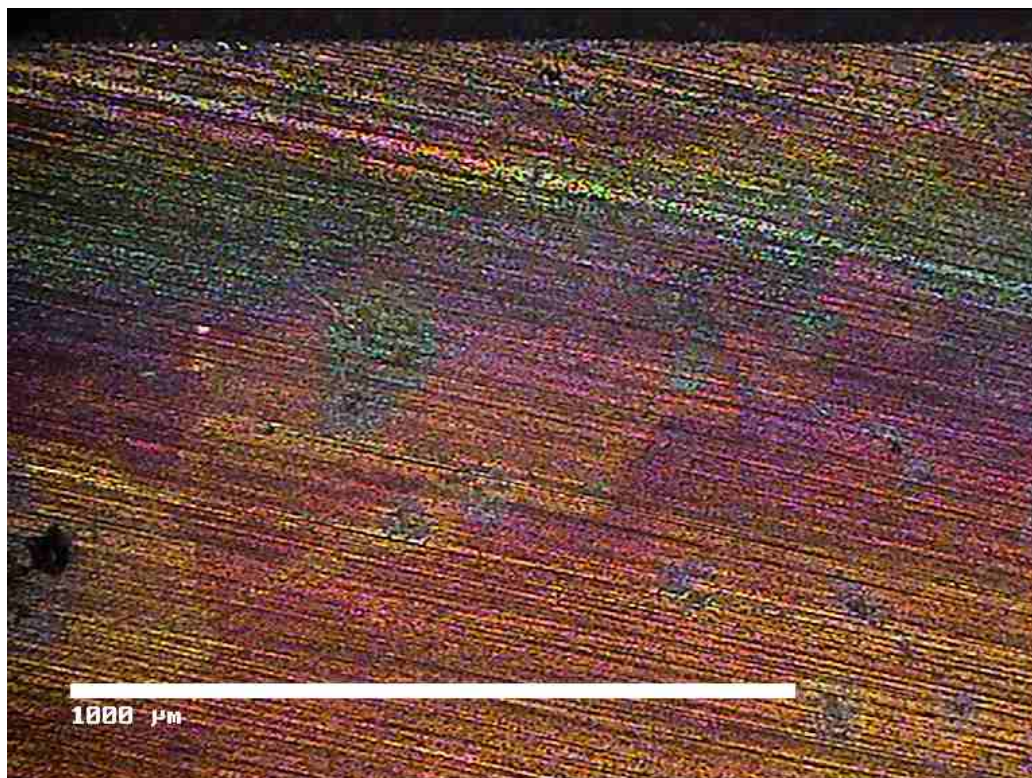
Figures 5 and 6 show microscope images. The coupon exposed in the chloride rich water in figure 5 shows the scratches and grooves left from the grinding of the surface. Similar grooves can be discerned in figure 6, on the coupon exposed in sulphide rich water. Beneath the dark layer that easily flakes off, the original topography is still visible.

Figure 5 Microscope image of a coupon exposed in the chloride rich water. Before pickling.

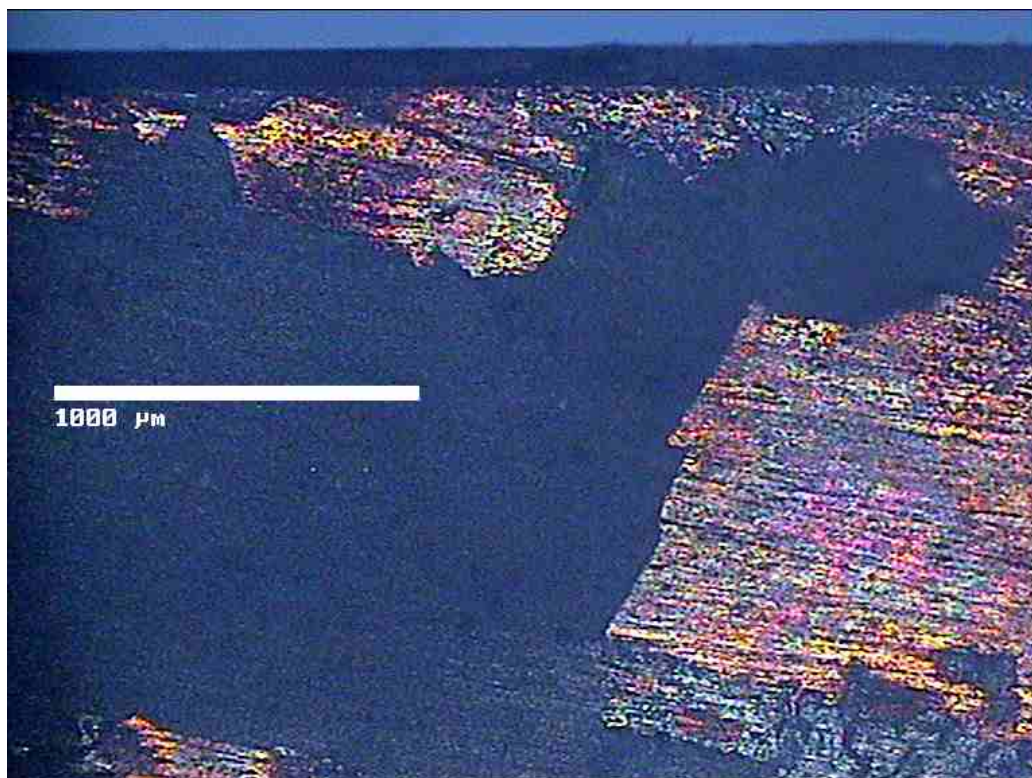
Figure 6 Microscope image of a coupon exposed in the sulphide rich water. Before pickling.

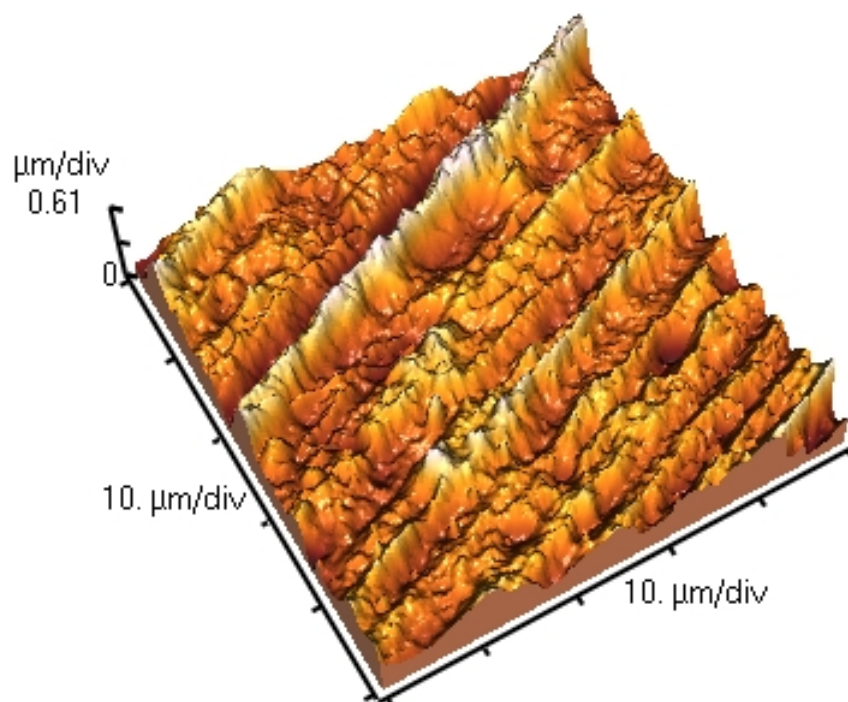
The surface profile on one coupon from each exposure sites was measured using AFM. The measurements were made after pickling to remove solid corrosion products. AFM images are shown in figures 7 and 8. The coupon exposed in the sulphide rich water at 1420 meters tunnel length showed a singular attack in the studied area. An approximately 0.5 μm deep cavity with a hemispherical appearance was found. The coupon exposed in the chloride rich water at 2880 meters tunnel length showed a very even surface without significant features.

Figure 7. Surface morphology from AFM of a copper coupon exposed in bore Hole 2880, Chloride rich water (Cl^- 11 000-13 000 mg/l).

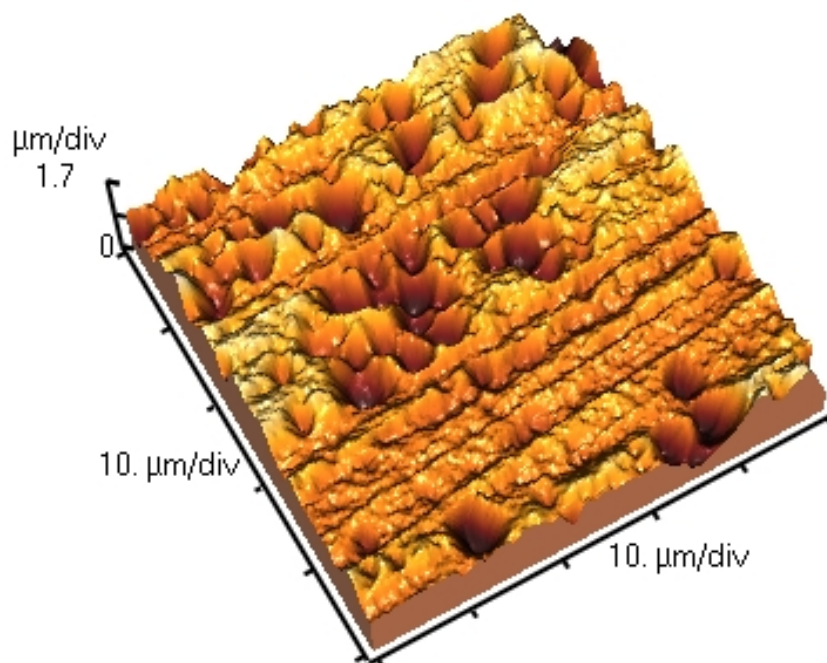
Figure 8. Surface morphology from AFM of a copper coupon exposed in bore Hole 1440, Sulphide rich water (HS^- 0.1- 0.4 mg).
