## **Comments to the quality assurance review draft report of the SKB's LOT experiment (SSM2020-5740-39, SSM reg nr, 2020-3872, ärende nr SSM2020-5740)**

## The most important comments to the SKB LOT-report TR-20-14

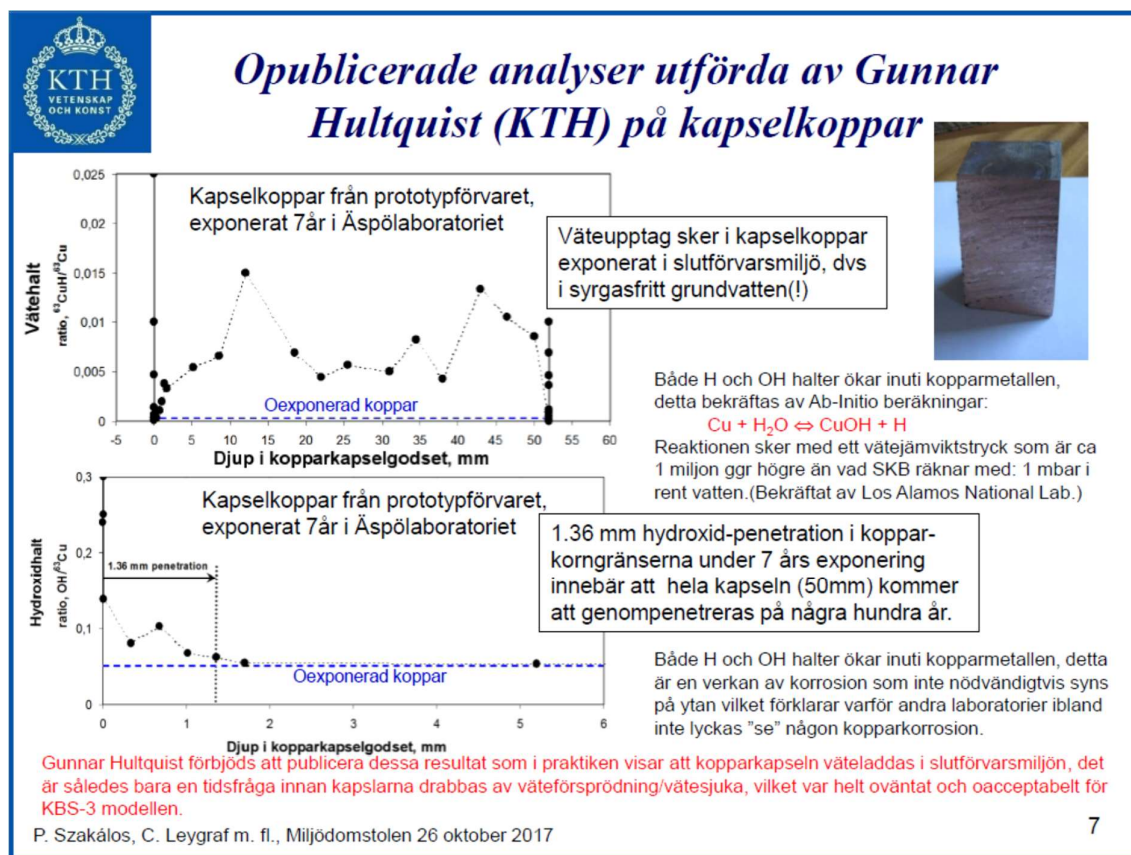
Gunnar Hultquist (KTH) has shown that the full-size copper canister in SKB's prototype repository was subjected to severe hydrogen uptake, throughout the whole thickness of 50 mm, during seven years of anoxic exposure in groundwater and bentonite in the Äspö hard rock laboratory (upper curve). The dotted blue line corresponds to the normal hydrogen content in SKB-copper. The relatively low hydrogen contents close to the outer and inner surfaces, around 0 mm and 50 mm, are a consequence of post-exposing the copper to oxygen (air) which act as an effective hydrogen getter. The lower curve shows the uptake of OH in the grain boundaries of the canister copper. This is evidence of internal corrosion which may not be visible on the copper outer surface. By extrapolation based on the OH-profile it can be concluded that the whole canister may be penetrated by OH within 250 years. However, hydrogen embrittlement and cracking of the copper canisters is expected much earlier.
