Exposure of Copper in Äspö Groundwaters

Author: Claes Taxén
Department: 70
Phone: 08-6741739
E-mail: claes.taxen@swerea.se
Date: 2009-04-16

Summary

This report describes an exposure that Korrosionsinstitutet performed at SKB's hard rock laboratory at Äspö. Copper coupons were exposed to groundwater at two different depths.

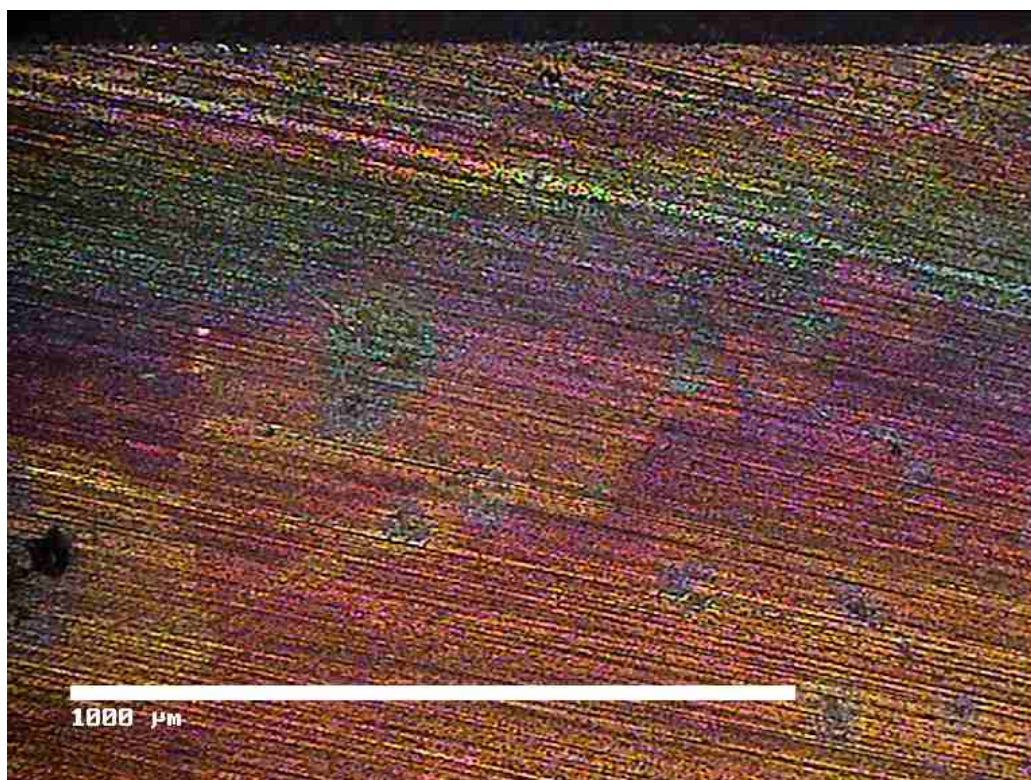
Figures 5 and 6 show microscope images. The coupon exposed in the chloride rich water in figure 5 shows the scratches and grooves left from the grinding of the surface. Similar grooves can be discerned in figure 6, on the coupon exposed in sulphide rich water. Beneath the dark layer that easily flakes off, the original topography is still visible.

Figure 5 Microscope image of a coupon exposed in the chloride rich water. Before pickling.

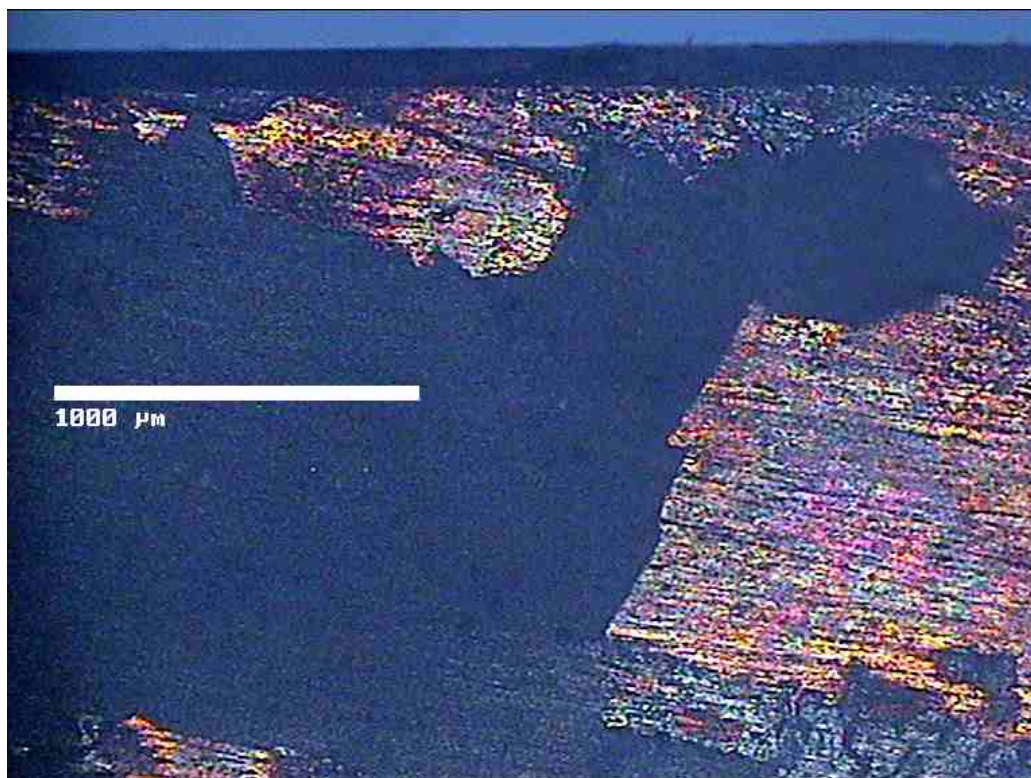
Figure 6 Microscope image of a coupon exposed in the sulphide rich water. Before pickling.

Copper coupons exposed to the sulphide rich water in bore hole 1420 show characteristics normally associated with this type of corrosion. A black deposit of insoluble corrosion products at the copper surface seems to be present in figures 4 and 6. The uneven coverage of the copper coupon, visible in both figures, also indicates that the deposit easily cracks and falls off the underlying metal. It seems likely that the relatively thick and more or less adherent corrosion products have provided some degree of barrier between the underlying copper metal and free sulphide in the water, during the exposure. This barrier may have been a limiting factor for the corrosion of the copper coupons exposed at bore hole 1420.
