Deposition vehicle Tests

Facilities within the Swedish RWM-system

Deposition vehicle, prototype #1

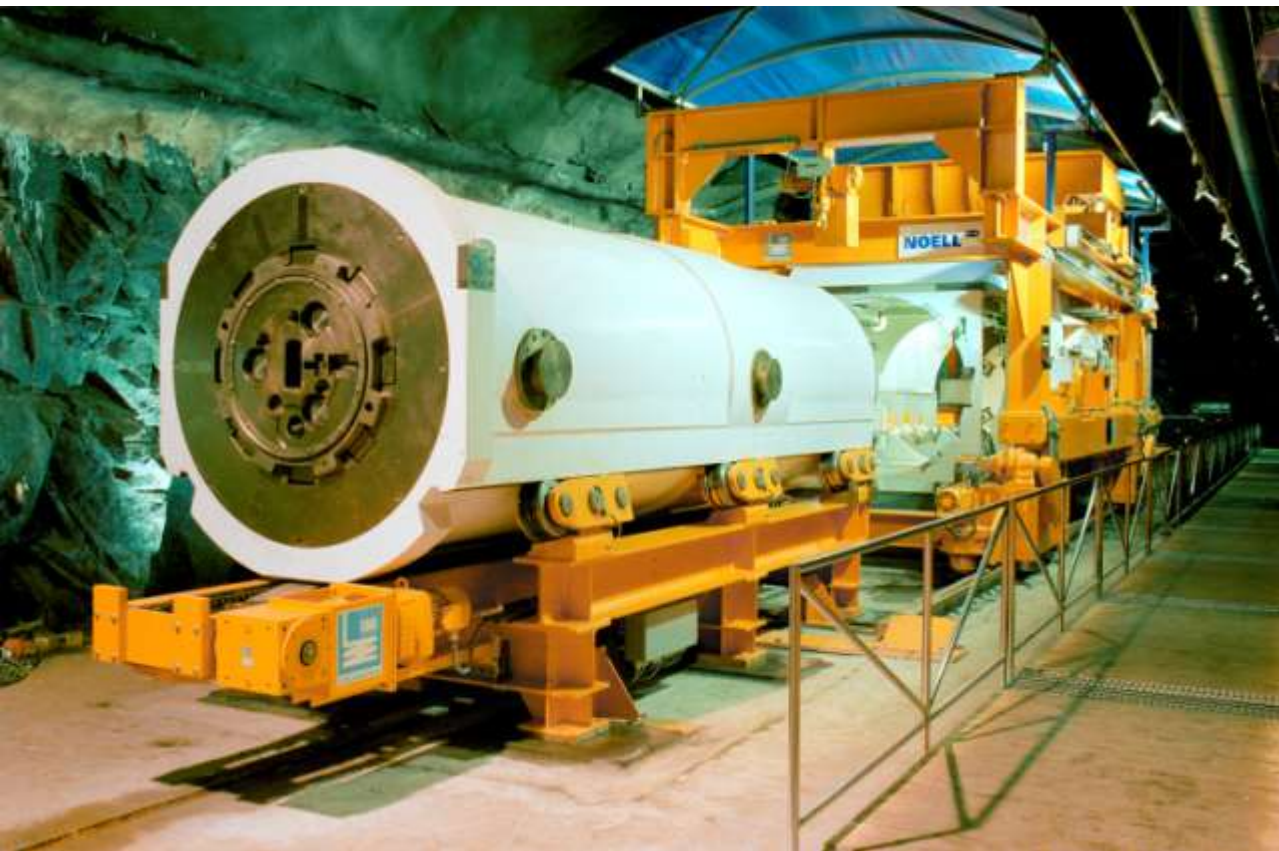
- Length 11.8 m
- Width 3.7m
- Height 4.6 m
- Weight empty 90 ton
- Weight of canister and shielding tube 50 ton
- Weight total 140 ton
- Drive Electric motor
- Speed 1 – 10 m/min

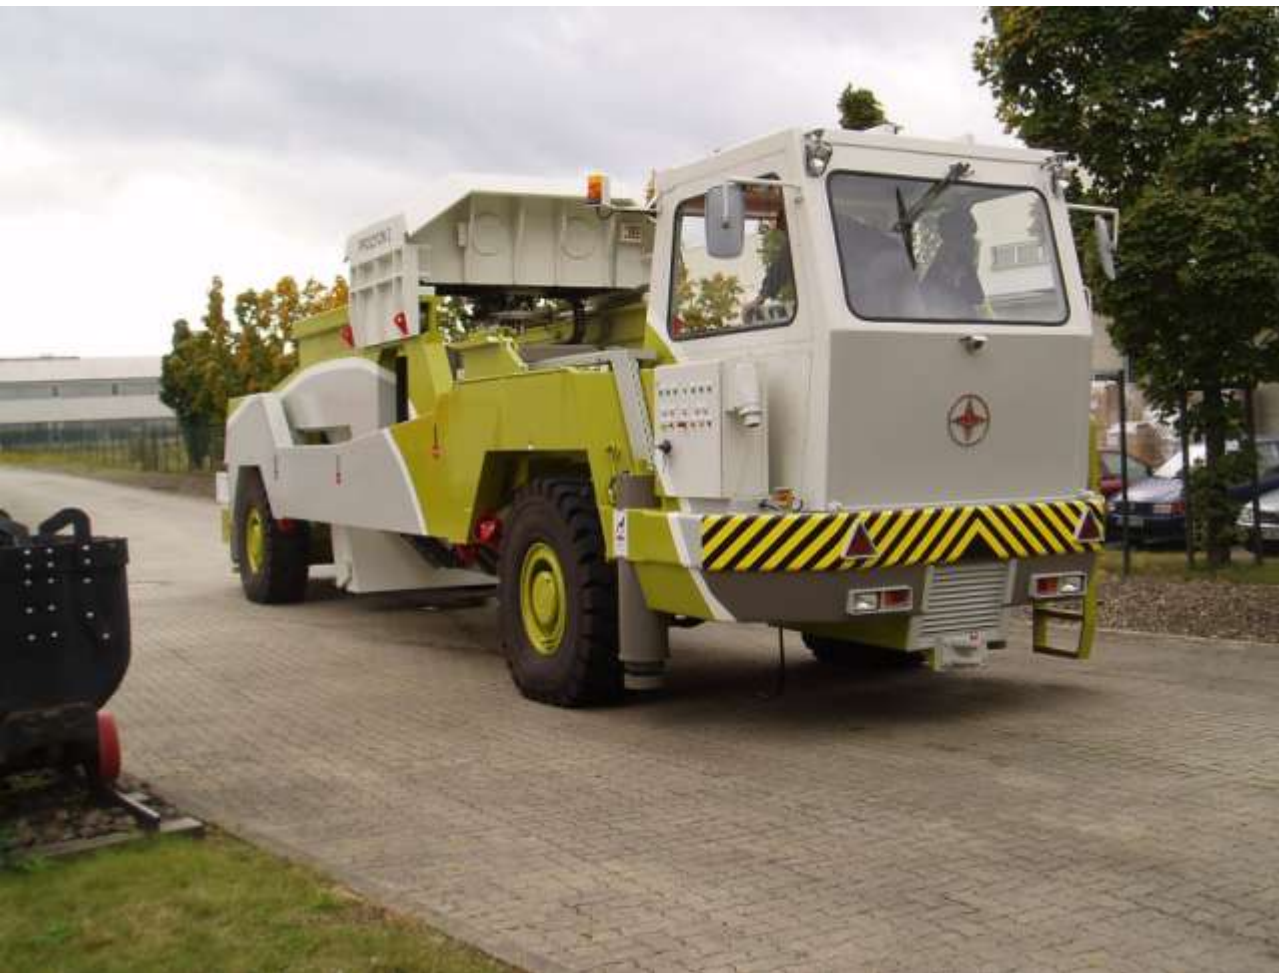
Deposition vehicle , prototype #2

- Length 14.1 m
- Width 3.1m
- Height 4.2 m
- Weight empty 72.4 ton
- Weight of canister 27.6 ton
- Weight total ≈100 ton
- Motor power 261 kW
- Drive hydrostatic
- Speed 5 km/h
- Operation mode full automatic
- Turning radius, outside 8.75 m

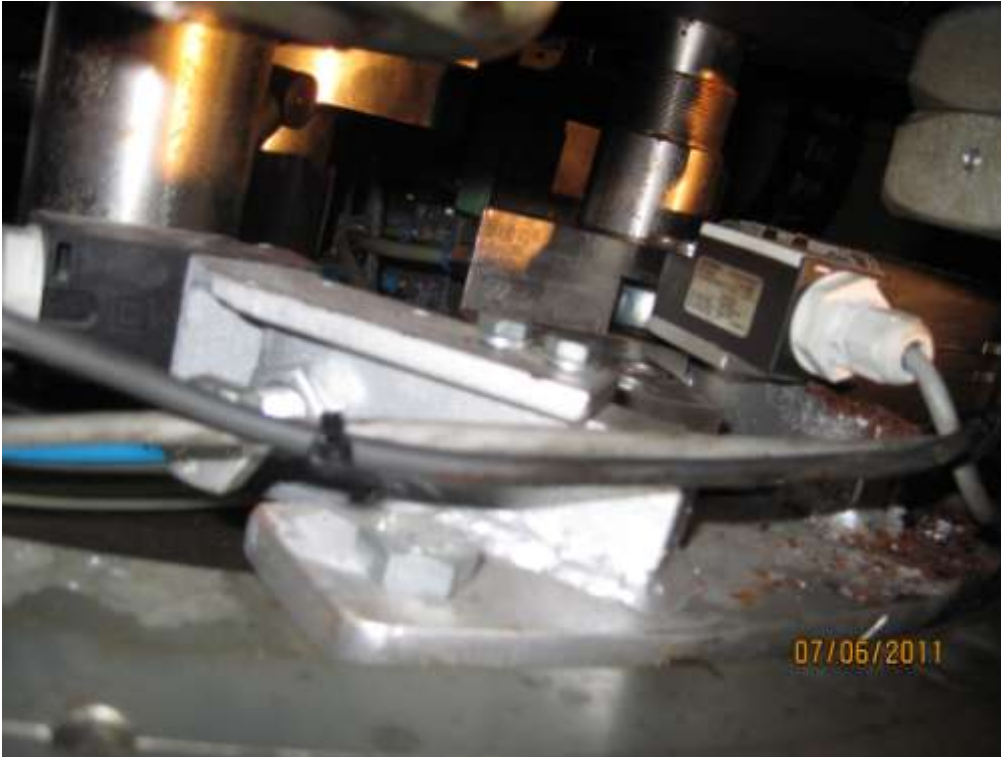
Inductive sensor (4)

The inductive sensors for the bayonet gripping work intermittently.

Position sensor was loose, tightened bolts and locked with lock-tight.

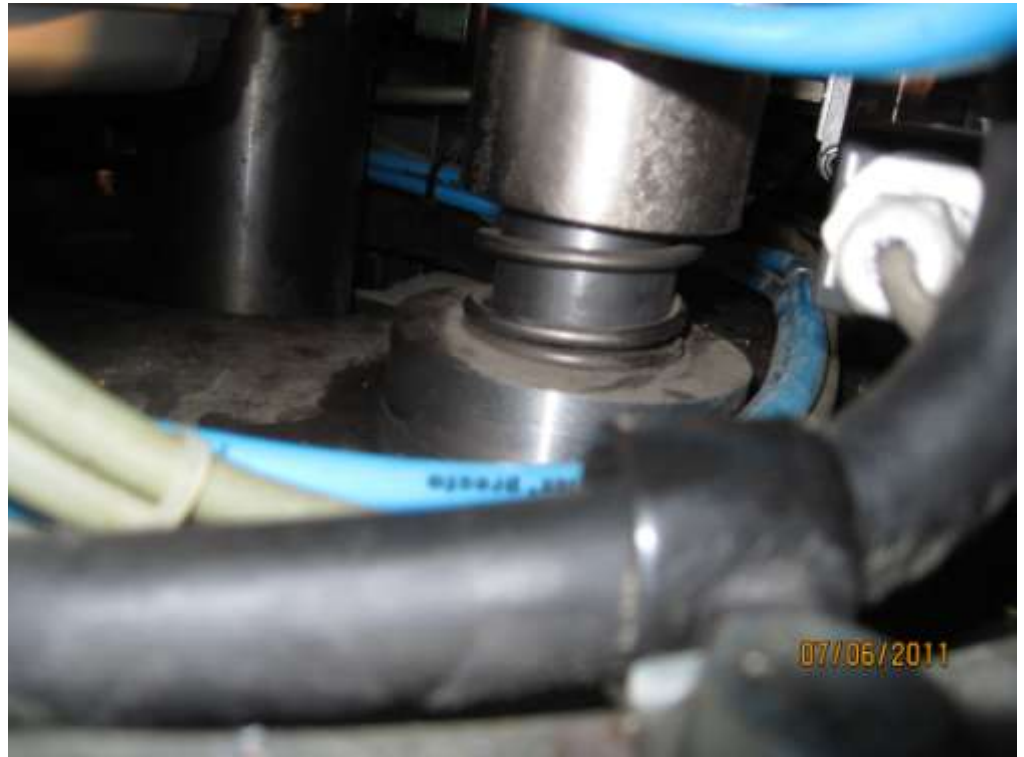
Grapple unit, cable drawing (9)

Continual errors with the twist lock

A cable get jammed at specific positions.

The cable was disconnected, examined and mounted at another position.

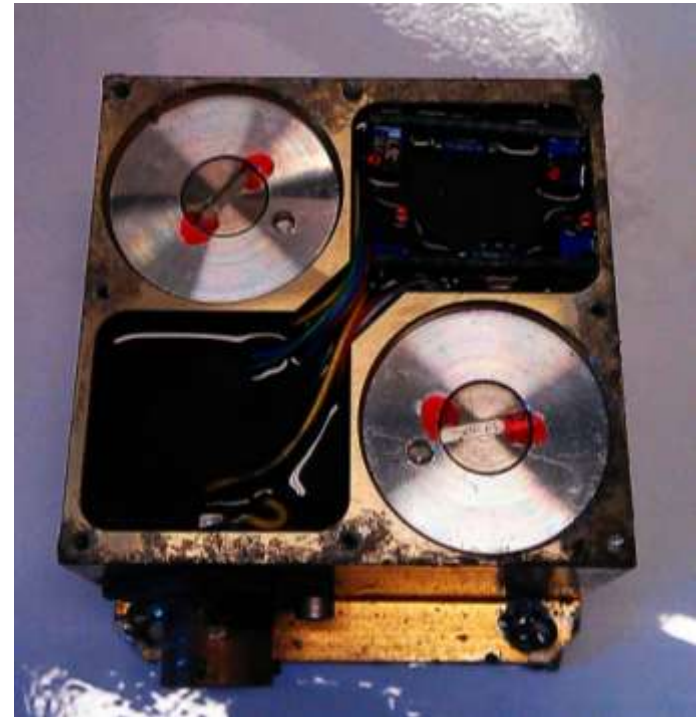
The Inclinator (10)

Totally destroyed internal by corrosion.

The damaged gasket.

1. The scanner was dismantled and sent back to the deliverer for exchange.
2. New gear drive installed, stainless steel.
3. Slide guides installed, robalon.
4. Position sensor was loose, tightened bolts and locked with lock-tight.
5. Computer screens replaced and mounted in moisture-proof boxes.
6. The valve assembly was cleaned, the contact was replaced, changed places for two cables in the switch cabinet.
7. Transmitter for the grip-out malfunctioned, replaced.
8. Power failure at vehicle start-up, UPS installed.
9. A deep examination of the grapple unit showed that a cable get jammed at specific positions. The cable was disconnected, examined and remounted in another position.
10. A gasket was damaged. The inclinometer was totally destroyed internal by corrosion, replaced by a new one.
