Document ID 1434744	Version 1.0	Status Approved	Reg no	Page 1 (127)
Author Ulf Ronneteg Thomas Grybäck			Date 2014-09-18	
Reviewed by Lisette Åkerman (QA)			Reviewed date 2014-09-29	
Approved by Jan Sarnet			Approved date 2014-09-30

Non-destructive testing of canister components and welds

Summary

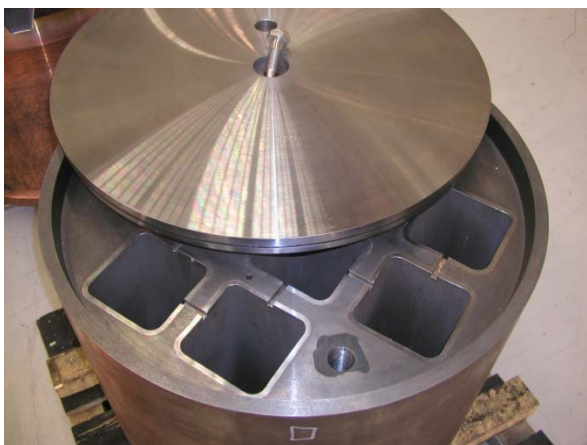
The steel lid (Figure 3-5) is manufactured from a conventional steel plate, which includes some associated parts such as the screw, gasket and valve for atmosphere replacement. The lid has a nominal thickness of 50 mm and a diameter of 910 mm (SKB 2010).

Figure 3-5. BWR insert with steel lid.

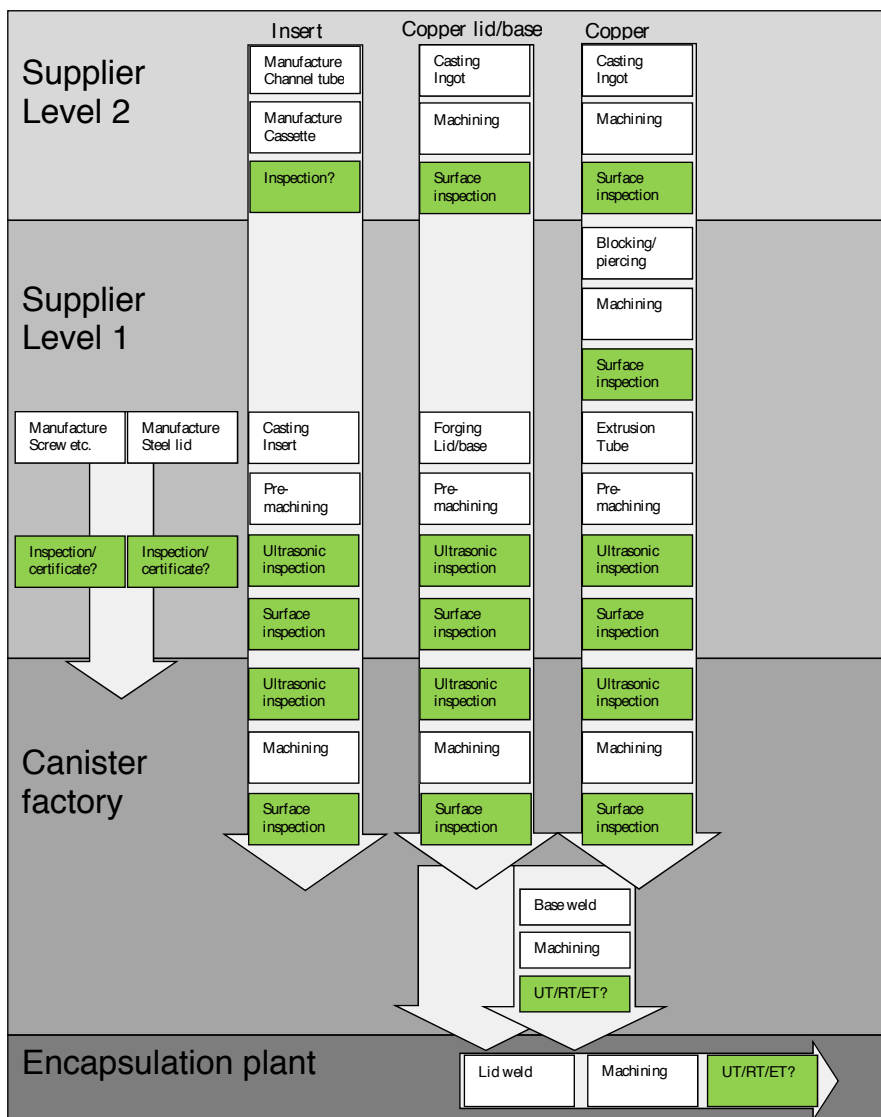
Figure 5-1. Preliminary inspection scheme for canister components and welds.

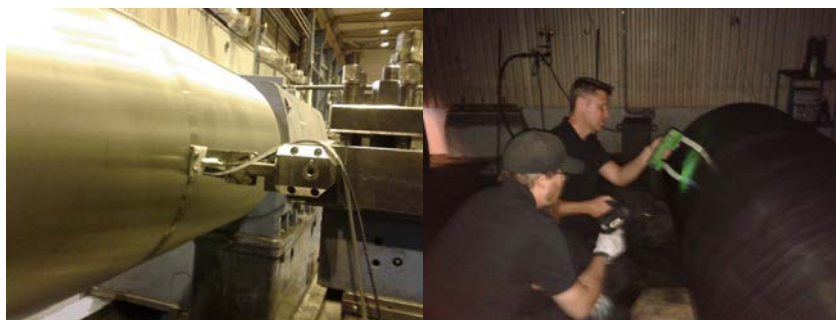
Figure 6-7. Ultrasonic and magnetic particle inspections of the inserts are performed by the supplier. The ultrasonic inspection (left) is automated using a turning machine as the manipulator; the cutting tool has been replaced with an ultrasonic probe that is fed with water as a couplant. The fluorescent magnetic particle inspection (right) is performed by magnetising each square decimetre of the insert in two orthogonal directions under UV lighting.

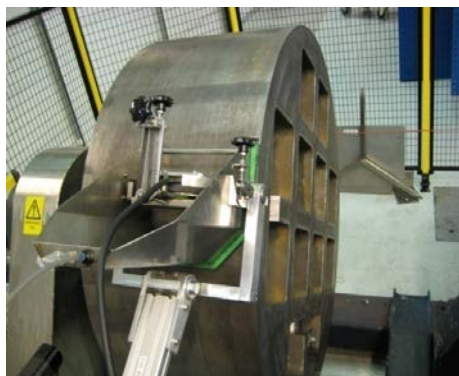
Figure 6-8. Linear array for local immersion inspection of the cast iron insert.

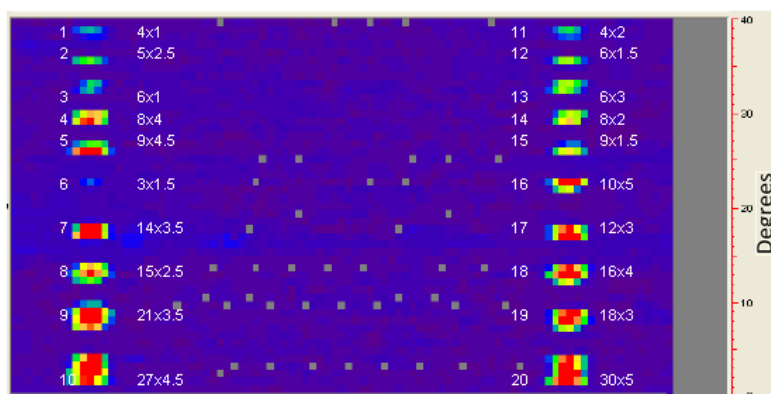
Figure 6-30. Eddy current inspection result from scanning reference object KLM162 containing surface-breaking elliptical EDM notches. The dimensions are presented in terms of length x depth. The grey pixels correspond to missing data, which are likely due to an encoder issue.

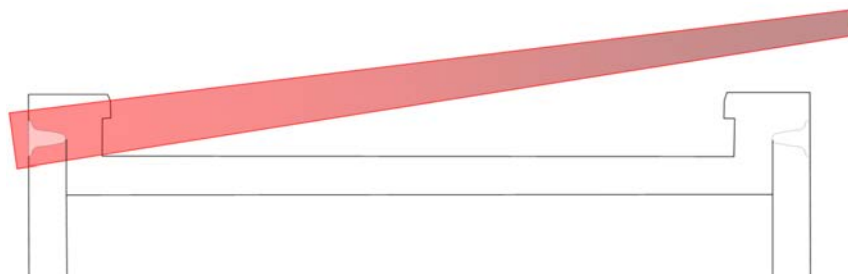
Figure 6-46. Principle drawing showing the X-ray source on the right and the detector on the left.

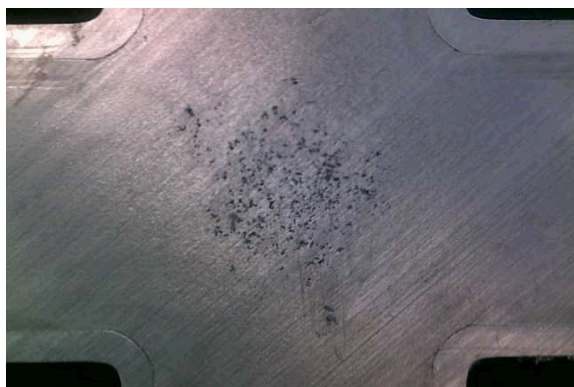
Figure 7-6. Photograph of the shrinkage pores indicated in Figure 7-5 between the fuel channels in a PWR insert.

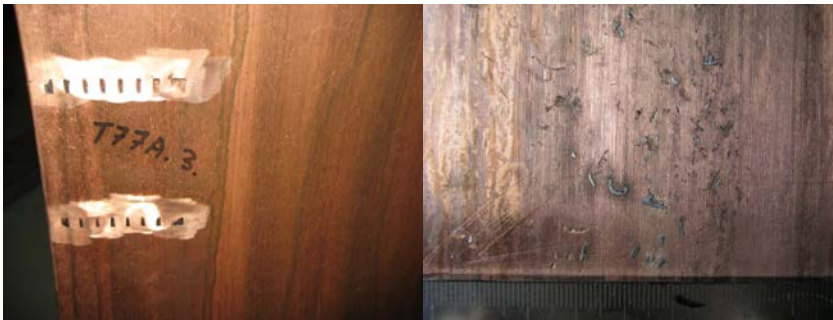
Figure 7-23. Handling defects manifested as indentations on the inside of tube T77 (left) and foreign material on the outside of tube T43.

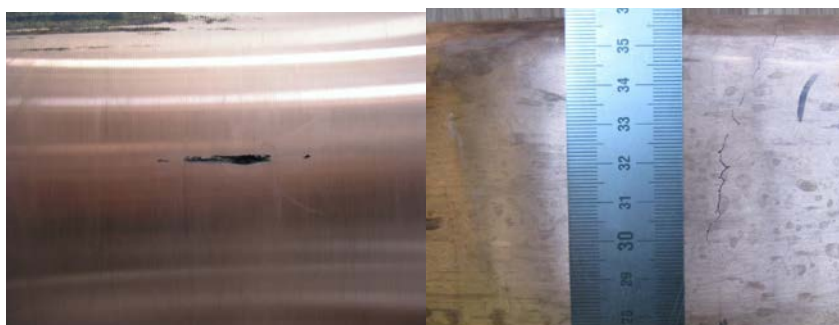
Figure 7-24. Manufacturing defects in copper tubes. The left image shows an axial scratch (T46) in an extruded tube and the right image shows a crack-like defect in a pierce-and-draw tube (T83).
