**Beträffande regeringens pågående prövning av kärnbränsleförvaret enligt miljöbalken (M2018/00217/Me) och kärntekniklagen (M2018/00221/Ke)**

# Corrosion-induced microstructure degradation of copper in sulfide-containing simulated anoxic groundwater studied by synchrotron high-energy X-ray diffraction and *ab-initio* density functional theory calculation

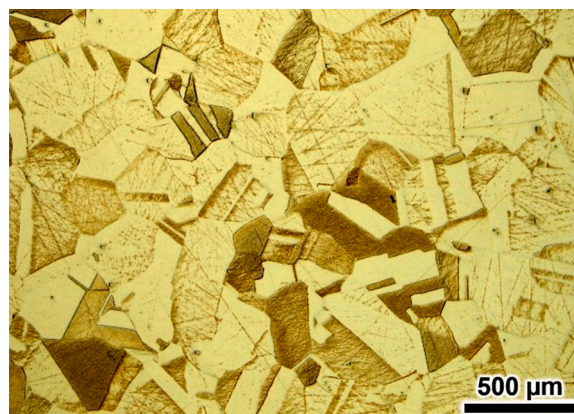
Fig. 1. Optical micrograph of an etched copper sample showing typical microstructure (large grains and annealing twins) of canister material.

spacing values expected for the Cu lattice, with small deviations across the measured depth reflecting the heterogeneities in the microstructure, such as grain boundaries and grains in different sizes as shown in Fig. 1. In contrast, the magnitude and scatter of the  $d$ -spacings increased for the pre-oxidized sample (Fig. 3b). The sulfur-exposed sample had the largest  $d$ -spacings, indicating most degradation (Fig. 3c). While the pre-oxidation affected the near-surface region down to a depth of 20–40  $\mu\text{m}$  (see also Fig. 5), the sulfur-exposure resulted in large lattice expansion down to 400  $\mu\text{m}$ , with some expansion occurred on individual sites in the microstructure between 400  $\mu\text{m}$  and 900  $\mu\text{m}$  in depth. It seems that compensating lattice contraction occurred in the sub-surface microstructure as compared to the non-exposed and pre-oxidized specimens (Fig. 3c). Hence, the exposure to the simulated groundwater caused both heterogeneous lattice expansion and contraction. The size of the large grains of the microstructure was 200–500  $\mu\text{m}$  and thus much larger than the X-ray beam size (20  $\mu\text{m} \times 55 \mu\text{m}$ ), which explains the discrete heterogeneities in the  $d$ -spacings. Each scan line contained signals from approximately 50–100 grains, which is well-representative for the entire microstructure. Compensating lattice contraction, to a small extent, was also observed for the pre-oxidized specimen (Fig. 3b).

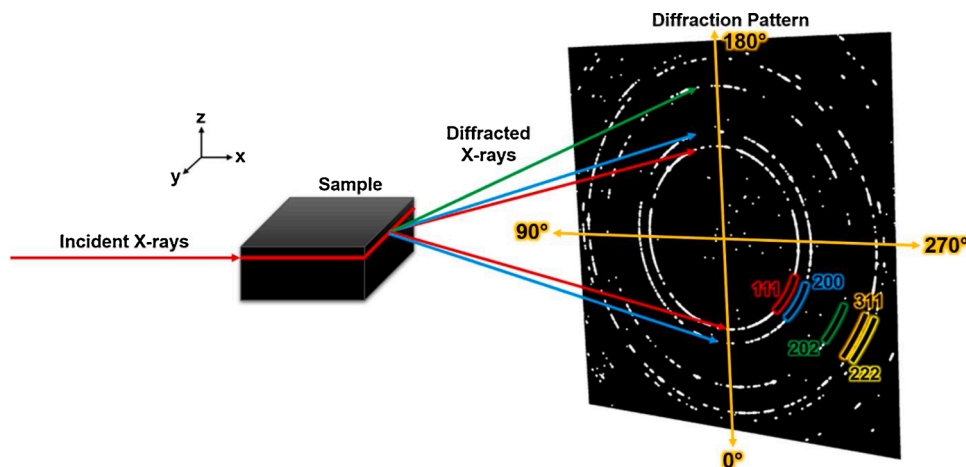
**Fig. 2.** Schematic illustration of the experimental setup for the HEXRD measurements showing X-rays radiating the copper specimen and the diffracted X-rays with the 2D diffraction pattern collected by a flat-panel detector. The azimuth angles are indicated.

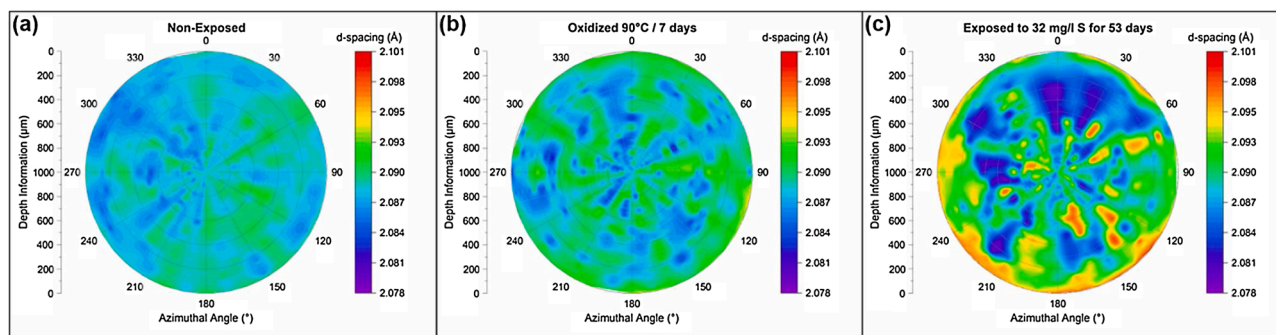
**Fig. 3.** Polar plots showing the calculated d-spacing of the Bragg peak with (111) orientation as a function of depth from the surface and azimuthal angle for the copper specimens of (a) the non-exposed condition, (b) pre-oxidized at 90 °C for seven days, and (c) pre-oxidized and exposed to 32 mg/l of sulfide-containing groundwater.

The non-exposed reference sample (Fig. 3a) shows quite uniform *d*-

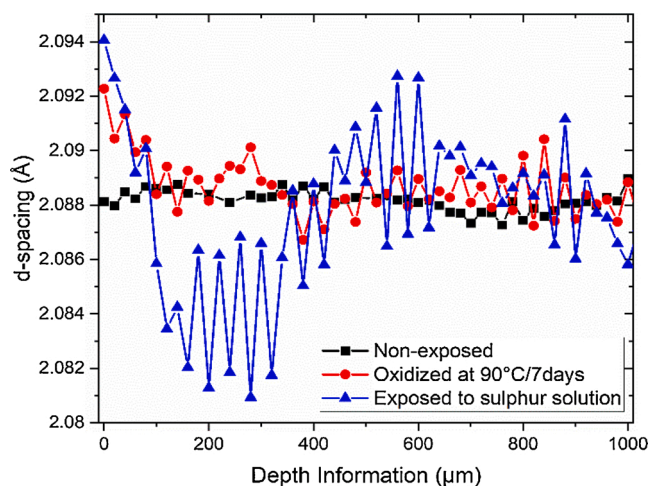
**Fig. 5.** The measured  $d$ -spacings (integrated over the entire (111)-oriented 2D-diffraction ring) plotted against the depth from the surface of the copper specimens.

Fig. 5 shows the measured  $d$ -spacings plotted against the depth, i.e., in-depth gradient, for the samples. The  $d$ -spacings were calculated from full-ring-integrated data, indicating the lattice expansion in the near-surface region caused by the pre-oxidation and the sulfur-exposure, which is evident by comparison with the non-exposed sample showing nearly constant  $d$ -spacing across the depth. The pre-oxidation led to lattice expansion of the near-surface region down to  $\sim 90\ \mu\text{m}$ . The exposure to the sulfide-containing groundwater resulted in an altered surface layer of  $\sim 400\ \mu\text{m}$ . The magnitude of lattice expansion was more pronounced for the sulfur-exposed sample, clearly demonstrating a lattice degradation effect induced by the sulfide-containing groundwater. In addition to lattice expansion of the near-surface region down to  $\sim 90\ \mu\text{m}$ , the sulfur-exposure also led to lattice contraction (depth of 100–400  $\mu\text{m}$  in Fig. 5) beneath the lattice expansion near-surface region. However, the pre-oxidized sample did not show a similar compensation effect; therefore, the mechanism for the sub-surface lattice contraction must be of a different nature. The pronounced lattice contraction in the sulfur-exposed sample might have been generated due to compensation of lattice expansion of the near-surface region.

It is well-known that the pre-oxidation causes the formation of copper oxides, typically  $\text{CuO}/\text{Cu}_2\text{O}$ , on the Cu surface. The oxides have higher lattice constants and thus lead to a widening of the Cu lattice underneath the oxides. However, the thickness of the oxide film was reported to be only a few hundreds of nm [42,43]. Our HEXRD results, shown in Fig. 5, suggest that the pre-oxidation causes significant lattice deformation in the near-surface region down to 90  $\mu\text{m}$  in depth. The surface grains became distorted, which led to the evolution of macro-strains. Note that the sulfur-exposed sample was also pre-oxidized; therefore, the measured data represent the effects of the pre-oxidation and sulfidation occurred during the exposure to the simulated groundwater. Therefore, the difference between these two samples shows the effect of interactions of the pre-oxidized sample with the sulfide-containing groundwater. The data of the sulfur-exposed sample show that the relative change of the lattice parameter in the surface region reaches a magnitude of  $10^{-3}$ , indicating a high level of lattice deformation developed in the surface region, which can be explained by considering the H-induced lattice dilation.

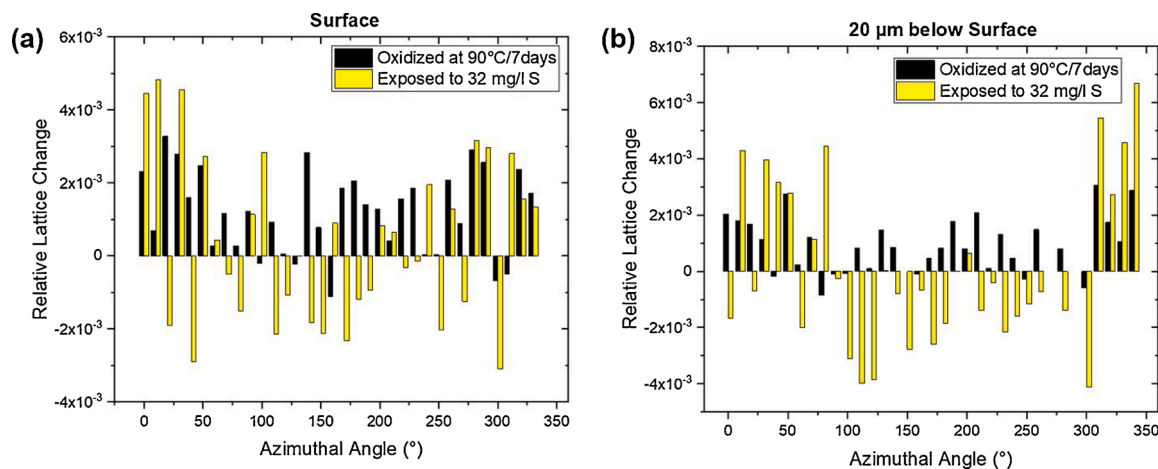
**Fig. 4.** The calculated relative change of lattice parameter in (a) the near-surface region, and (b) 20  $\mu\text{m}$  below the surface, for the pre-oxidized and the sulfur-exposed sample, respectively.

relative change of the lattice parameter at different depths, which includes strain development due to H insertion into the lattice. As shown in Fig. 4, the pre-oxidation caused lattice expansion of the surface region, evidenced by positive values of the relative lattice change at most azimuthal angles (Fig. 4a). In contrast, the sulfur-exposure resulted in both lattice expansion and contraction in the surface region (Fig. 4a) and

the sub-surface region at 20  $\mu\text{m}$  (Fig. 4b), varying with azimuthal angle. The non-uniform lattice deformation is due to the large scatter in grain size in the microstructure, as explained above. A histogram figure summarizes the measured  $d$ -spacings for all tested specimens can be found in the supplementary material (Fig. S1), which shows the lattice degradation as surface and near-surface lattice expansion and the formation of compensating lattice contraction in the sub-surface, which was more severe for the sulfur-exposed Cu sample than the pre-oxidized one.

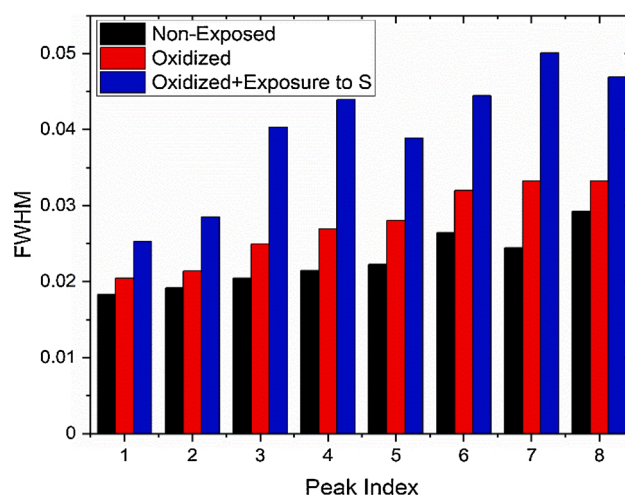
Fig. 6. Full-width at half maximum (FWHM) values from all measured diffraction peaks for the analyzed copper specimens, averaged over the entire sample thickness.

The fitting results of the full-ring diffraction data in Fig. 6 revealed that the full-width at half maximum (FWHM) values of all Bragg peaks increased by the pre-oxidation and exposure to the S-containing water, with the latter having the most severe effect. Increase of FWHM typically indicates the formation of micro-deformation, i.e., the deformation within grains, and/or the reduction of the grain size. The deformation of the surface layer due to the formation of corrosion products result in heterogeneous grain deformation, which is reduced with increasing depth in bulk. However, the exposure to the S-containing water resulted in larger surface deformation (lattice expansion) and also sub-surface deformation (lattice contraction). The oxidation on the surface was rather homogeneous and caused a widening of the lattice, but the degradation caused by the exposure to the S-containing water exhibited a more heterogeneous nature. During the exposure to the simulated groundwater, Cu sulfides can form as a result of the corrosion of Cu. Moreover, pre-formed  $\text{Cu}_2\text{O}$  film can also be converted to the  $\text{Cu}_2\text{S}$  film, which was reported to extend into the bulk of Cu for about 100 nm from

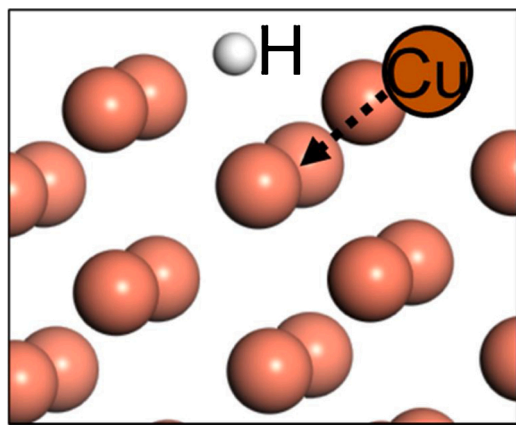
**Fig. 10.** A snapshot shows a surface Cu atom moves to and finally occupies a subsurface Cu vacancy when H atom is located at the first octahedral interstitial site.

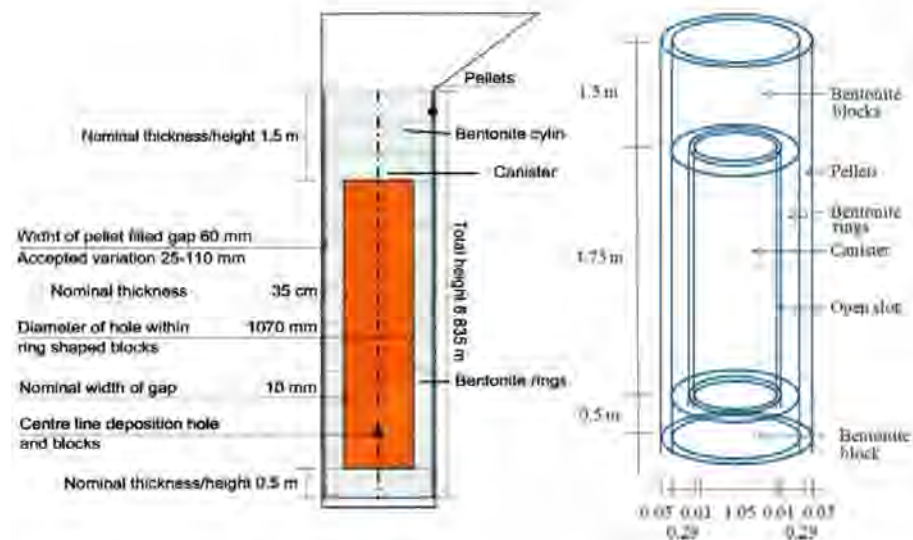
**Figure 2.1.** Configuration and geometry of the deposition hole with copper canister and bentonite buffer. From SKB-report TR-14-12 (to the left) and from SKB-report TR-17-15, Figure 9-1 (to the right). The drilled hole in the bed rock has a diameter of around 1.8 meter.

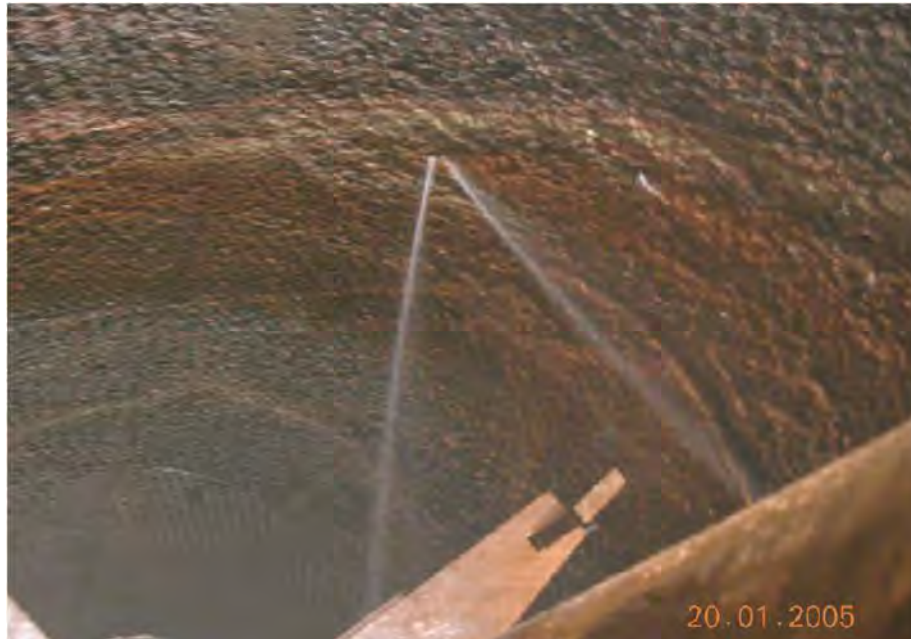
**Figure 2.2.** From Figure 3 in SKB-report R-05-44. Typical inflow pattern in Äspö hard rock laboratory showing high pressurized groundwater seeping out of a drilled rock surface. This photo is taken from a depth of only 220 m, i.e. the water pressure is around 22 bar, only half of that prevailing in a real repository. The cracks in the deposition holes in Forsmark are believed to be smaller but the pressure of the ground water is still 50 bar.

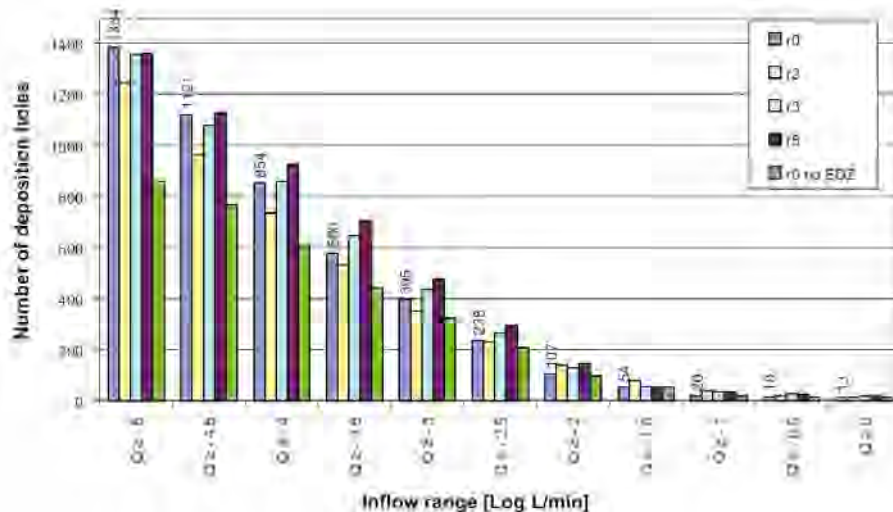
**Figure 2.3.** From SKB-report R-13-21, Fig. 3-4. Complementary cumulative distributions of the total inflow to each deposition hole for each case. According to case r0 (the five simulations r0-r5, give roughly the same outcome) there are 1384 deposition holes out of 6916 that have at least one crack that gives an inflow of ground water more than  $10^{-5}$  L/min ( $\geq 5.3$  litre/year). 854 deposition holes have an inflow of more than  $10^{-4}$  L/min ( $\geq 53$  litre/year) and 395 deposition holes has an inflow of more than  $10^{-3}$  L/min ( $\geq 530$  litre/year).

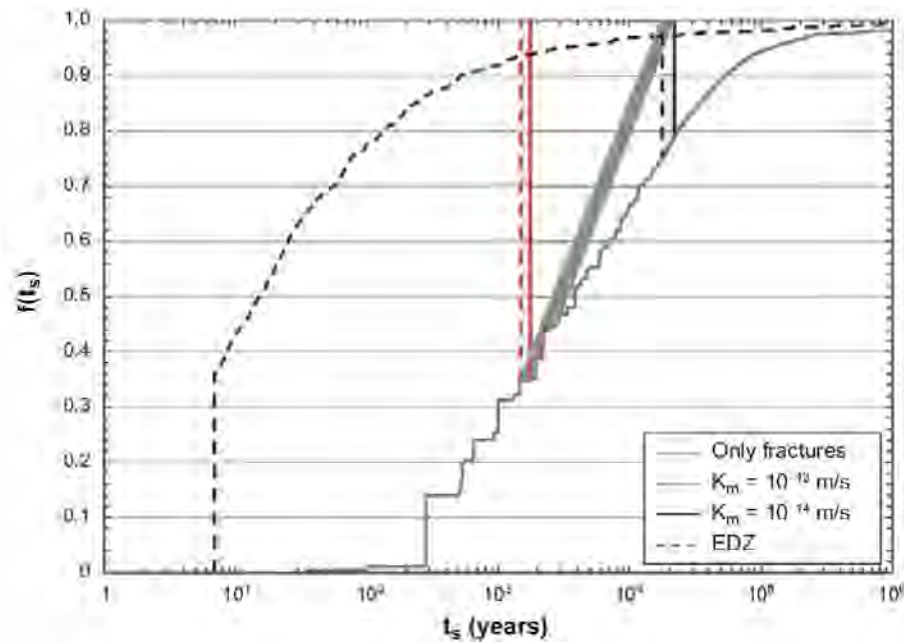
**Figure 2.4.** Modified graph based on Fig. 7-15 in /Sellin P. et al. 2017/. The solid grey line identifies the cumulative distribution of saturation times,  $f(t_s)$ , in the Forsmark repository calculated assuming no matrix flow, i.e. only flow via macro cracks. The vertical lines (red and black) identify the time interval within which all deposition holes will reach full saturation if the matrix hydraulic conductivity has the value  $K_m = 10^{-13}$  m/s and  $K_m = 10^{-14}$  m/s respectively, see point (i) above. The fat grey line represents a linear distribution (realistic simplification), taking into account the variations in measured  $K_m$  values in Forsmark. It is thus indicated that the last tunnel and deposition holes with the lowest hydraulic conductivity will be water saturated only after  $\geq 15.000$  years by matrix inflow and that it takes around 3000 years to saturate 50% of the deposition holes, mainly by cracks in the deposition holes and tunnels. The dashed black line identifies the distribution of saturation times if no flow resistance was present in the tunnels (only of theoretical interest).

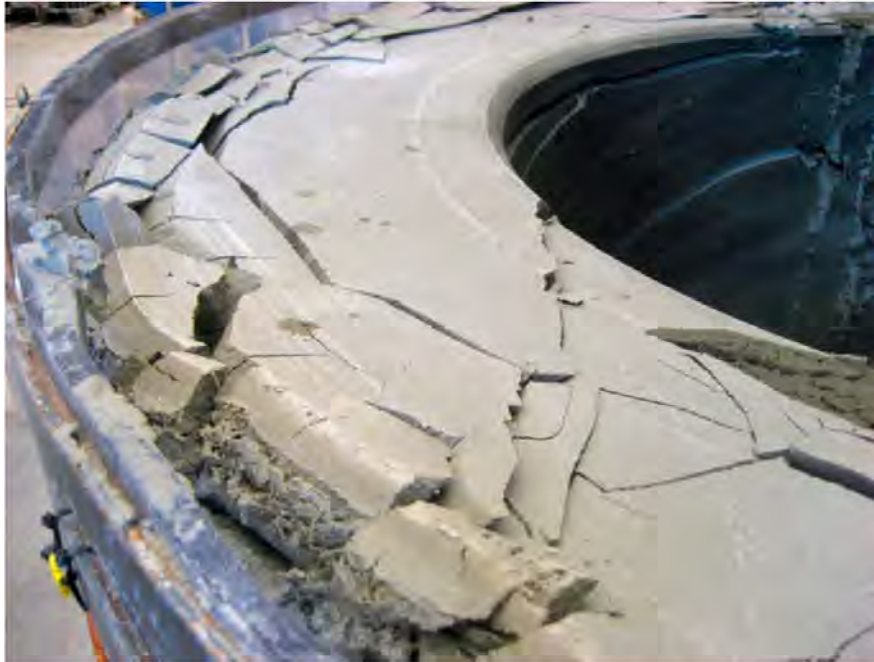
**Figure 2.5.** From SKB-report TR-17-15, Fig 2.9. SKB has shown in several reports that it is impossible to add water to bentonite blocks without severe cracking under normal pressure.

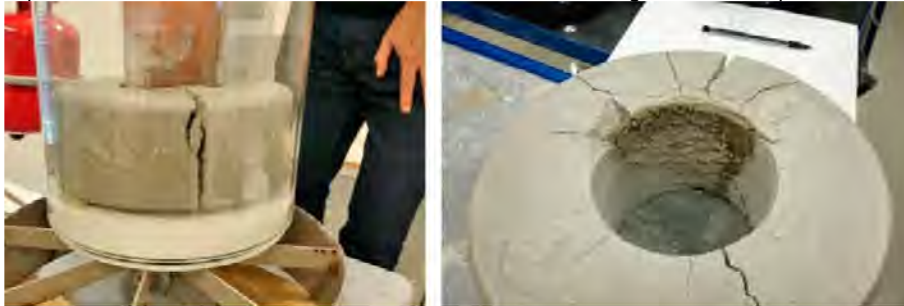
**Figure 2.6.** From Figure 2-8 in SKB TR-15-09. Left: Test 3 at termination. Right: Bottom side of the bentonite ring showing a condensation “nucleus” and cracks. Severe cracking of the bentonite rings occurred already within 7 days, which was the experiment duration time.

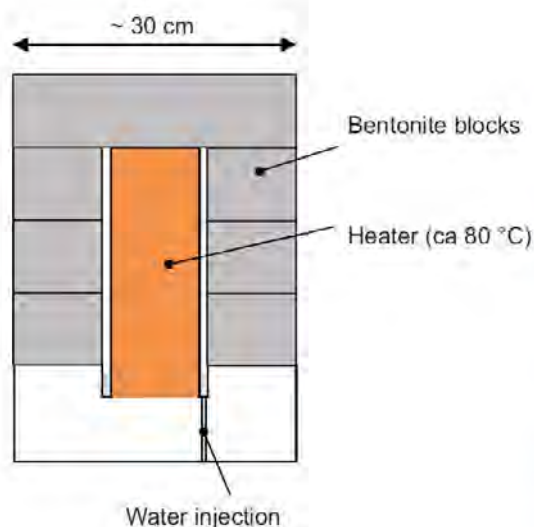
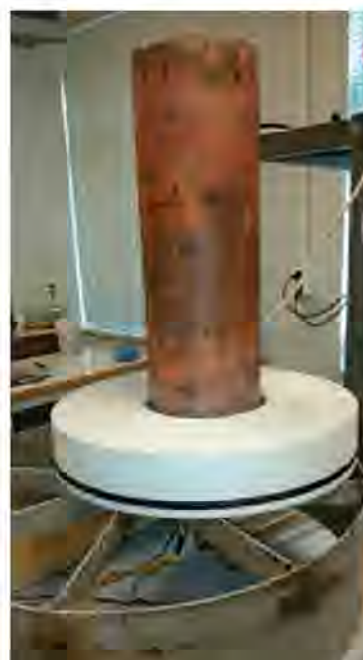
**Figure 2.7.** From Figure 2-1 in TR 15-09. The test set-up, which to a certain extent is a model of a KBS-3 deposition hole. Mounted on a plastic plate is a copper tube which is heated by circulating water to approximately 80 °C. "Water injection" seen to the left is actually a hole for low pressure water vapour to enter the slot between the Cu-heater and the bentonite rings. The outside of the set-up was covered by a plexiglass tube (not visible here).

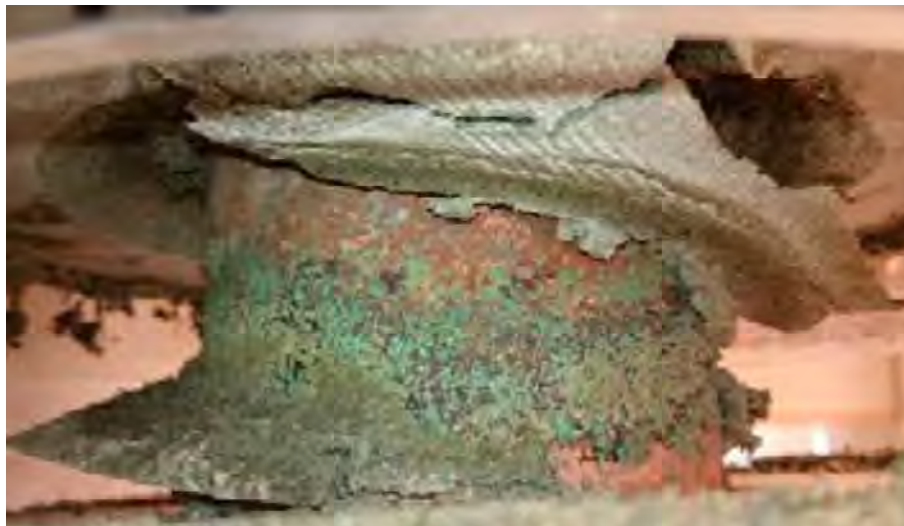
**Figure 2.8.** Detail from Figure 2-27 in TR 15-09. Severe corrosion of the copper heating tube after only seven days of laboratory exposure that at least reminds of the true Sauna effect, i.e. with only indirect contact with 0.6M chloride solution.

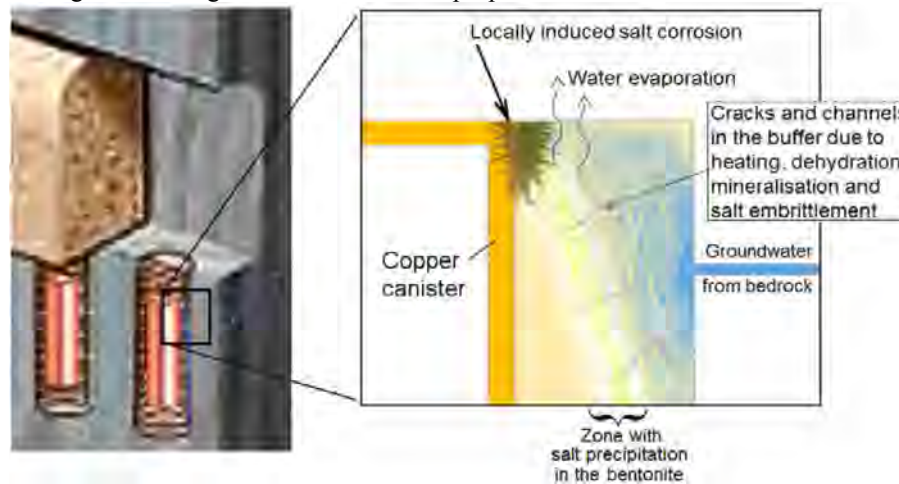
**Figure 2.9.** The Sauna effect in a repository with water evaporation, salt enrichment and copper corrosion. Furthermore, the precipitated salt will destroy the properties of the bentonite buffer /Szakálos P. and Seetharaman S. 2012/.

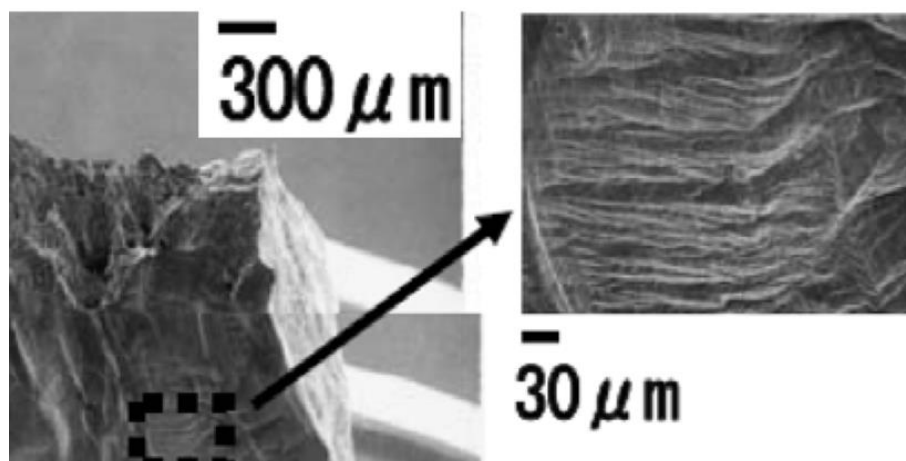
**Figure 3.2.** Crack-free copper surface when tested during the same conditions as in Figure 3.1 but with a sulphur free (inert) environment. No indication of any crack initiation visible in high magnification, see detailed micrograph to the right. Slow strain rate testing (SSRT) results from Figure 10 in /Taniguchi and Kawasaki 2008/.

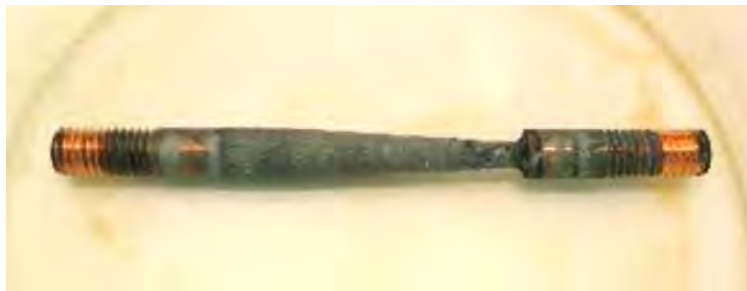
**Figure 3.3.** Example of SSRT exposed sample, 9 % strain at the thinnest part of the tapered sample (not exposed to final fracture).

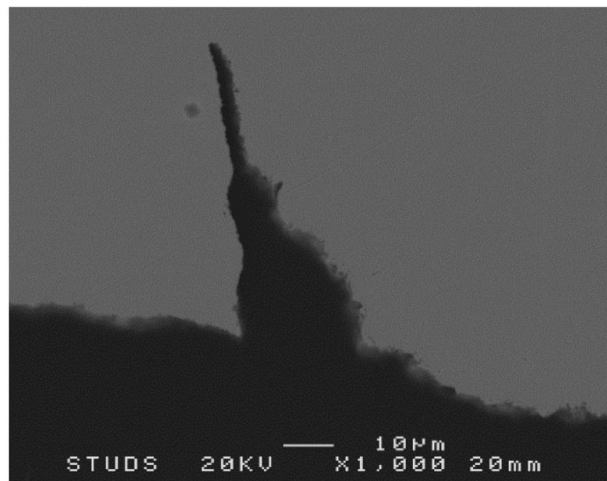
**Figure 3.4.** From Figure 16 in /R. Becker, J. Öjjerholm 2017/: Specimen #3 ( $10^{-3} \text{ M}$  sulphide), SEM image of a crack observed at the narrowest part of tapered gage section.

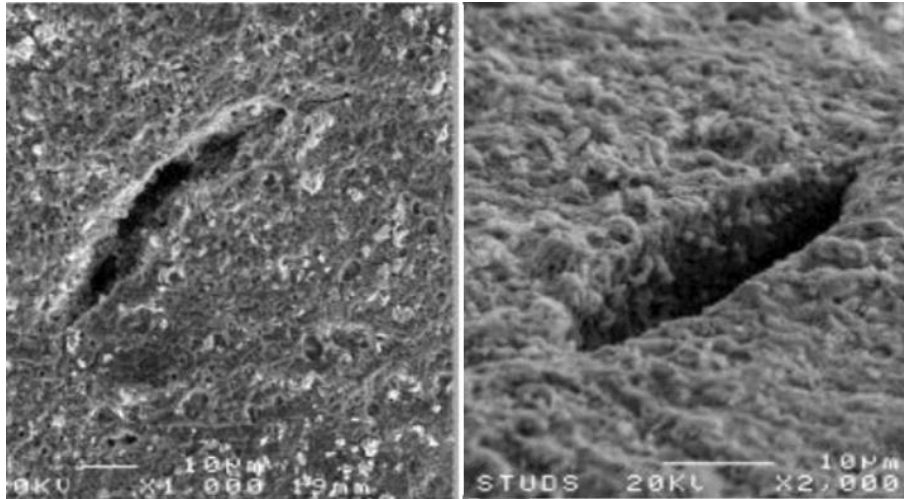
**Figure 3.5.** From Figure 2 in /Forsström A. et al. 2017/. Surface cracks near the narrowest part of Specimen #3 ( $10^{-3}$  M sulphide) after SSRT testing.

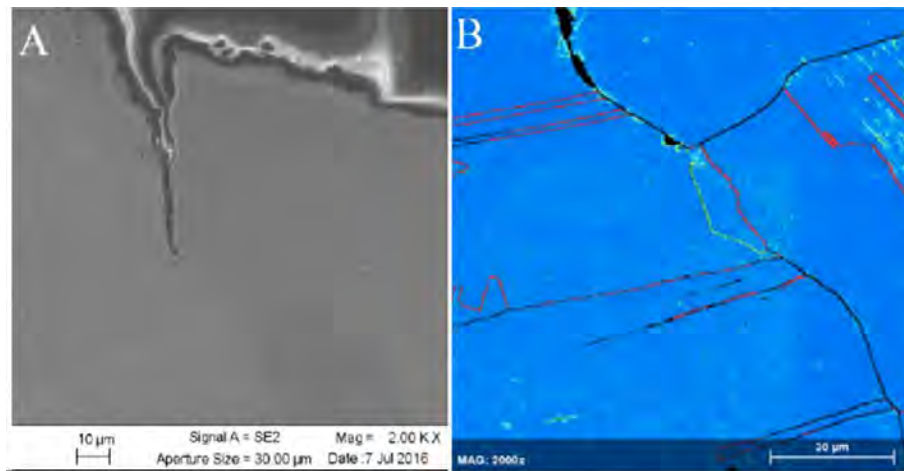
**Figure 3.6.** From Figure 3 in /Forsström A. et al. 2017/. Cross-section images of a SCC crack in the narrow section of Specimen #3. EBSD image showing crack propagation along a random grain boundary. Twin boundaries are marked in red and local misorientation in shades of green.

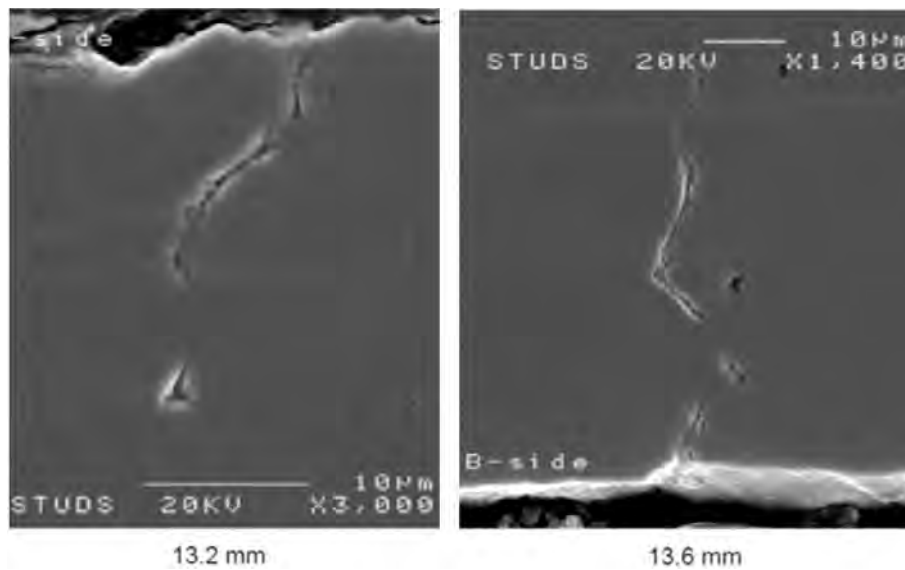
**Figure 3.7.** Part from Figure 21 in /R. Becker, J. Öjjerholm 2017/. Initiation of blisters and cracks could be detected also at lower sulphide concentrations quite far away from the narrowest part (with the highest stress) of the sample, i.e. at a distance of 13.2-13.6 mm. Exposures 3 (specimen #5) exposed to  $10^{-4}$  M sulphide.

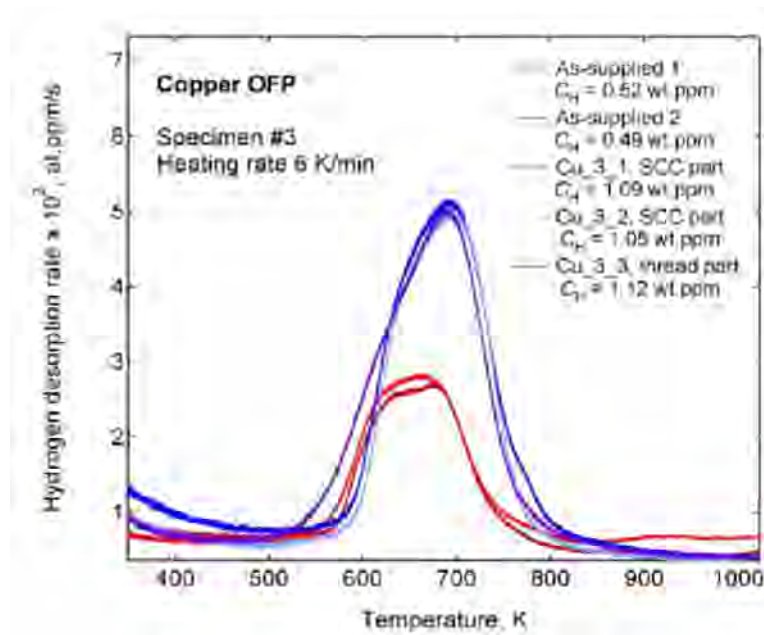
**Figure 3.9.** Hydrogen desorption curves (TDS) from /Forsström A. et al. 2017/ shows a systematically higher hydrogen content in the SSRT-exposed copper samples (blue and purple curves) compared with the as supplied SKB-copper metal (red curves). The TDS curves look similar for all tested samples, i.e. #3, #5 and #7. The systematic increase in hydrogen content in combination with the detected blisters in the inner sections of the copper samples (crack like defects, see Fig. 3.8) shows that copper exposed in an anoxic corrosive environment will suffer not only from SCC (surface cracking) but also from hydrogen induced grain boundary blisters and eventually cracking inside the bulk metal. This represents, in other words, the evidence for hydrogen embrittlement in oxygen free copper.

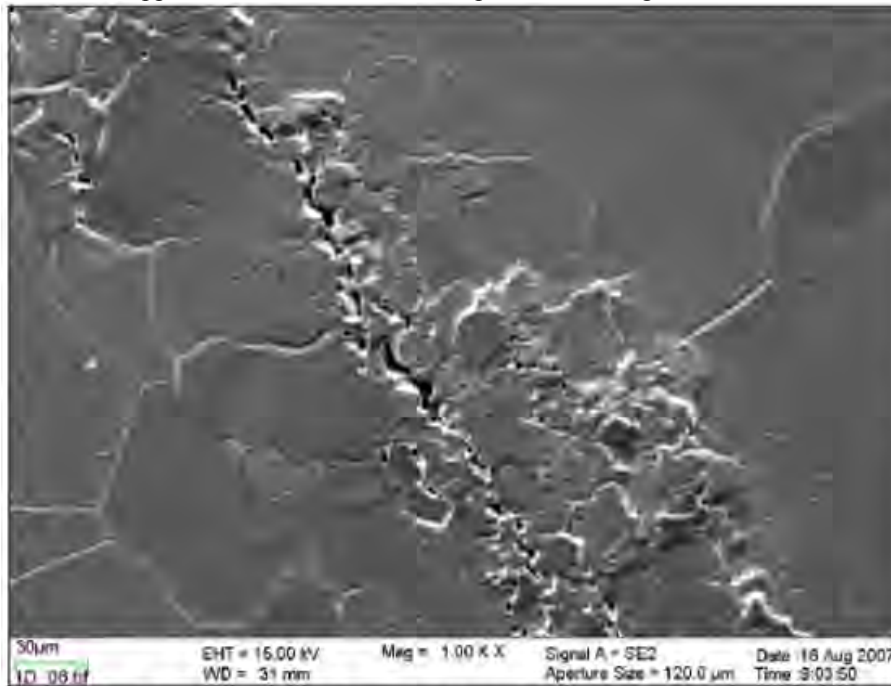
**Figure 15. Sample 1DV. Voids and heavy deformation are clearly visible at the region of entrapped oxide particles.**

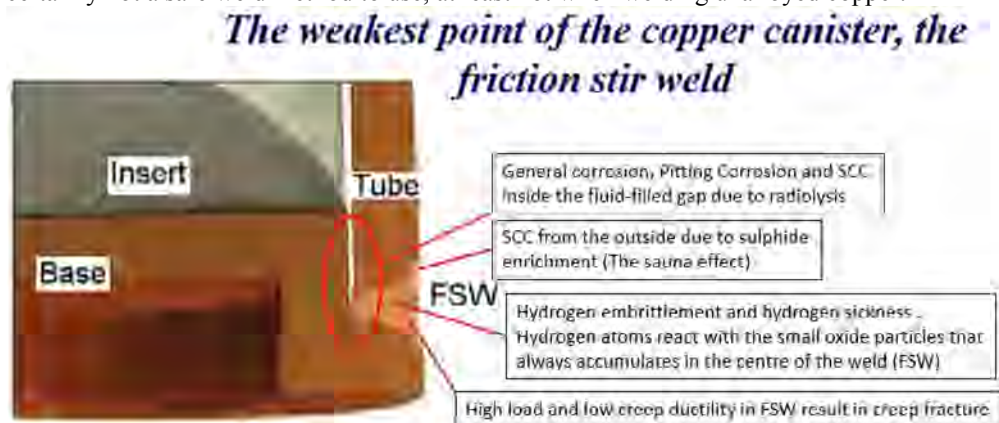
**Figure 3.11.** Detail from /Szakálos P. et al. 2017/. The weakest point of the canister is the Friction Stir Weld (FSW) and the fastest degradation mechanism is “hydrogen sickness” in the welds.

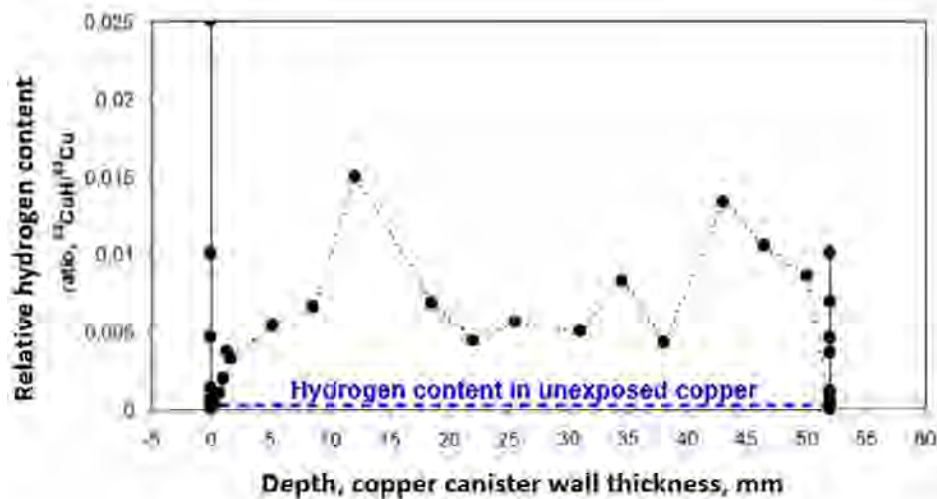
**Figure 3.12.** Full thickness canister copper exposed to the Swedish groundwater for seven years in the heated prototype repository, 80-90°C, at Äspö hard rock laboratory. The remarkable result shows that the copper canister is hydrogen charged throughout the whole thickness. The outermost surfaces have a very high H-content due to formation of corrosion products containing hydrogen and hydroxide. The hydrogen content in the first 10 mm of the inner/outer thickness has been subjected to spontaneous de-gassing when exposed to air since the hydrogen activity in the copper metal in contact with air is close to zero. The accepted hydrogen content in canister copper is 0.6 weight-ppm which coincide with the blue dotted line (unexposed copper). The hydrogen is detected by SIMS measurements and based on the H/Cu-ratio it can be estimated that the average hydrogen content in the copper is significantly higher than 1 wt-ppm.

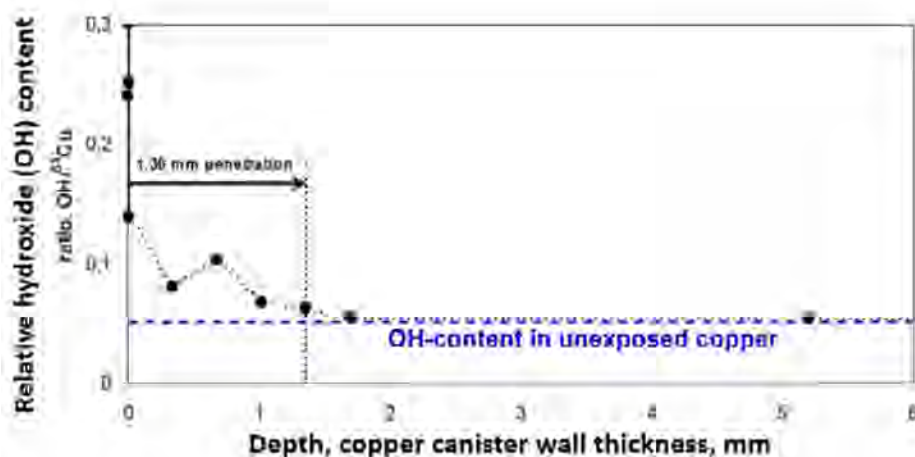
**Figure 3.13.** The hydroxide content of the first few mm of the full thickness canister copper exposed to the Swedish groundwater for seven years in the prototype repository at Äspö hard rock laboratory. The graph shows that hydroxide penetrates the copper metal, most probably in defects including grain boundaries. Once OH has entered the metal it is accumulated there, i.e. it is thermodynamically stable, i.e. evidence for internal anoxic corrosion. The hydroxide is detected by SIMS measurements.

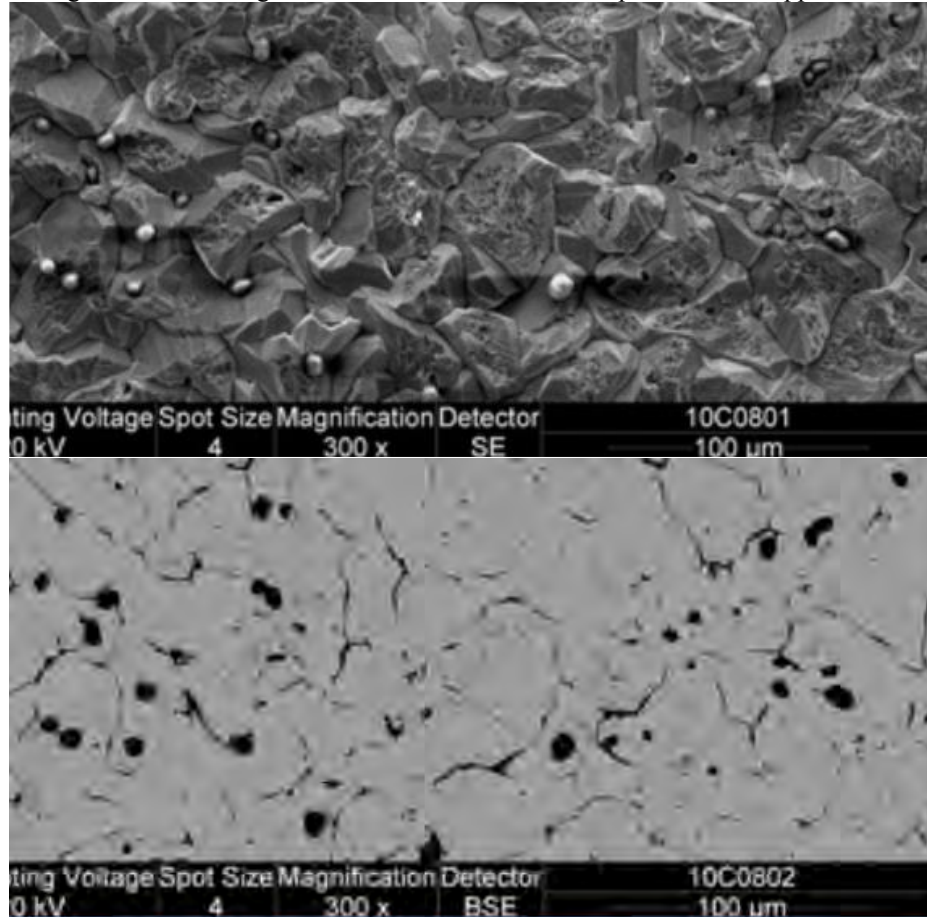
**Figure 3.14.** Detail from Figure 4 in /Ariilahti E. et al 2011/. The SEM-image at the top shows a post exposure fractured area ahead of the true crack tip for which EDS analysis showed average of 22.5 at-% sulphur. The backscatter electron image of the same area (bottom picture) shows darker sulphur-rich precipitates mostly at the grain boundaries.

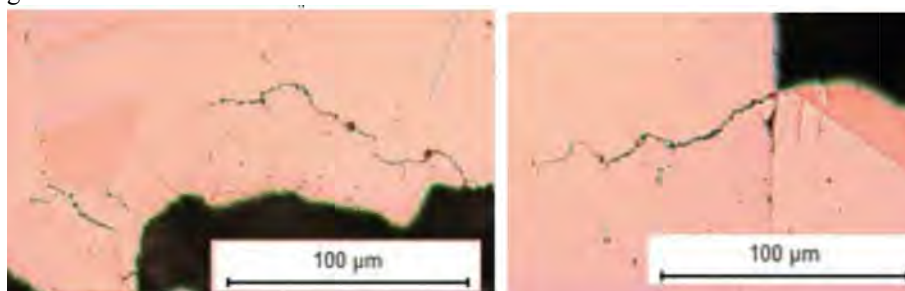
**Figure 3.15.** Details from Figure 4-7 in /Gordon A. et al. 2017/. Middle part of pre-crack of WOL sample M4 4:1 (MiniCan 4), showing smaller cracks emanating perpendicular to the direction of the main crack.

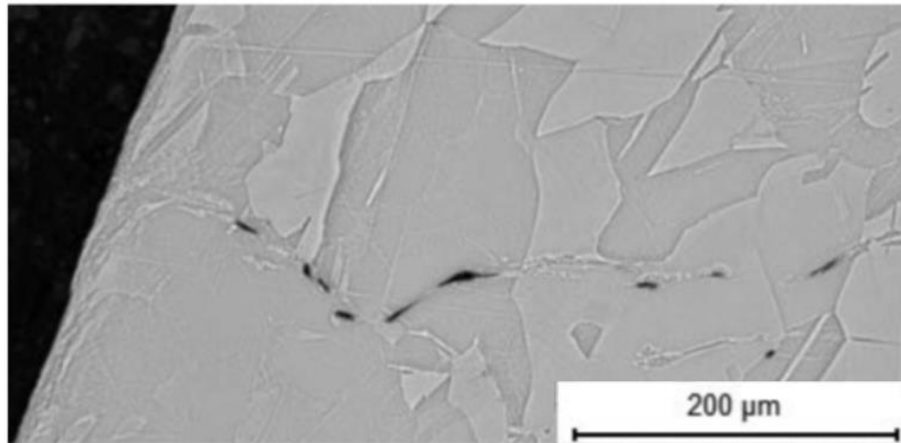
**Figure 3.16.** Details from Figure 4-5in /Gordon A. et al. 2017/. U-bend sample M4 1.1 had an area of cold deformation near the surface, but also present were pores which appeared to be aligned along the grain boundaries.

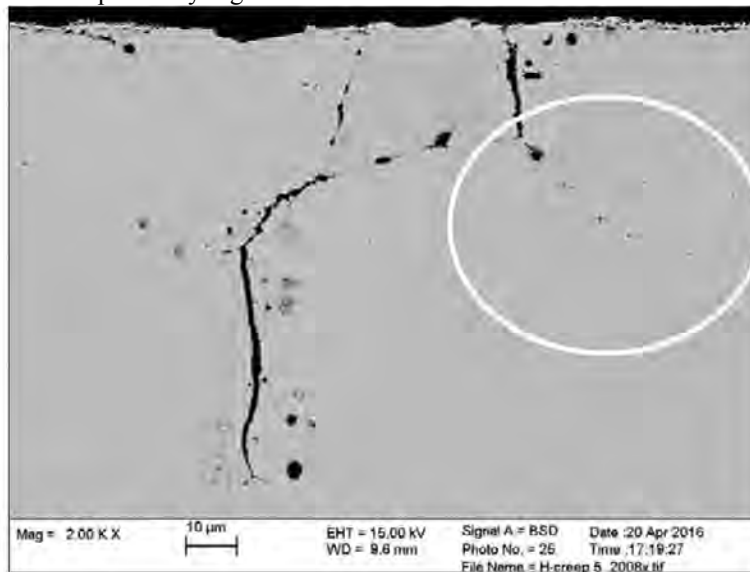
**Figure 3-8.** Specimen H-creep-05 tested at RT for 1 005.7 hours hydrogen charging time and creep stress of 170 MPa. Larger cracks were discovered. The specimen was tested in soft annealed condition without any pre-strain.

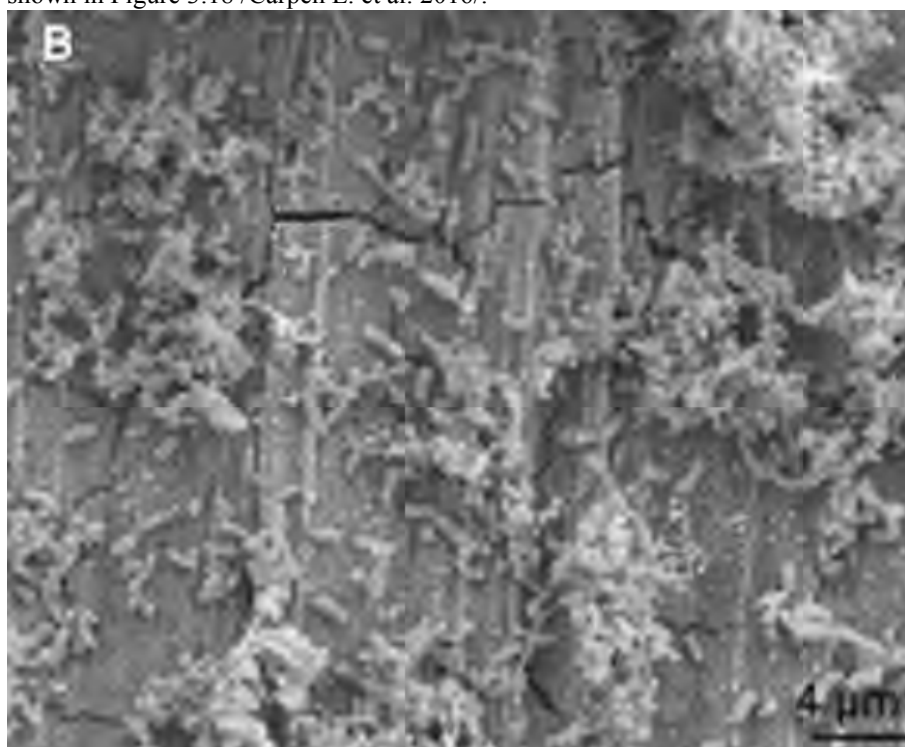
**Figure 3.18.** Microbial corrosion on the surface of unalloyed copper creates micro cracks due to sulphur enrichment. SRB colonies convert sulphate to sulphide which results in SCC/ Carpén L. et al. 2016/.

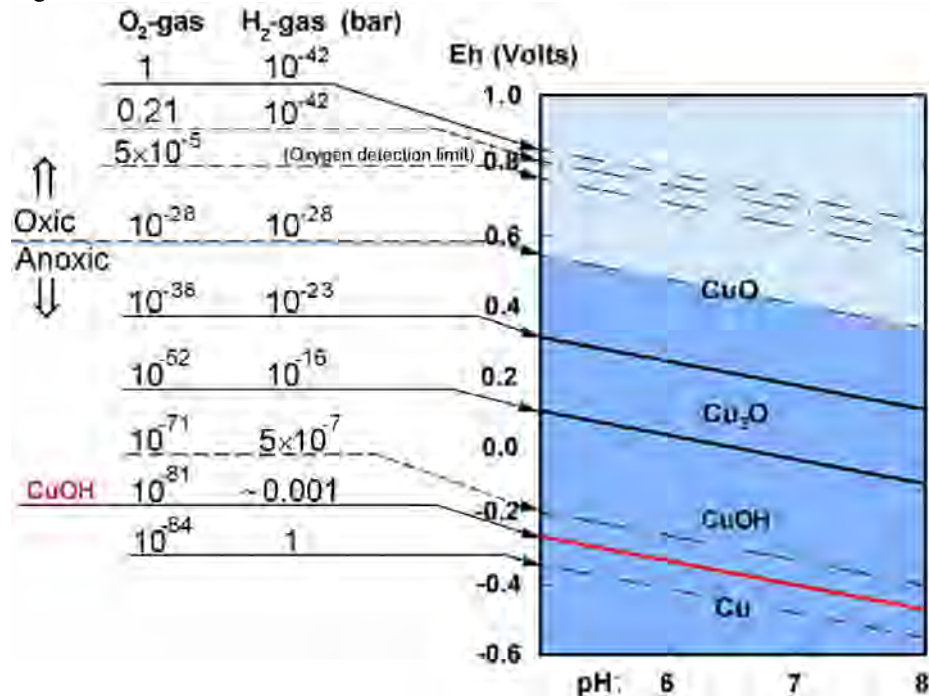
**Figure 4.1.** Pourbaix diagram based on /Szakálos P et al. 2007/. The light blue area at the top shows the oxic region with predominantly dissolved oxygen gas. The somewhat darker blue area shows the anoxic region with predominately dissolved hydrogen gas. The anoxic corrosion product Cu<sub>2</sub>O (cuprite) is only formed at very low oxygen and hydrogen partial pressures represented by the black solid lines. The solid red line marks the lower stability region for the monovalent hydroxide CuOH, which is stable up to around 1 mbar hydrogen gas pressure.

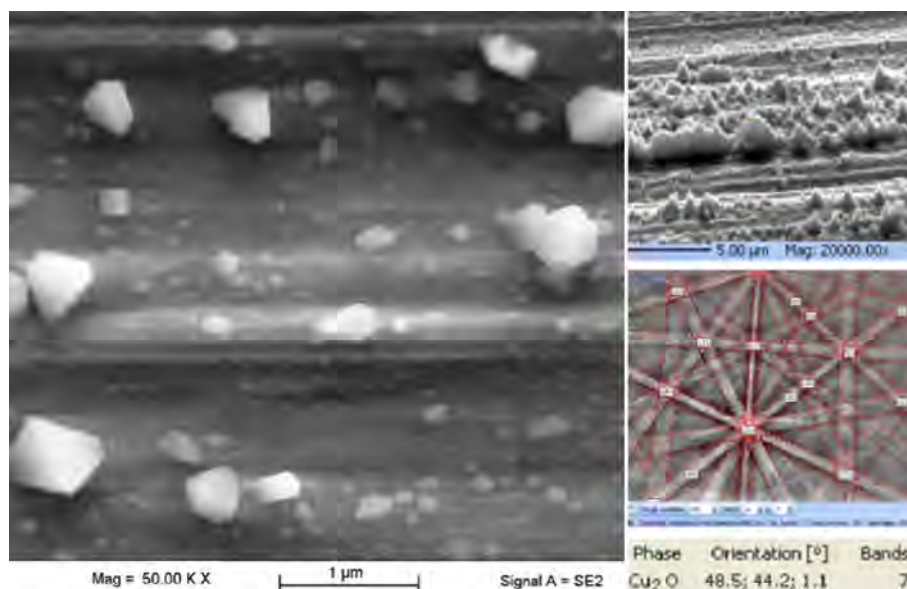
**Figure 4.2.** Unalloyed copper exposed to pure oxygen free water at 50°C for 12 months. The sample was moved directly from the anoxic water to the SEM/EBSD equipment to avoid any oxidic corrosion. The light crystals on the exposed surface have a somewhat distorted Cu<sub>2</sub>O-crystal structure, i.e. cuprite (detected by EBSD), but contain high amount of hydrogen (SIMS) /Szakálos P. and Hultquist G. 2013/ and Land and Environmental Court in Nacka, Sweden, case no. M 1333-11, Addendum 690.

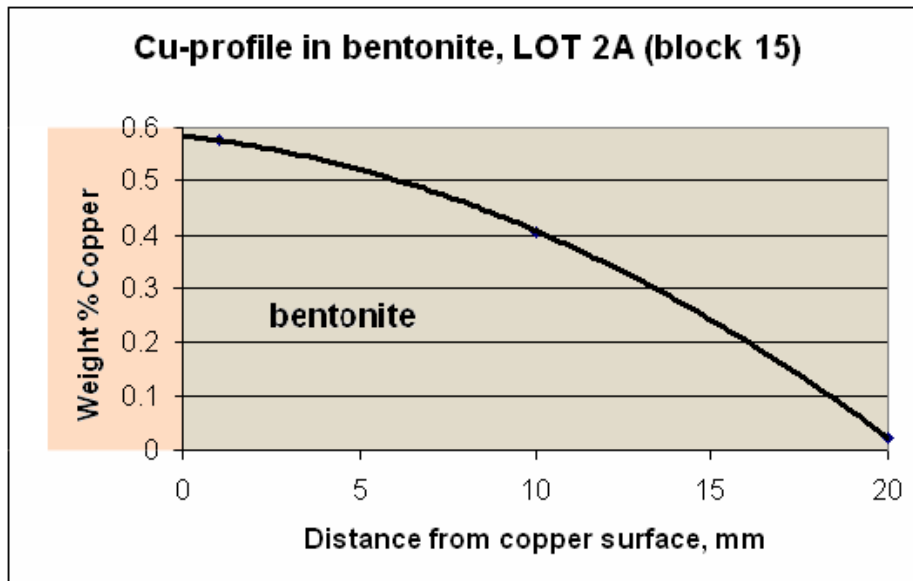
**Figure 4.3.** The bentonite acts as a Cu-ion sink and both copper and bentonite mutually destroy each other in an accelerated manner. Raw data from /Karlund O. et al. 2009/. LOT A2, Appendix 6; Characterization of the A2 parcel, Bundesanstalt für Geowissenschaften und Rohstoffe.

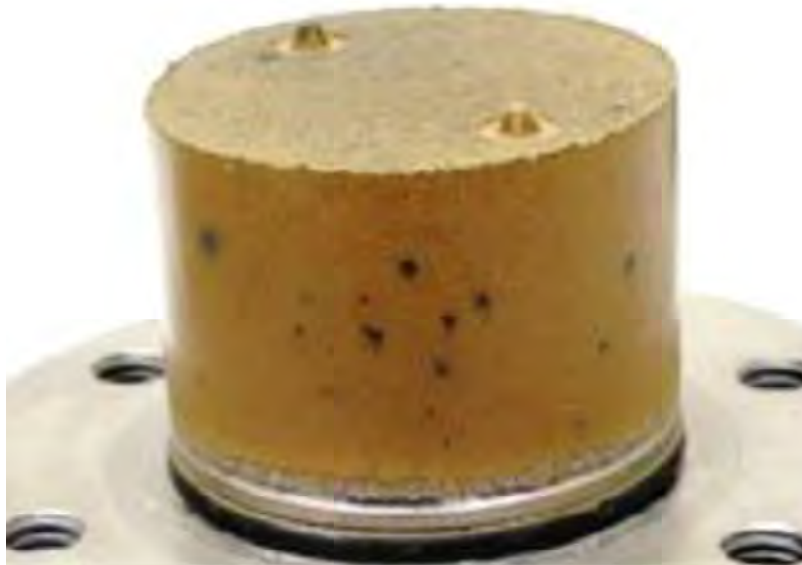
Black colonies of iron sulphide produced by sulphide producing bacteria in Asha bentonite at 1750 kg/m<sup>3</sup> wet density and with addition of lactate and sulphide producing bacteria

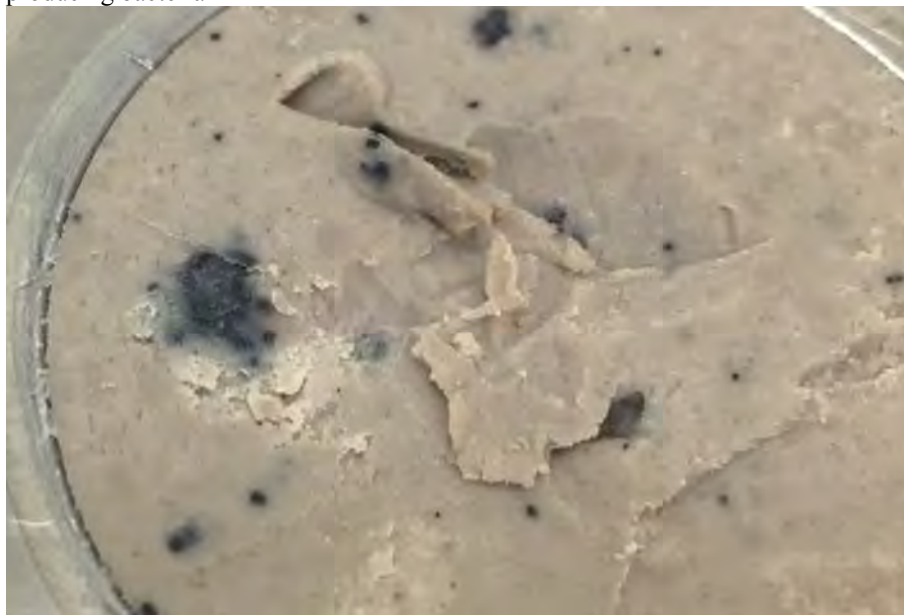
Black colonies of iron sulphide produced by sulphide producing bacteria observed during sampling of test cell with GMZ bentonite.

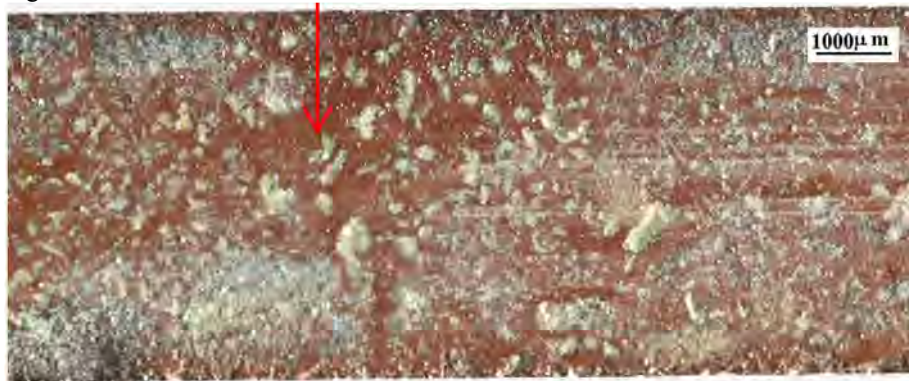
**Figure 4.5.** A macrograph showing an exposed copper sample severely attacked by pitting corrosion, from Appendix B in the FEBEX-report /Wersin P. and Kober F 2017/.
