**Beträffande regeringens pågående prövning av kärnbränsleförvaret enligt miljöbalken (M2018/00217/Me) och kärntekniklagen (M2018/00221/Ke)**

# Corrosion-induced microstructure degradation of copper in sulfide-containing simulated anoxic groundwater studied by synchrotron high-energy X-ray diffraction and *ab-initio* density functional theory calculation

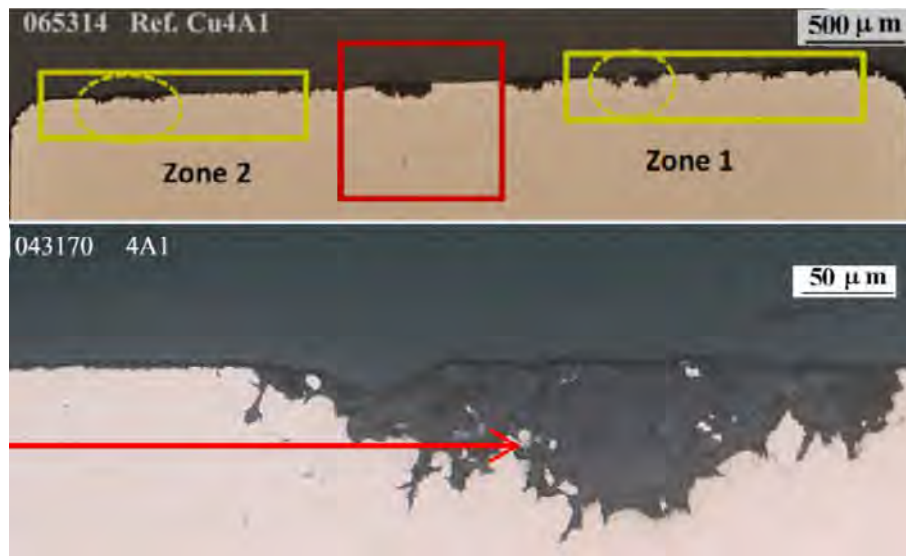
**Figure 4.6.** Metallographic cross-sections showing the exposed copper sample with pitting corrosion, up to 100 μm in depth. From Appendix B in the FEBEX-report /Wersin P. and Kober F 2017/.

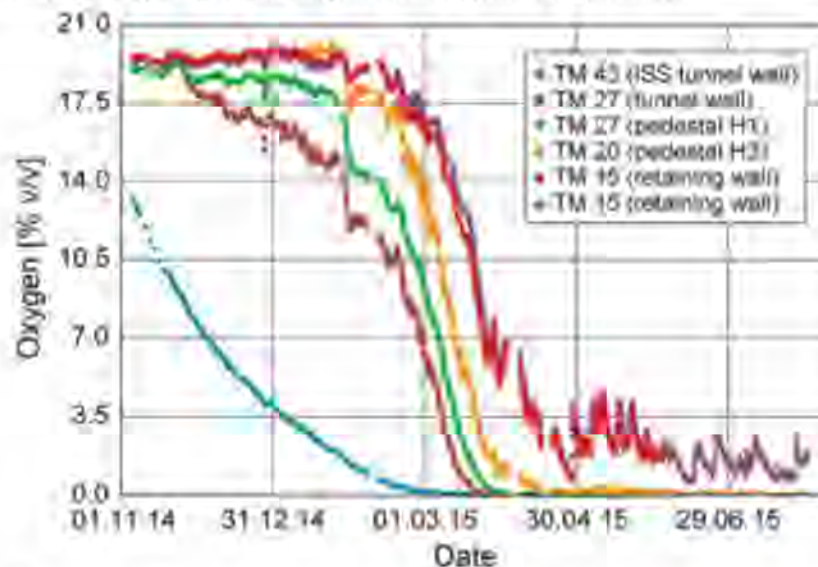
**Fig. 11** Oxygen concentrations at different measurement locations along the FE tunnel from November 2014 (shortly after backfilling started) until July 2015

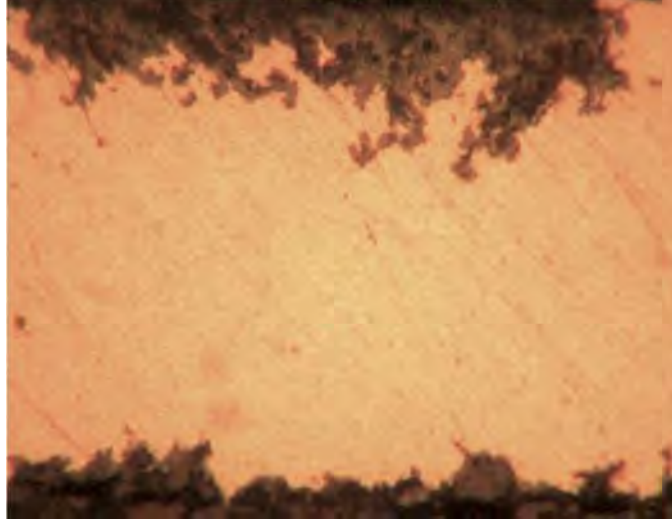
**Figure 4.8.** Light optical cross-section of the initially 100 $\mu\text{m}$  thick copper foil after 15 years exposure in distilled anoxic water at room temperature. Localised corrosion attack is clearly visible. Scale: the height of the micrograph is 90  $\mu\text{m}$ . /Hultquist G. et al. 2008/.

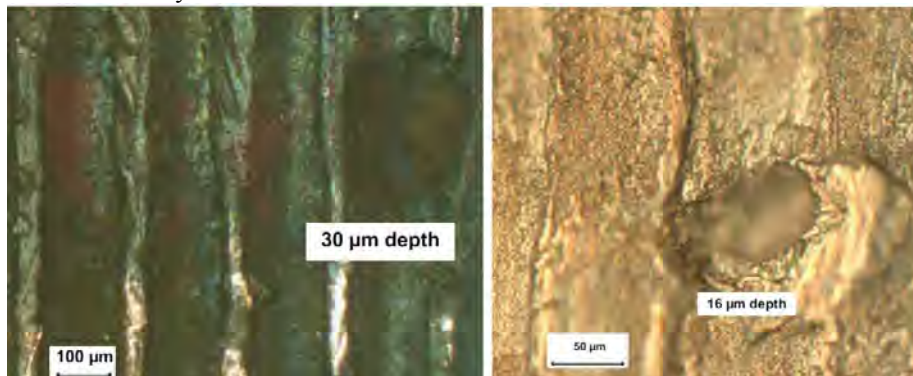
**Figure 4.9.** Example of pitting corrosion on one acid cleaned sample (to the right) and an un-cleaned sample to the left /Gordon A. et al. 2018b/. Maximum pitting corrosion rate: 6  $\mu\text{m}/\text{year}$ .

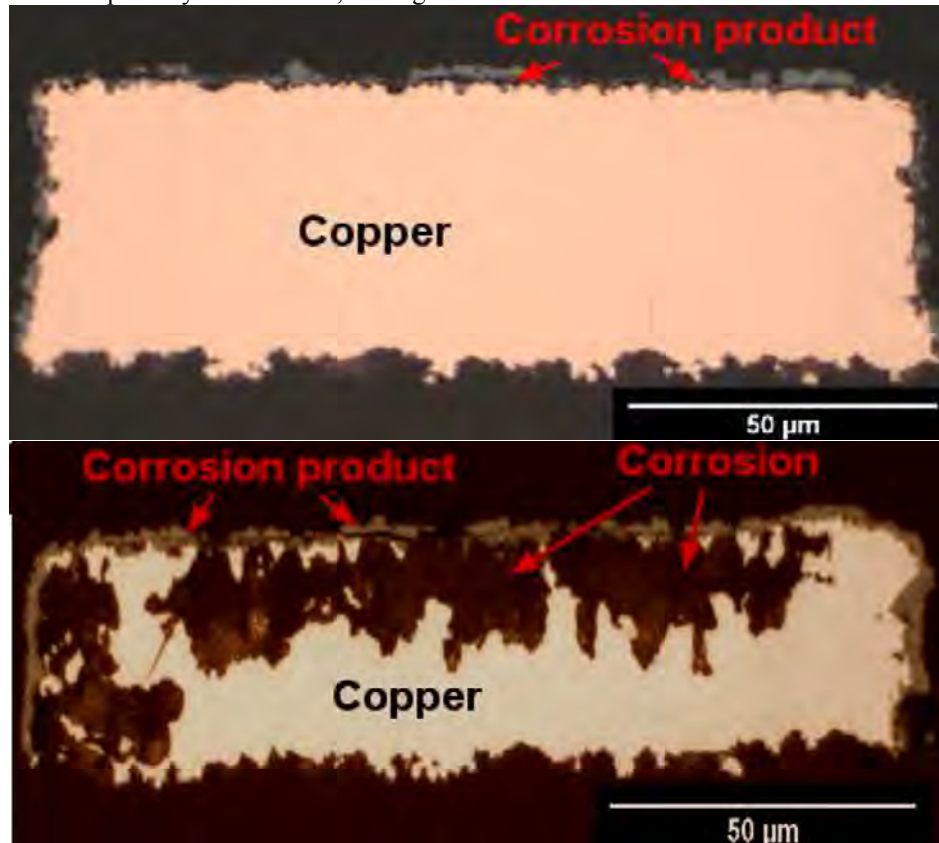
**Figure 4.10.** Results from Figure 5 in /Marja-aho M. et al. 2018/. Corrosion tests performed in simulated geological nuclear waste repository, at temperatures 10–12°C and oxygen level below 1 ppm. Simulated groundwater, with chemical composition of groundwater stabilized with bentonite. The micrograph at the top shows a cross-section, originally 200×35µm<sup>2</sup>, of a sample exposed for 4 months without SRB (abiotic environment) and micrograph at the bottom shows a sample exposed 4 months with naturally occurring SRB in groundwater (biotic environment).

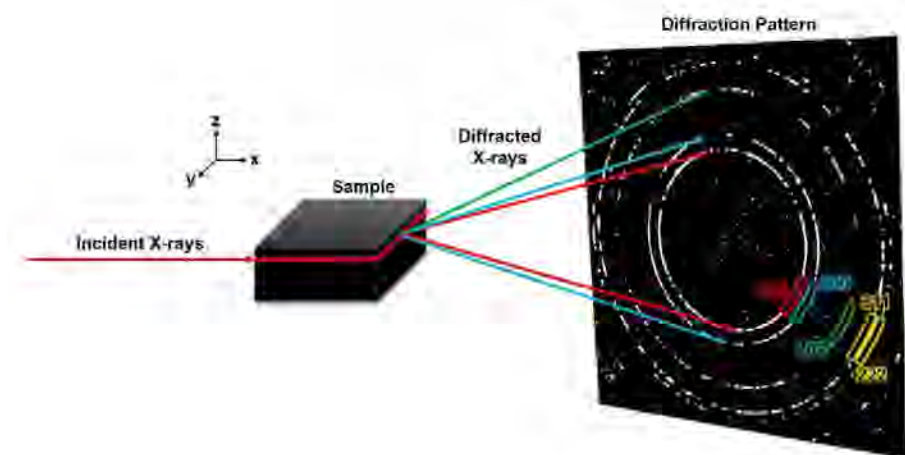
**Figure 5.1.** Experimental setup of high-energy x-ray diffraction measurements showing x-rays radiating the copper specimen and the diffracted x-rays with the 2D diffraction pattern collected by a detector.

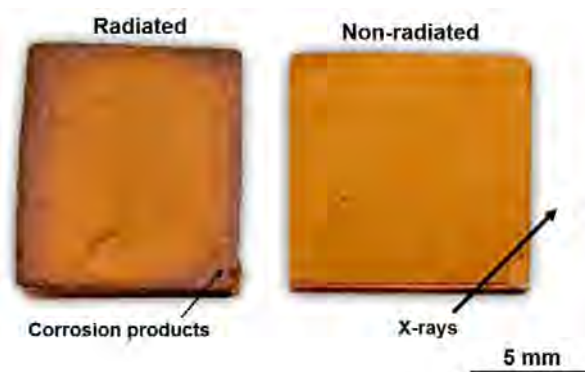
**Figure 5.2.** Photograph of some of the copper samples to be investigated. The radiated specimen in this case was exposed to oxygen-free water for 64 hours with a simultaneous exposure to 28.6 kGy of gamma radiation. The non-radiated specimen was exposed to oxygen-free water for 64 hours only. The bar shows the scan direction of x-rays through the specimen.
