**TECHNICAL NOTE**

# 1. Discussion and conclusions concerning the five corrosion issues pointed out by The Land and Environmental Court

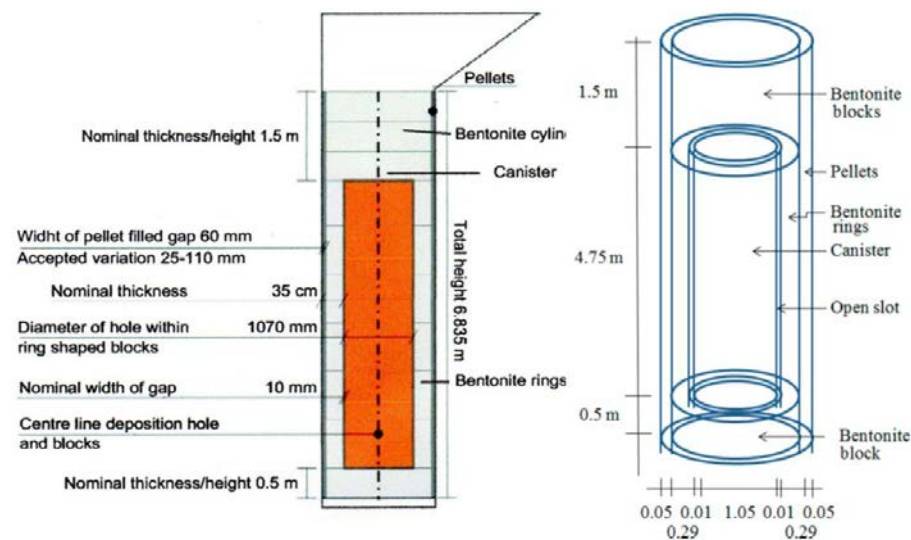
**Figure 2.1.** Configuration and geometry of the deposition hole with copper canister and bentonite buffer. From SKB-report TR-14-12 (to the left) and from SKB-report TR-17-15, Figure 9-1 (to the right). The drilled hole in the bed rock has a diameter of around 1.8 meter.

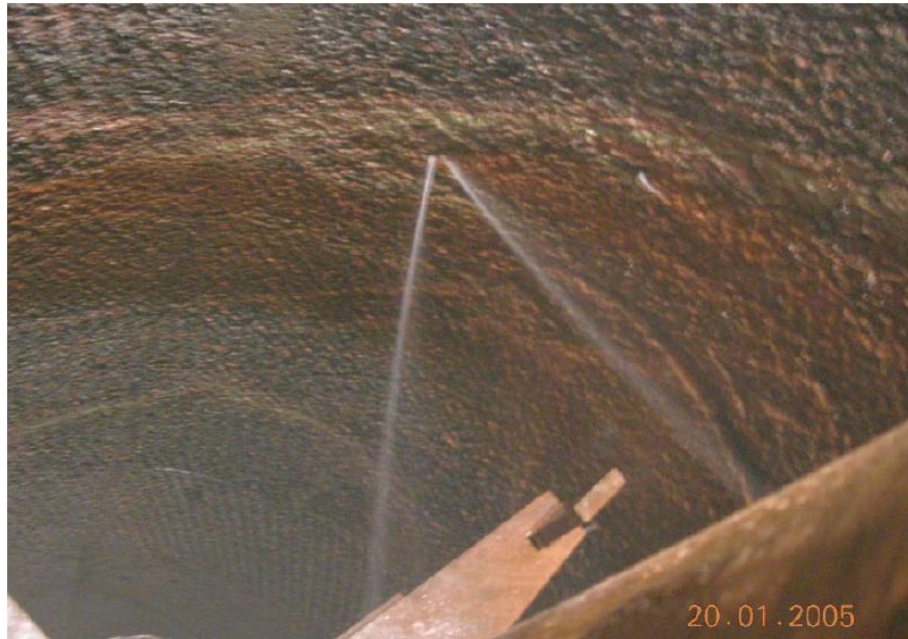
**Figure 2.2.** From Figure 3 in SKB-report R-05-44. Typical inflow pattern in Äspö hard rock laboratory showing high pressurized groundwater seeping out of a drilled rock surface. This photo is taken from a depth of only 220 m, i.e. the water pressure is around 22 bar, only half of that prevailing in a real repository. The cracks in the deposition holes in Forsmark are believed to be smaller but the pressure of the ground water is still 50 bar.

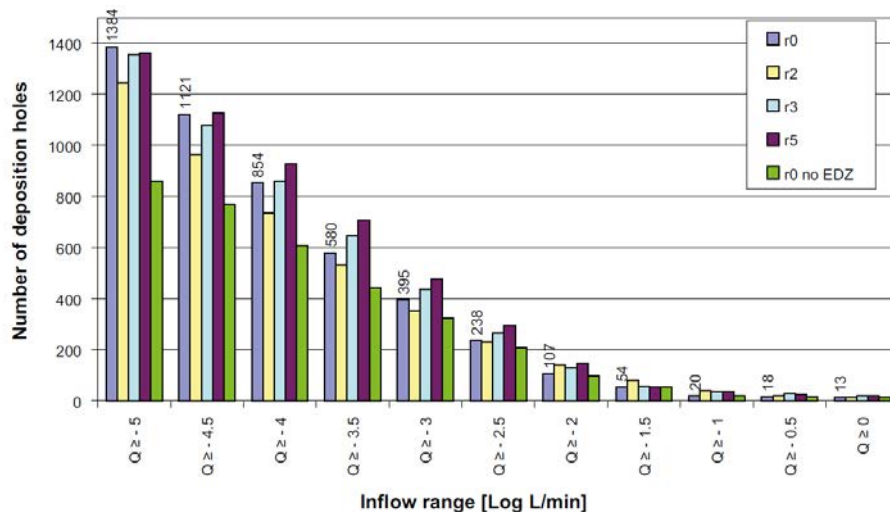
**Figure 2.3.** From SKB-report R-13-21, Fig. 3-4. Complementary cumulative distributions of the total inflow to each deposition hole for each case. According to case r0 (the five simulations r0-r5, give roughly the same outcome) there are 1384 deposition holes out of 6916 that have at least one crack that gives an inflow of ground water more than  $10^{-5}$  L/min ( $\geq 5.3$  litre/year). 854 deposition holes have an inflow of more than  $10^{-4}$  L/min ( $\geq 53$  litre/year) and 395 deposition holes has an inflow of more than  $10^{-3}$  L/min ( $\geq 530$  litre/year).

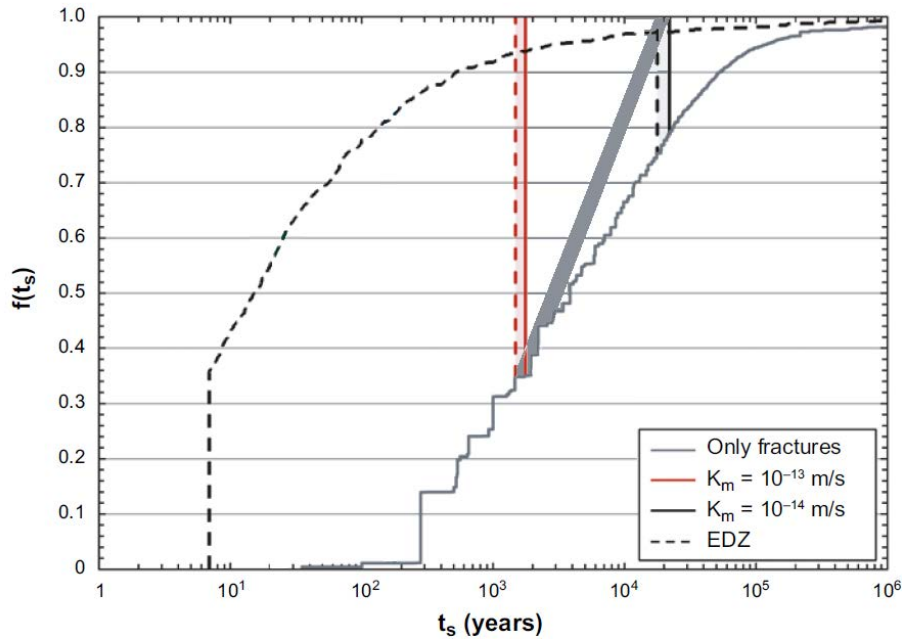
**Figure 2.4.** Modified graph based on Fig. 7-15 in /Sellin P. et al. 2017/. The solid grey line identifies the cumulative distribution of saturation times,  $f(t_s)$ , in the Forsmark repository calculated assuming no matrix flow, i.e. only flow via macro cracks. The vertical lines (red and black) identify the time interval within which all deposition holes will reach full saturation if the matrix hydraulic conductivity has the value  $K_m = 10^{-13}$  m/s and  $K_m = 10^{-14}$  m/s respectively, see point (i) above. The fat grey line represents a linear distribution (realistic simplification), taking into account the variations in measured  $K_m$  values in Forsmark. It is thus indicated that the last tunnel and deposition holes with the lowest hydraulic conductivity will be water saturated only after  $\geq 15,000$  years by matrix inflow and that it takes around 3000 years to saturate 50% of the deposition holes, mainly by cracks in the deposition holes and tunnels. The dashed black line identifies the distribution of saturation times if no flow resistance was present in the tunnels (only of theoretical interest).

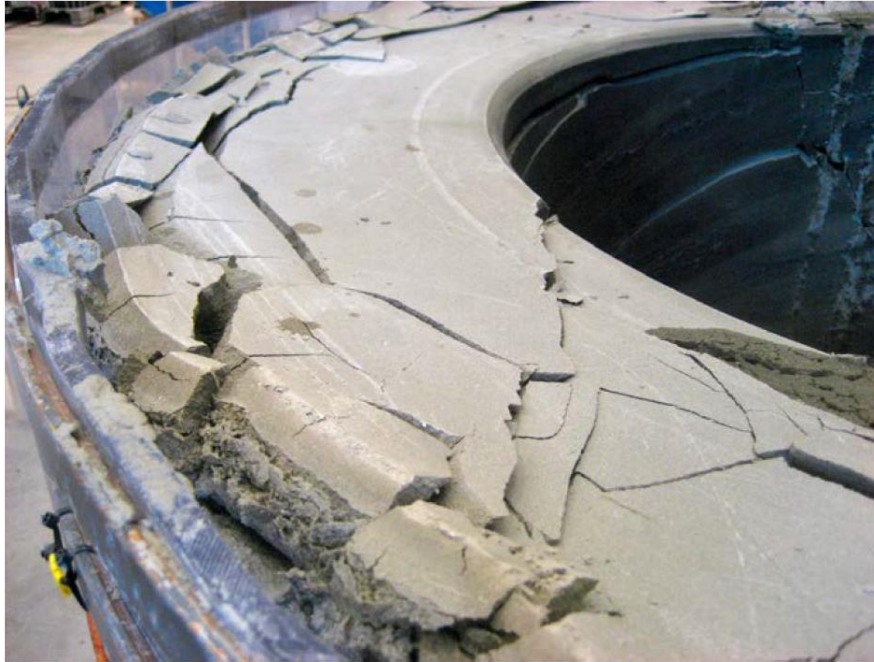
**Figure 2.5.** From SKB-report TR-17-15, Fig 2.9. SKB has shown in several reports that it is impossible to add water to bentonite blocks without severe cracking under normal pressure.

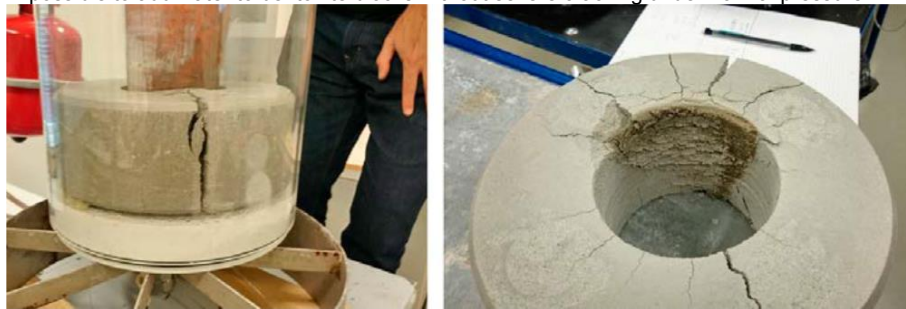
**Figure 2.6.** From Figure 2-8 in SKB TR-15-09. Left: Test 3 at termination. Right: Bottom side of the bentonite ring showing a condensation “nucleus” and cracks. Severe cracking of the bentonite rings occurred already within 7 days, which was the experiment duration time.

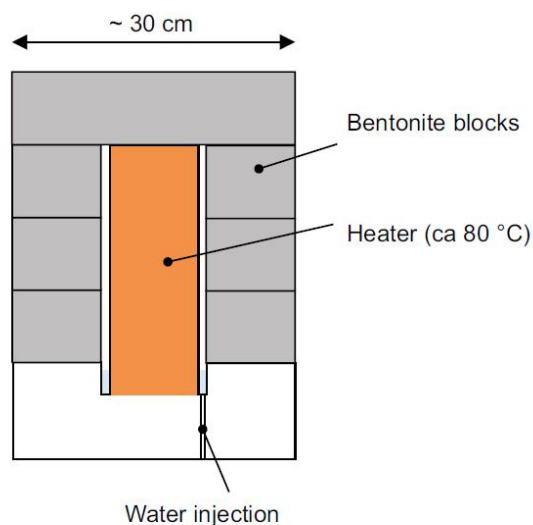
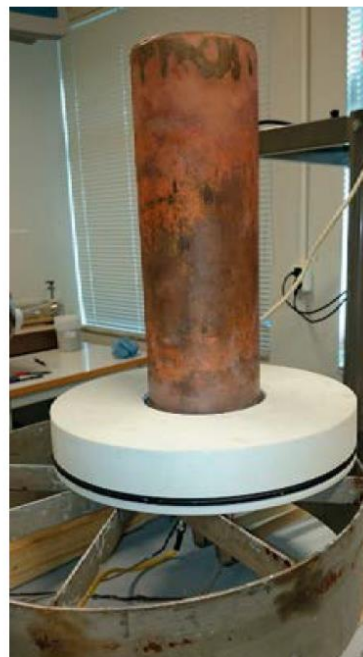
**Figure 2.7.** From Figure 2-1 in TR 15-09. The test set-up, which to a certain extent is a model of a KBS-3 deposition hole. Mounted on a plastic plate is a copper tube which is heated by circulating water to approximately 80 °C. "Water injection" seen to the left is actually a hole for low pressure water vapour to enter the slot between the Cu-heater and the bentonite rings. The outside of the set-up was covered by a plexiglass tube (not visible here).

Fundamentally, the set-up for Sauna tests 1-9, TR-15-09 and TR-17-07, has a known major flaw concerning the water supply system compared to the real repository situation. In reality the major supply of water will be by liquid water seeping out from bed rock cracks as shown in Figure 2.2 and not as moist air as in the set-up, see Figure 2.7. The authors Birgersson and Goudarzi, as well as SKB, are fully aware of that it has been proven impossible to inject liquid water without destroying the bentonite buffer totally with cracks and piping, as shown in Figure 2.5 and 2.6. The only way to solve this fundamental problem for the whole concept of KBS-3 is to apply a proper water counter pressure of 50 bar, i.e. reach saturation in the tunnels, so the cracks and piping would eventually heal, but unfortunately that will occur far too late in a Forsmark repository. The proper counter pressure in the tunnels will only be reached after around 2000-15.000 years, see Figure 2.4, thus the "sauna"-effect will be impossible to stop for several thousands of years in Forsmark. The main four arguments, already listed up in the Abstract in TR-17-07 that are claimed to indicate that "severe amount of salt in a KBS-3 deposition hole during the saturation process is highly unlikely and can be disregarded" are based on experiments that are not relevant due to several reasons:

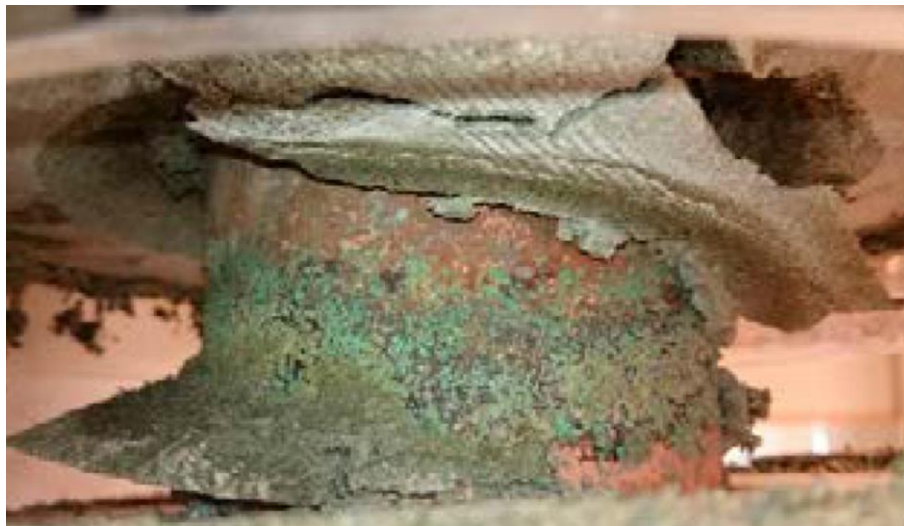
**Figure 2.8.** Detail from Figure 2-27 in TR 15-09. Severe corrosion of the copper heating tube after only seven days of laboratory exposure that at least reminds of the true Sauna effect, i.e. with only indirect contact with 0.6M chloride solution.

4) The only test that used salt water was Test 7 and that exposure did experience real Sauna effect with massive copper corrosion during only seven days of salt exposure, see Figure 2.8. However SKB omitted to discuss this at least more relevant test in their supplementary report TR-19-15.

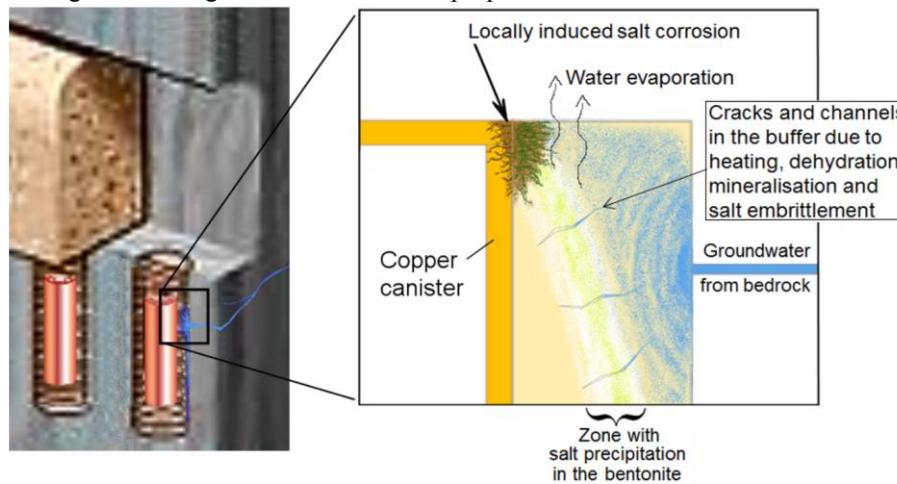
**Figure 2.9.** The Sauna effect in a repository with water evaporation, salt enrichment and copper corrosion. Furthermore, the precipitated salt will destroy the properties of the bentonite buffer /Szakálos P. and Seetharaman S. 2012/.

The Sauna effect will also destroy the bentonite buffer, as shown in Figure 2.9. When the salt crystals precipitate in the bentonite it will convert the clay to a brittle and cracked mineral “cake” for several thousand years and most likely it will never regain its original swelling and diffusion barrier properties.

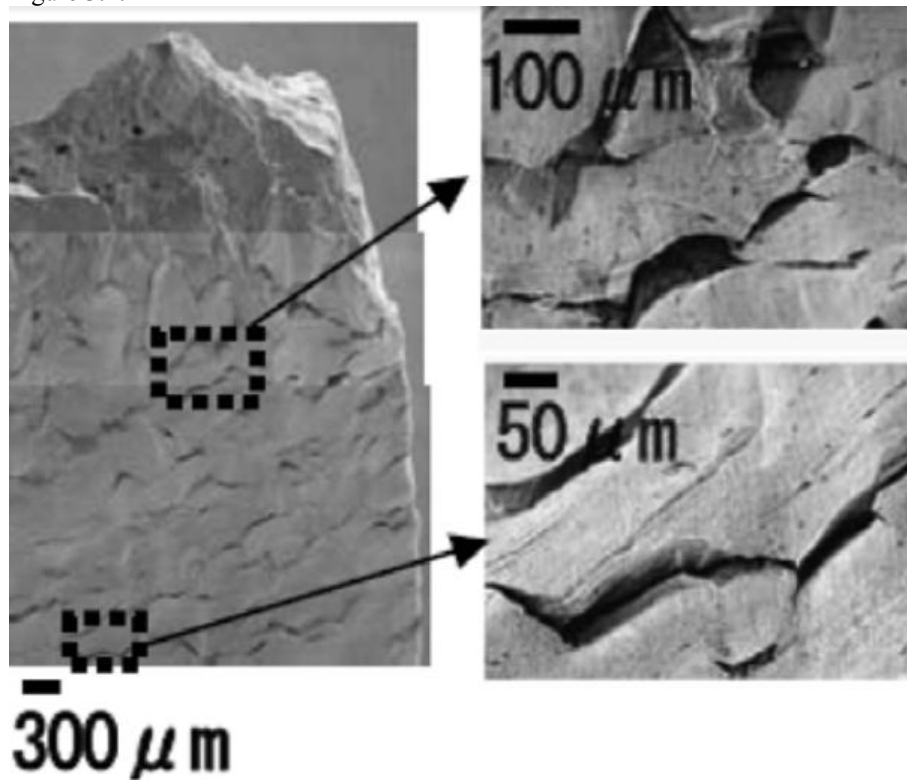
**Figure 3.1.** Fractured copper sample due to Stress Corrosion Cracking (SCC) in 0.01M sulphide containing seawater at 80°C after 7 days exposure. Initiation of minor cracks was detected at 0.001M sulphide concentration (not shown here). Slow strain rate testing (SSRT) results from Figure 10 in /Taniguchi and Kawasaki 2008/.

/Taniguchi and Kawasaki 2008/ showed that unalloyed copper (CuOFP copper) is indeed sensitive to stress corrosion cracking (SCC) in sulphide containing sea water. Multiple cracks due to SCC, preferably in the copper grain boundaries are seen in Figure 3.1.

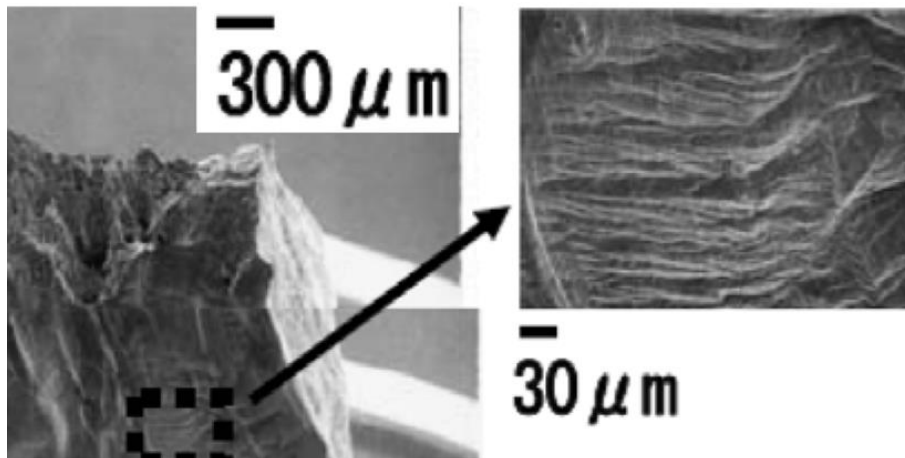
**Figure 3.2.** Crack-free copper surface when tested during the same conditions as in Figure 3.1 but with a sulphur free (inert) environment. No indication of any crack initiation visible in high magnification, see detailed micrograph to the right. Slow strain rate testing (SSRT) results from Figure 10 in /Taniguchi and Kawasaki 2008/.

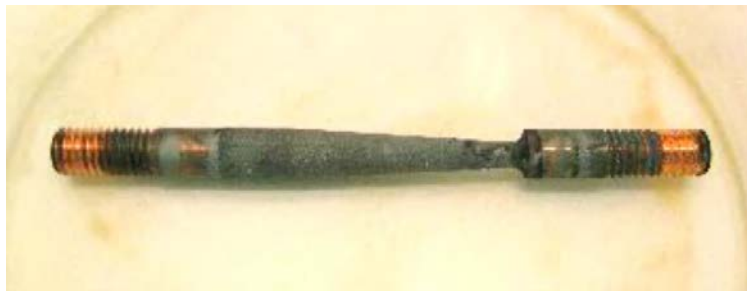
**Figure 3.3.** Example of SSRT exposed sample, 9 % strain at the thinnest part of the tapered sample (not exposed to final fracture).

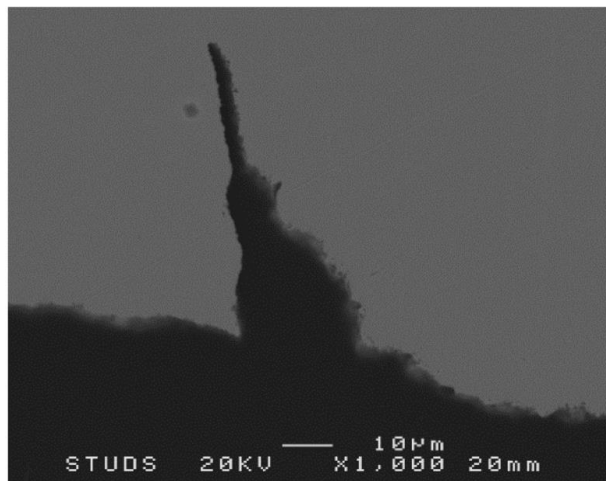
**Figure 3.4.** From Figure 16 in /R. Becker, J. Öjjerholm 2017/: Specimen #3 ( $10^{-3} \text{ M}$  sulphide), SEM image of a crack observed at the narrowest part of tapered gage section.

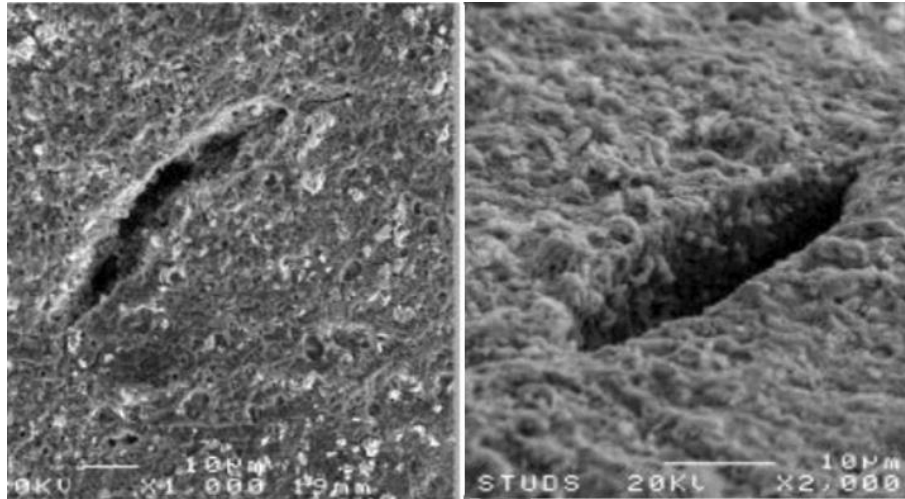
**Figure 3.5.** From Figure 2 in /Forsström A. et al. 2017/. Surface cracks near the narrowest part of Specimen #3 ( $10^{-3}$  M sulphide) after SSRT testing.

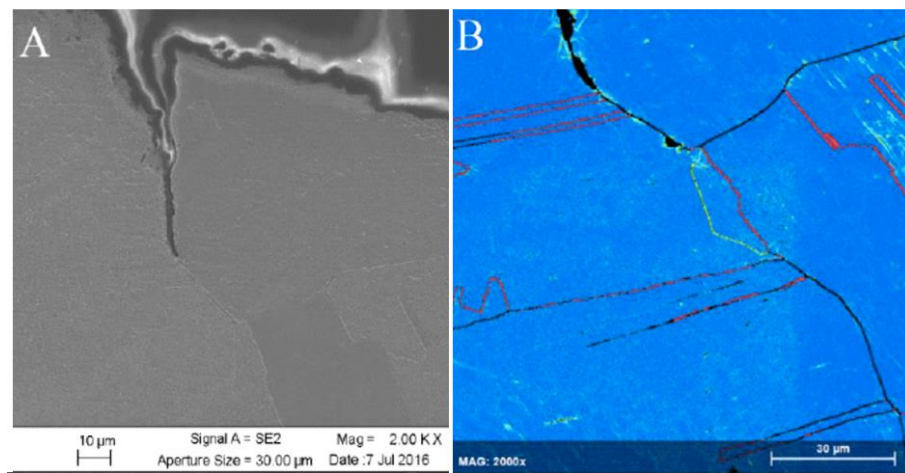
**Figure 3.6.** From Figure 3 in /Forsström A. et al. 2017/. Cross-section images of a SCC crack in the narrow section of Specimen #3. EBSD image showing crack propagation along a random grain boundary. Twin boundaries are marked in red and local misorientation in shades of green.

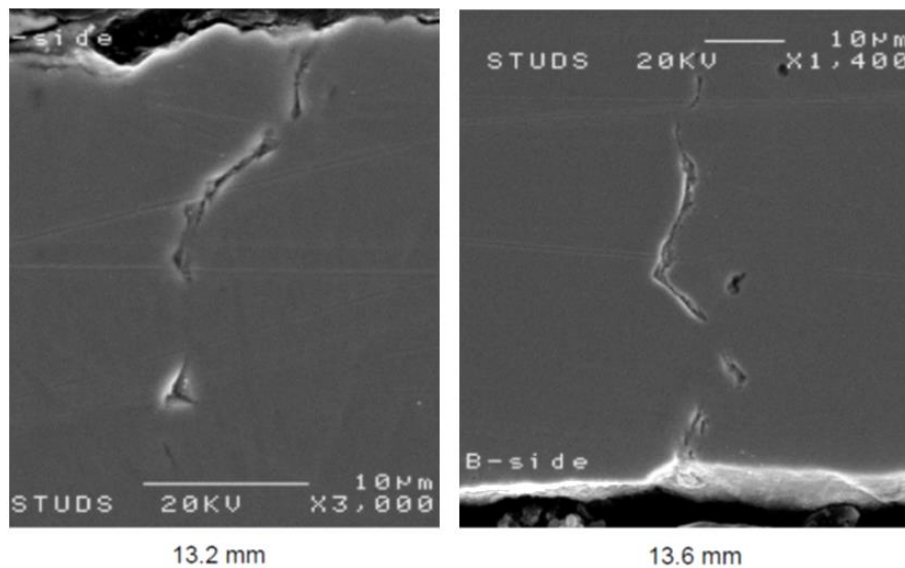
**Figure 3.7.** Part from Figure 21 in /R. Becker, J. Öjjerholm 2017/. Initiation of blisters and cracks could be detected also at lower sulphide concentrations quite far away from the narrowest part (with the highest stress) of the sample, i.e. at a distance of 13.2-13.6 mm. Exposures 3 (specimen #5) exposed to  $10^{-4}$  M sulphide.

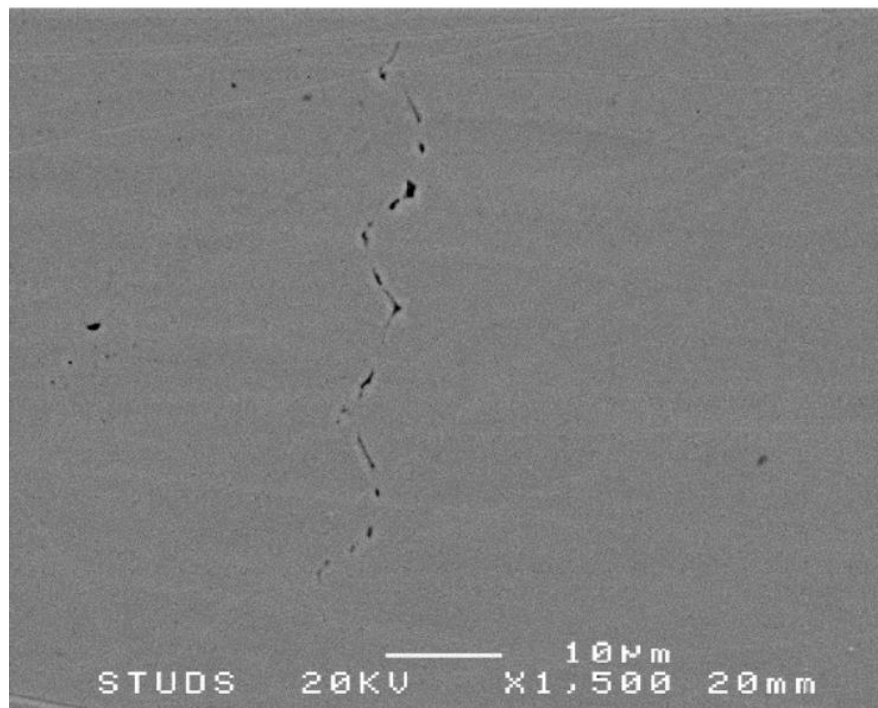
**Figure 3.8.** From Figure 22 in /R. Becker, J. Öjjerholm 2017/, specimen #5, ( $10^{-5}$  M sulphide). Defects in shape of blisters in the copper grain boundaries was detected deep inside the SSRT samples. In fact, similar defects were also found in the unloaded head section of the samples, irrespective of the sulphide content during the various exposures. These grain boundary blisters cannot be initiated by sulphur since they are formed deep inside the metal, they are instead initiated by fast moving hydrogen.

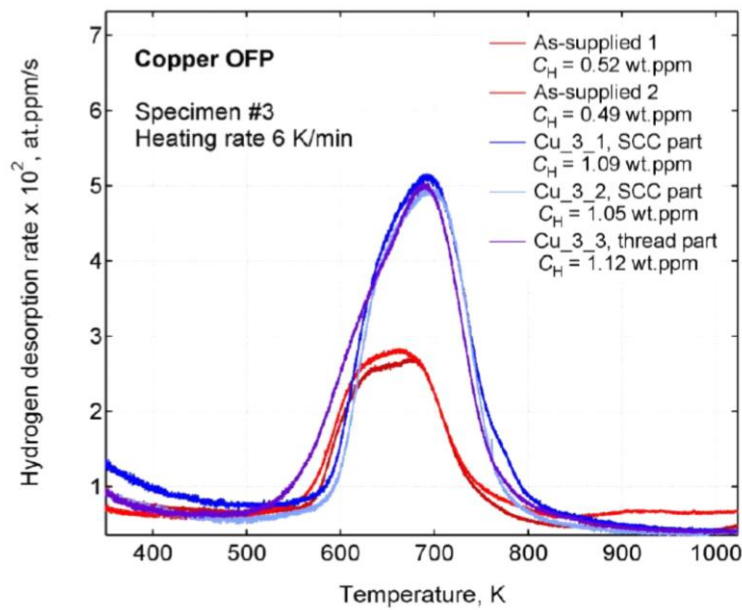
**Figure 3.9.** Hydrogen desorption curves (TDS) from /Forsström A. et al. 2017/ shows a systematically higher hydrogen content in the SSRT-exposed copper samples (blue and purple curves) compared with the as supplied SKB-copper metal (red curves). The TDS curves look similar for all tested samples, i.e. #3, #5 and #7. The systematic increase in hydrogen content in combination with the detected blisters in the inner sections of the copper samples (crack like defects, see Fig. 3.8) shows that copper exposed in an anoxic corrosive environment will suffer not only from SCC (surface cracking) but also from hydrogen induced grain boundary blisters and eventually cracking inside the bulk metal. This represents, in other words, the evidence for hydrogen embrittlement in oxygen free copper.

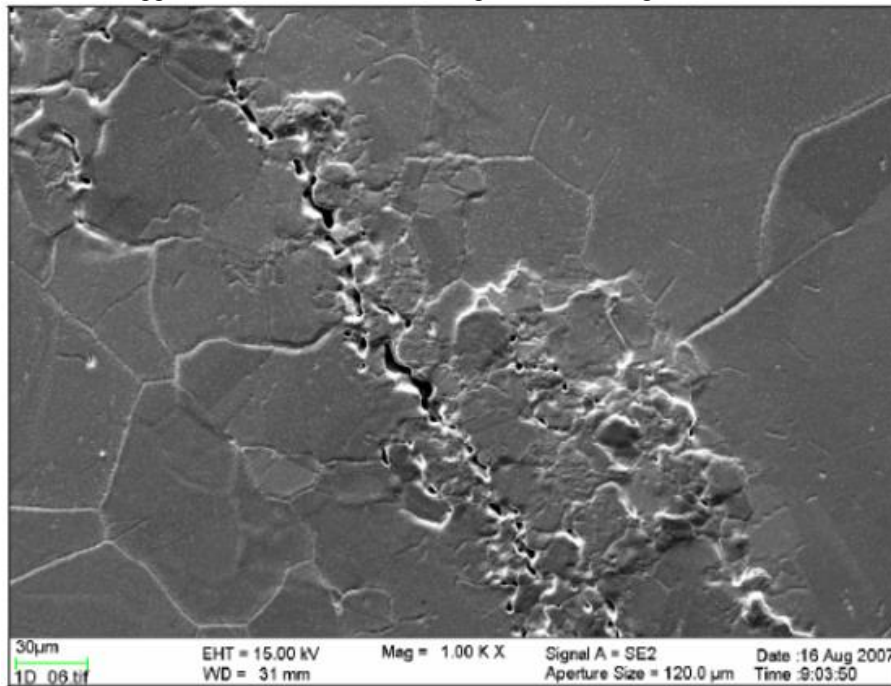
**Figure 15. Sample 1DV. Voids and heavy deformation are clearly visible at the region of entrapped oxide particles.**

The only prerequisite for hydrogen embrittlement (“hydrogen sickness”) in oxygen containing copper is the presence of an anoxic environment with hydrogen on at least one side of the exposed copper metal. No load or stress in the copper metal is needed since the moving hydrogen atoms will simply react with the small oxide particles inside the copper metal under formation of water/steam blisters and eventually crack formation. In fact, this is exactly what will happen in the copper canister welds. The friction stir welds (FSW) will inevitably contain some oxygen particles. In TR-11-01 p. 173 it is stated that some oxide particles will always form in a FSW, also when using a shielding gas, especially at the inner lid/tube interface, i.e. at the root of the weld zone. /Savolainen K. et al 2008/ has studied the problem with hydrogen sickness in FSW in copper and shown that it is a real problem, see Figure 3.10.

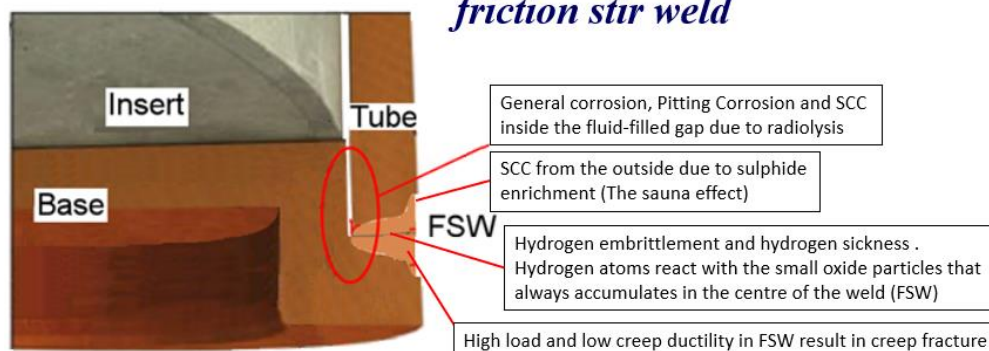
**Figure 3.11.** Detail from /Szakálos P. et al. 2017/. The weakest point of the canister is the Friction Stir Weld (FSW) and the fastest degradation mechanism is “hydrogen sickness” in the welds.

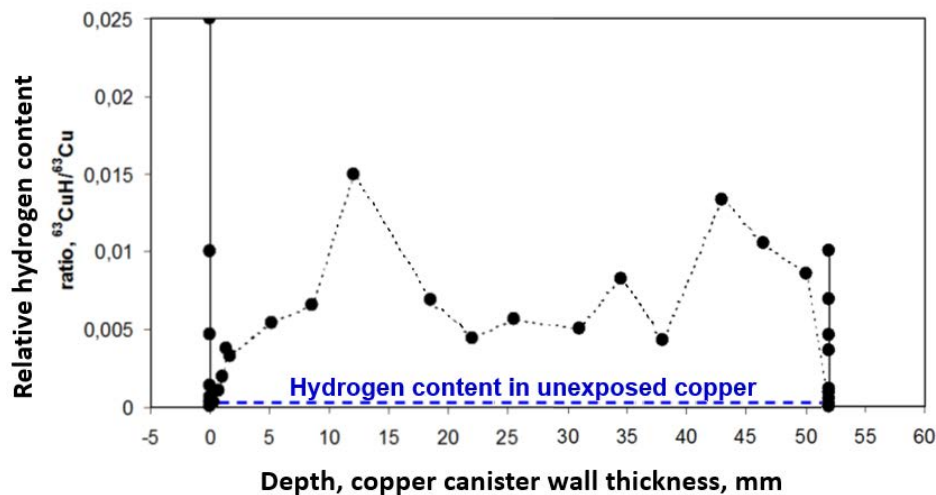
**Figure 3.12.** Full thickness canister copper exposed to the Swedish groundwater for seven years in the heated prototype repository, 80-90°C, at Äspö hard rock laboratory. The remarkable result shows that the copper canister is hydrogen charged throughout the whole thickness. The outermost surfaces have a very high H-content due to formation of corrosion products containing hydrogen and hydroxide. The hydrogen content in the first 10 mm of the inner/outer thickness has been subjected to spontaneous de-gassing when exposed to air since the hydrogen activity in the copper metal in contact with air is close to zero. The accepted hydrogen content in canister copper is 0.6 weight-ppm which coincide with the blue dotted line (unexposed copper). The hydrogen is detected by SIMS measurements and based on the H/Cu-ratio it can be estimated that the average hydrogen content in the copper is significantly higher than 1 wt-ppm.

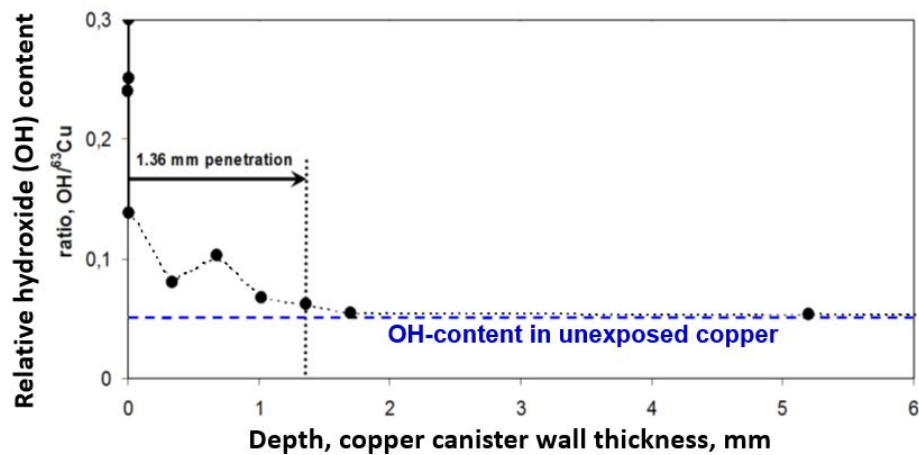
**Figure 3.13.** The hydroxide content of the first few mm of the full thickness canister copper exposed to the Swedish groundwater for seven years in the prototype repository at Äspö hard rock laboratory. The graph shows that hydroxide penetrates the copper metal, most probably in defects including grain boundaries. Once OH has entered the metal it is accumulated there, i.e. it is thermodynamically stable, i.e. evidence for internal anoxic corrosion. The hydroxide is detected by SIMS measurements.

**Issue (a).** Corrosion in pure oxygen-free water is discussed in detail in section 4.3. It is concluded that copper corrosion by pure water has a much higher equilibrium hydrogen pressure than that of pure and dry  $\text{Cu}_2\text{O}$  since at least two more strictly anoxic corrosion products exist,  $\text{CuOH}$  and a hydrogen containing and somewhat distorted  $\text{Cu}_2\text{O}$ -crystal, see Figure 4.2. It is confirmed by Ab-initio calculations that the hydrogen equilibrium pressure is around 1 mbar for  $\text{CuOH}$  /Belonoshko A.B. and Rosengren A. 2012/. Since issue (a) also includes oxygen-free water corrosion in general it should be added that internal corrosion is found to take place as hydroxide formation ( $\text{CuOH}$ ) inside the copper metal when exposed to anoxic ground water, as shown in section 3.6. This internal corrosion process with  $\text{CuOH}$  is also confirmed by Ab-initio calculations /Korzhavyi P. and Sandström R. 2014/. SKB has not incorporated these anoxic corrosion processes in the safety analysis. In the Supplementary information it is discarded as negligible which is obviously not true, since the internal corrosion by hydroxide formation can penetrate the copper canister within some few hundred years, as shown in Figure 3.13.

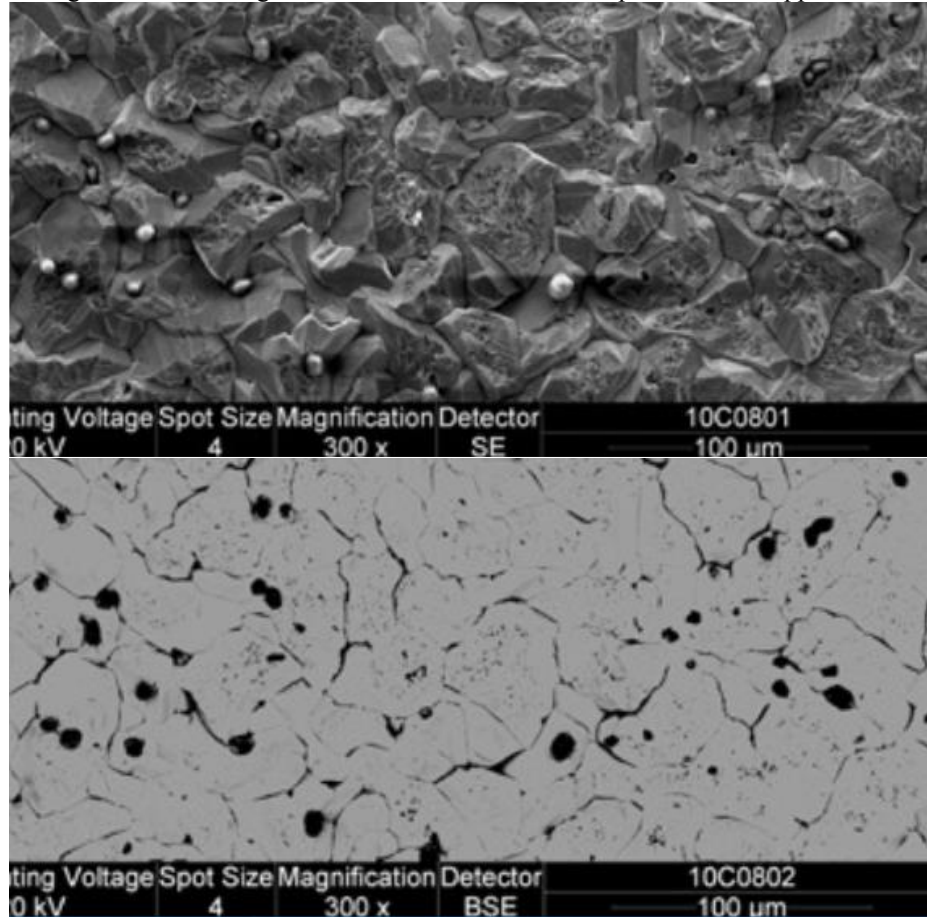
**Figure 3.14.** Detail from Figure 4 in /Ariilahti E. et al 2011/. The SEM-image at the top shows a post exposure fractured area ahead of the true crack tip for which EDS analysis showed average of 22.5 at-% sulphur. The backscatter electron image of the same area (bottom picture) shows darker sulphur-rich precipitates mostly at the grain boundaries.

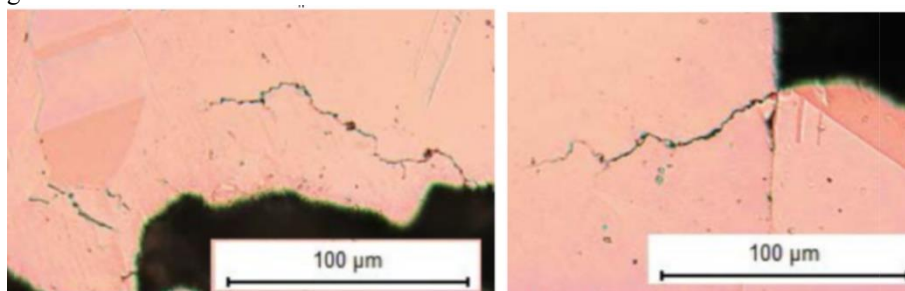
**Figure 3.15.** Details from Figure 4-7 in /Gordon A. et al. 2017/. Middle part of pre-crack of WOL sample M4 4:1 (MiniCan 4), showing smaller cracks emanating perpendicular to the direction of the main crack.

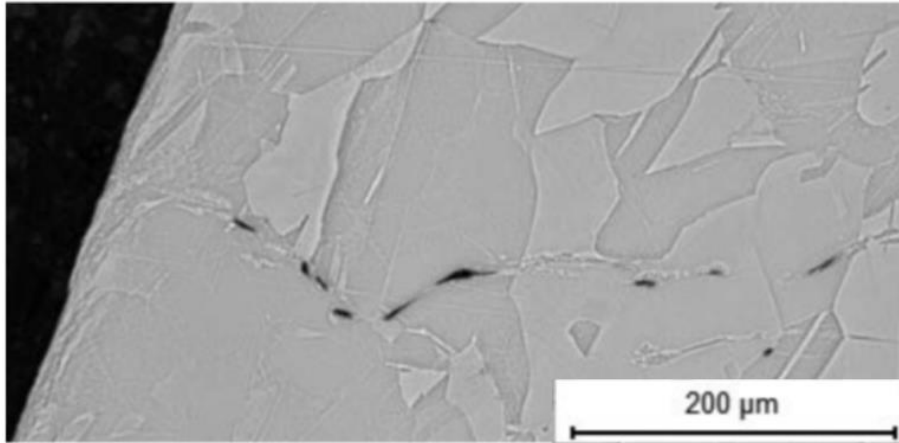
**Figure 3.16.** Details from Figure 4-5in /Gordon A. et al. 2017/. U-bend sample M4 1.1 had an area of cold deformation near the surface, but also present were pores which appeared to be aligned along the grain boundaries.

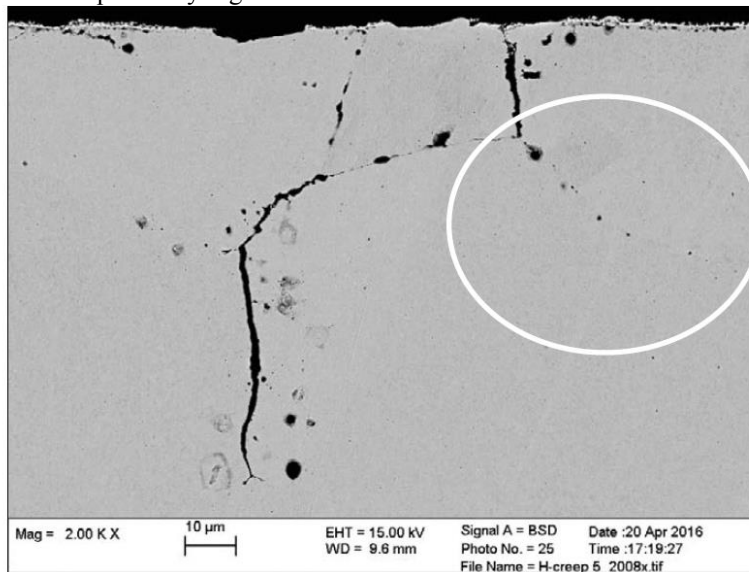
**Figure 3-8.** Specimen H-creep-05 tested at RT for 1 005.7 hours hydrogen charging time and creep stress of 170 MPa. Larger cracks were discovered. The specimen was tested in soft annealed condition without any pre-strain.

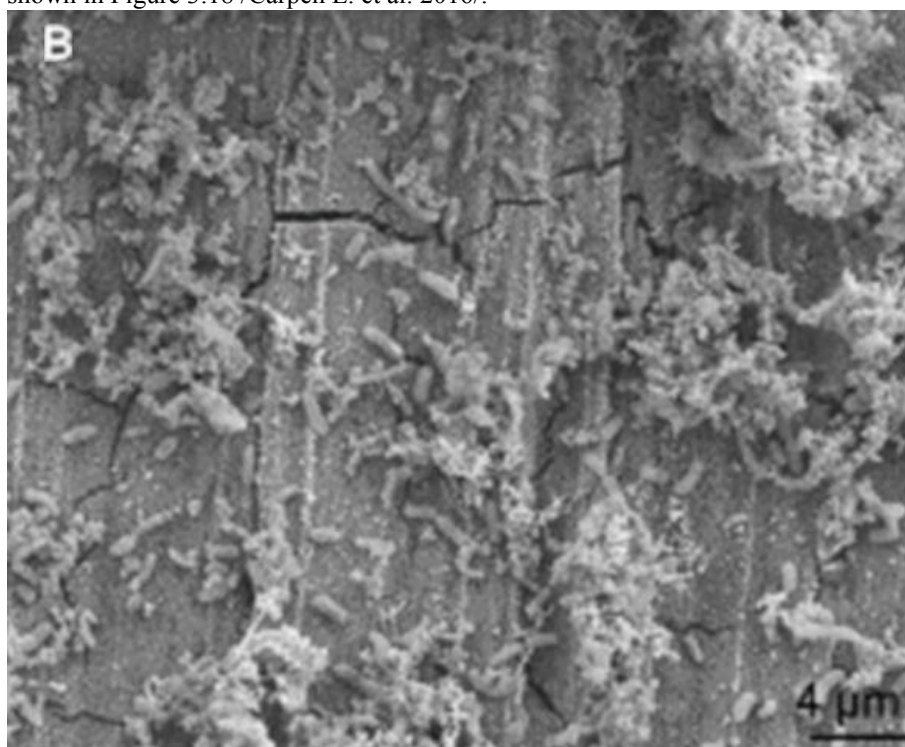
**Figure 3.18.** Microbial corrosion on the surface of unalloyed copper creates micro cracks due to sulphur enrichment. SRB colonies convert sulphate to sulphide which results in SCC/ Carpén L. et al. 2016/.

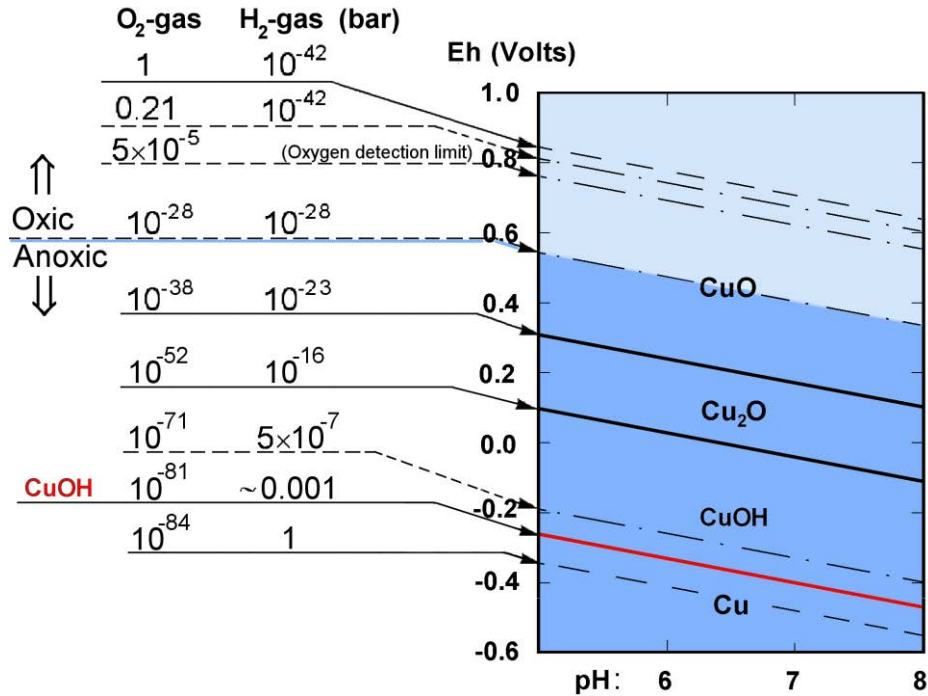
**Figure 4.1.** Pourbaix diagram based on /Szakálos P et al. 2007/. The light blue area at the top shows the oxic region with predominantly dissolved oxygen gas. The somewhat darker blue area shows the anoxic region with predominately dissolved hydrogen gas. The anoxic corrosion product Cu<sub>2</sub>O (cuprite) is only formed at very low oxygen and hydrogen partial pressures represented by the black solid lines. The solid red line marks the lower stability region for the monovalent hydroxide CuOH, which is stable up to around 1 mbar hydrogen gas pressure.

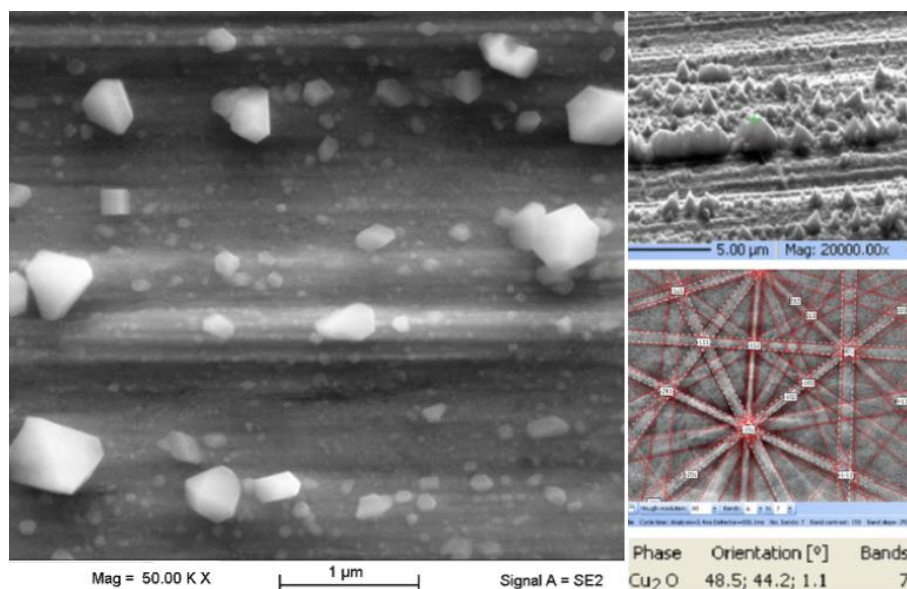
**Figure 4.2.** Unalloyed copper exposed to pure oxygen free water at 50°C for 12 months. The sample was moved directly from the anoxic water to the SEM/EBSD equipment to avoid any oxidic corrosion. The light crystals on the exposed surface have a somewhat distorted Cu<sub>2</sub>O-crystal structure, i.e. cuprite (detected by EBSD), but contain high amount of hydrogen (SIMS) /Szakálos P. and Hultquist G. 2013/ and Land and Environmental Court in Nacka, Sweden, case no. M 1333-11, Addendum 690.

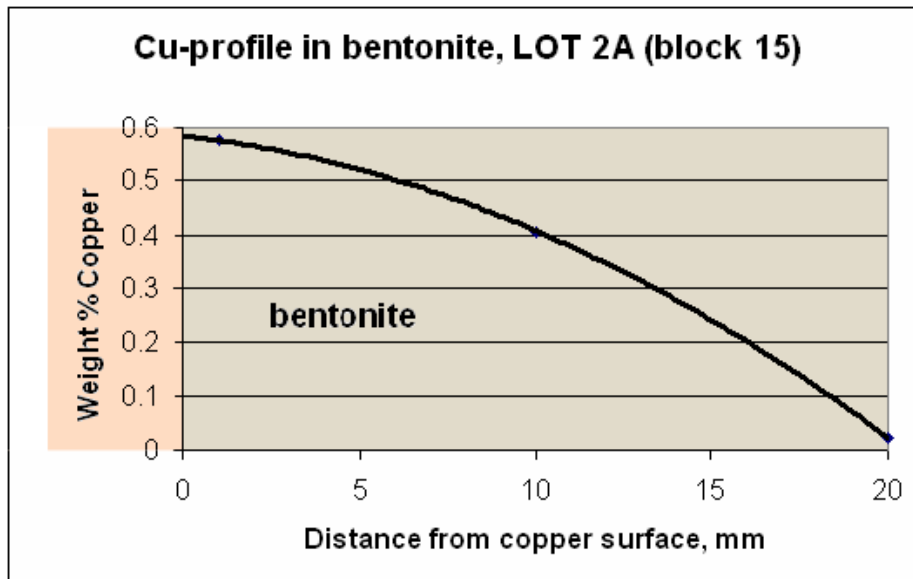
**Figure 4.3.** The bentonite acts as a Cu-ion sink and both copper and bentonite mutually destroy each other in an accelerated manner. Raw data from /Karlund O. et al. 2009/. LOT A2, Appendix 6; Characterization of the A2 parcel, Bundesanstalt für Geowissenschaften und Rohstoffe.

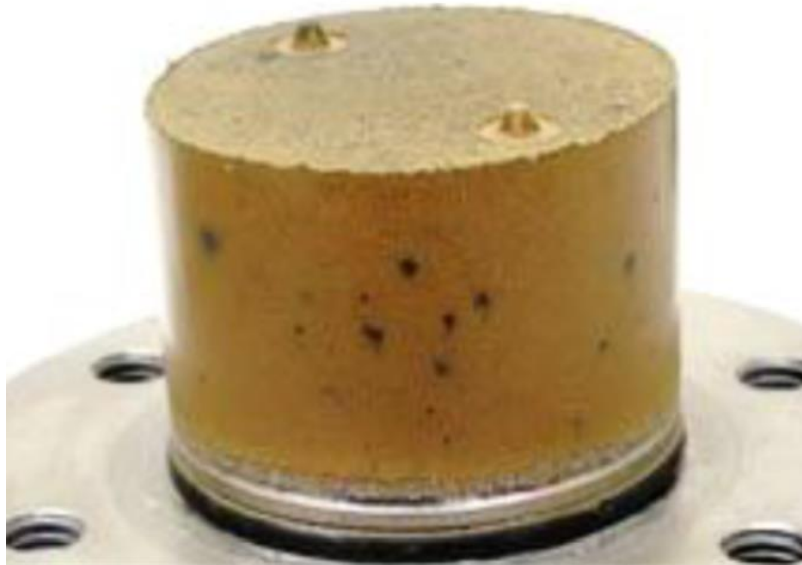
Black colonies of iron sulphide produced by sulphide producing bacteria in Asha bentonite at 1750 kg/m<sup>3</sup> wet density and with addition of lactate and sulphide producing bacteria

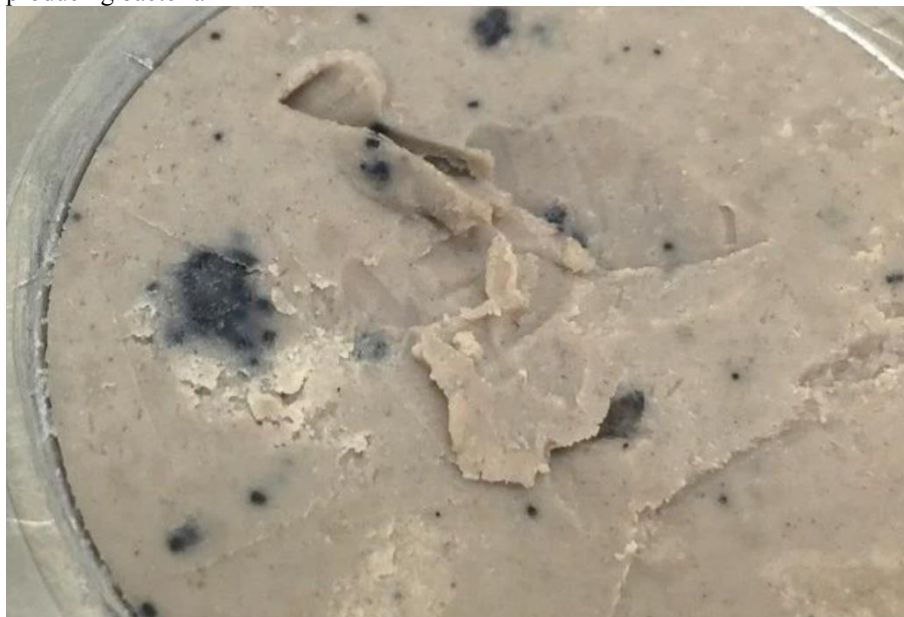
Black colonies of iron sulphide produced by sulphide producing bacteria observed during sampling of test cell with GMZ bentonite.

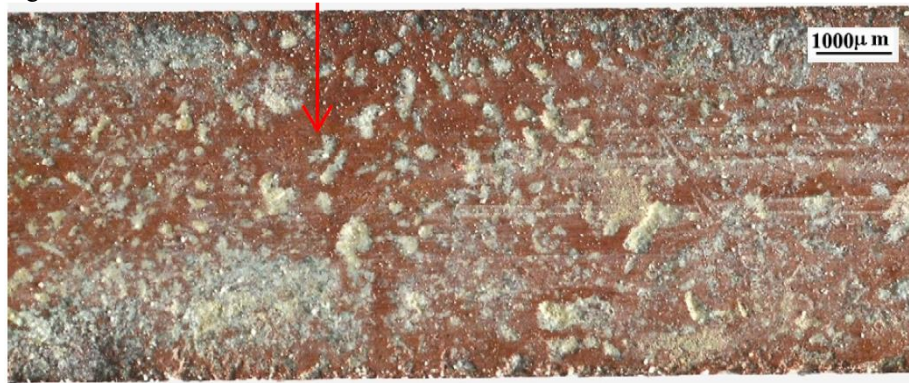
**Figure 4.5.** A macrograph showing an exposed copper sample severely attacked by pitting corrosion, from Appendix B in the FEBEX-report /Wersin P. and Kober F 2017/.

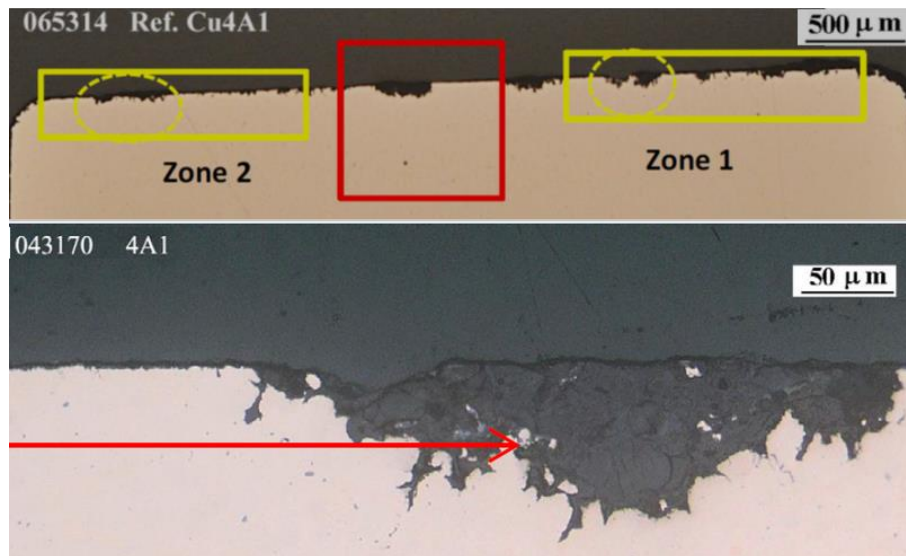
**Figure 4.6.** Metallographic cross-sections showing the exposed copper sample with pitting corrosion, up to 100μm in depth. From Appendix B in the FEBEX-report /Wersin P. and Kober F 2017/.

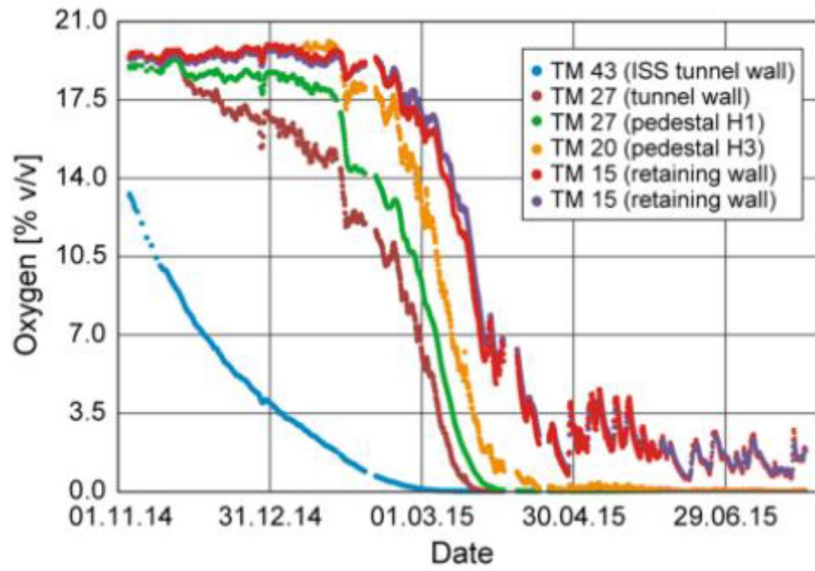
**Fig. 11** Oxygen concentrations at different measurement locations along the FE tunnel from November 2014 (shortly after backfilling started) until July 2015

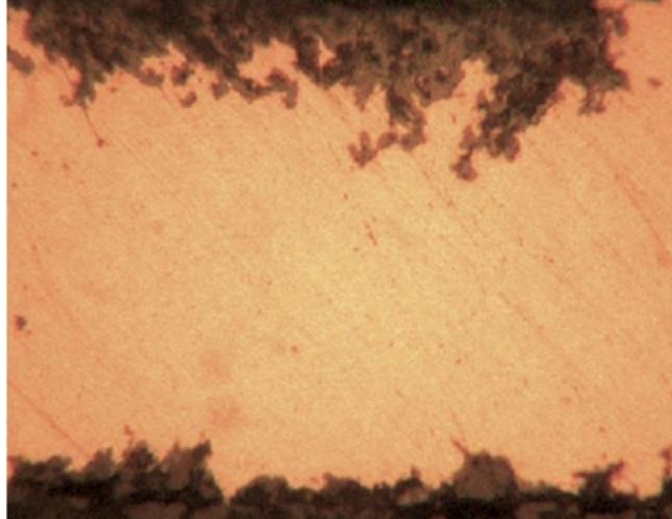
**Figure 4.8.** Light optical cross-section of the initially 100µm thick copper foil after 15 years exposure in distilled anoxic water at room temperature. Localised corrosion attack is clearly visible. Scale: the height of the micrograph is 90 µm. /Hultquist G. et al. 2008/.

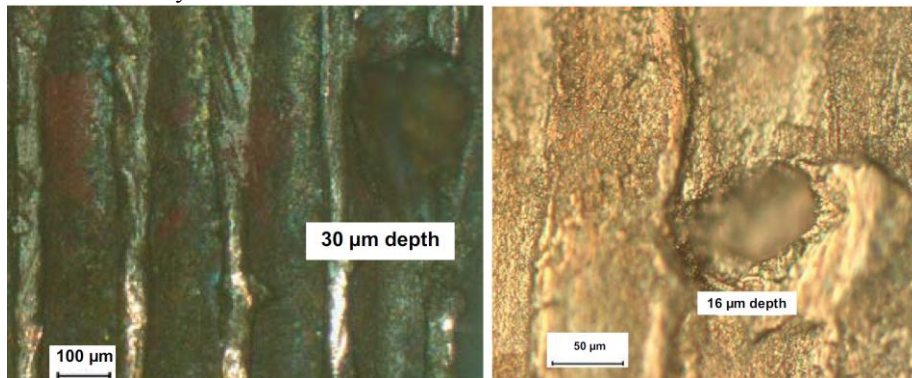
**Figure 4.9.** Example of pitting corrosion on one acid cleaned sample (to the right) and an un-cleaned sample to the left /Gordon A. et al. 2018b/. Maximum pitting corrosion rate: 6 µm/year.
