**TECHNICAL NOTE**

# 1. Discussion and conclusions concerning the five corrosion issues pointed out by The Land and Environmental Court

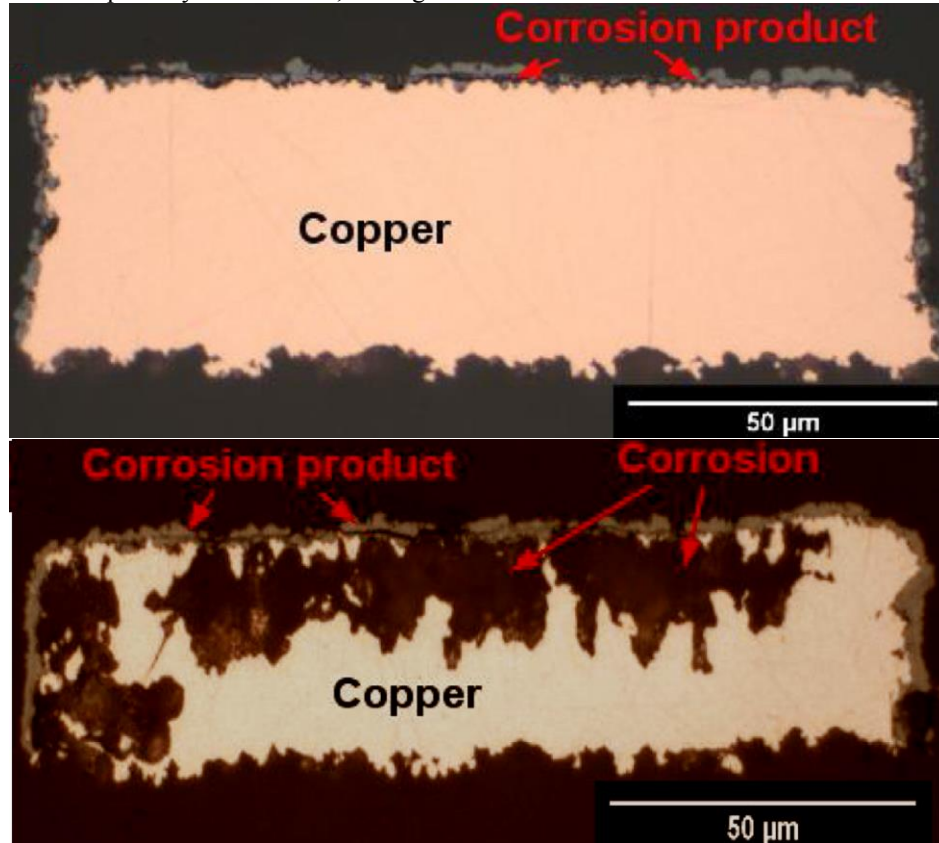
**Figure 4.10.** Results from Figure 5 in /Marja-aho M. et al. 2018/. Corrosion tests performed in simulated geological nuclear waste repository, at temperatures 10–12°C and oxygen level below 1 ppm. Simulated groundwater, with chemical composition of groundwater stabilized with bentonite. The micrograph at the top shows a cross-section, originally 200×35µm<sup>2</sup>, of a sample exposed for 4 months without SRB (abiotic environment) and micrograph at the bottom shows a sample exposed 4 months with naturally occurring SRB in groundwater (biotic environment).

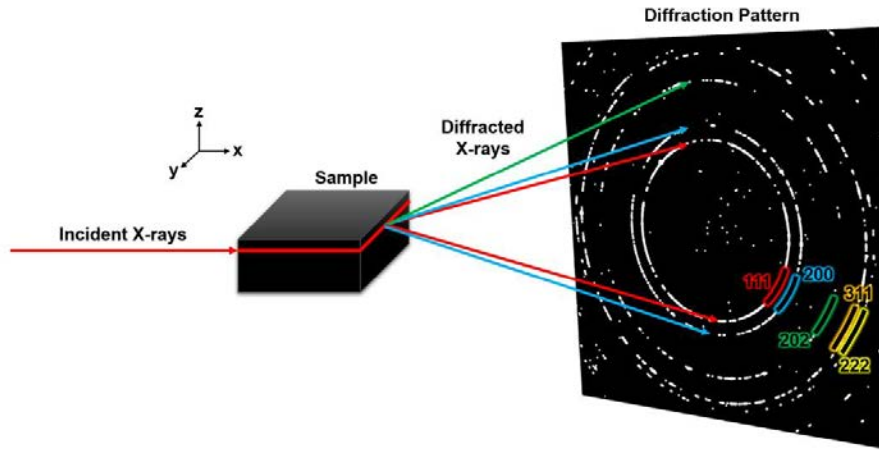
**Figure 5.1.** Experimental setup of high-energy x-ray diffraction measurements showing x-rays radiating the copper specimen and the diffracted x-rays with the 2D diffraction pattern collected by a detector.

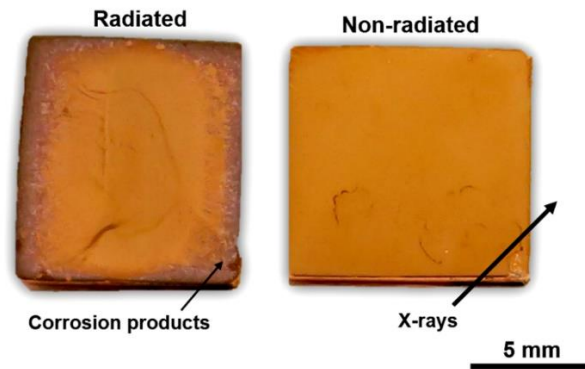
**Figure 5.2.** Photograph of some of the copper samples to be investigated. The radiated specimen in this case was exposed to oxygen-free water for 64 hours with a simultaneous exposure to 28.6 kGy of gamma radiation. The non-radiated specimen was exposed to oxygen-free water for 64 hours only. The bar shows the scan direction of x-rays through the specimen.
