R-15-11

Further metallographic analysis of MiniCan SCC test specimens

SVENSK KÄRNBRÄNSLEHANTERING AB

Suzanne Aggarwal, Venugopal Addepalli, Nicholas Smart
Amec Foster Wheeler

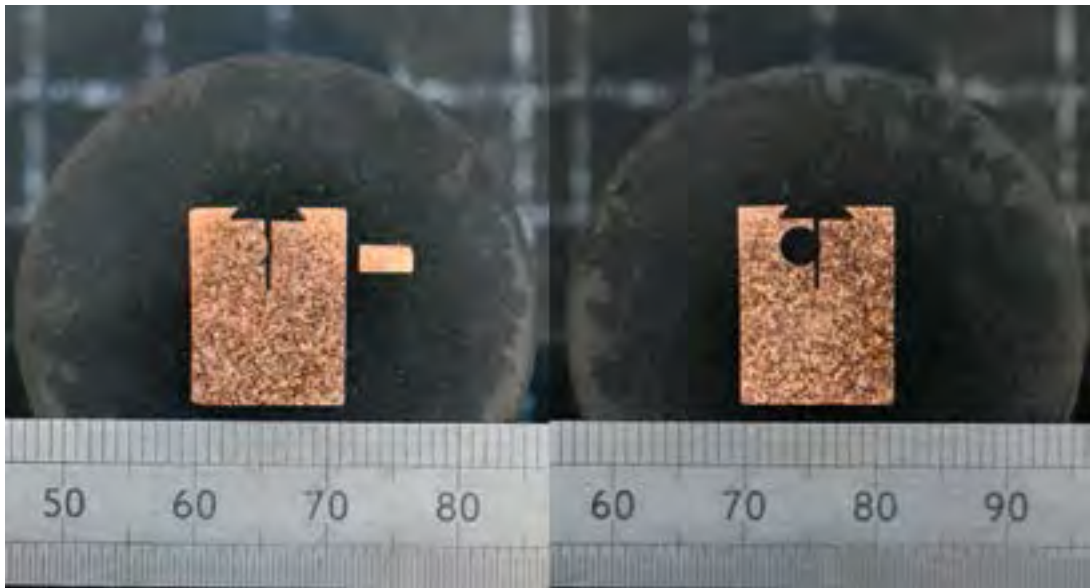
Figure 3-1 shows the WOL specimens before they were removed from the Bakelite mounts and Figure 3-2 shows the opened WOL specimens; there was a range of discoloration on the notch and pre-crack area, along with fresh shiny surfaces on the fast fracture areas. The pre-crack region is evident from the thumbnail shapes emanating from the notch created in the WOLs. WOL B sections appear to have a much darker deposit on the surface of the pre-crack region.

Figure 3-1. WOL A (LHS) and WOL B (RHS) prior to being cut out of Bakelite.

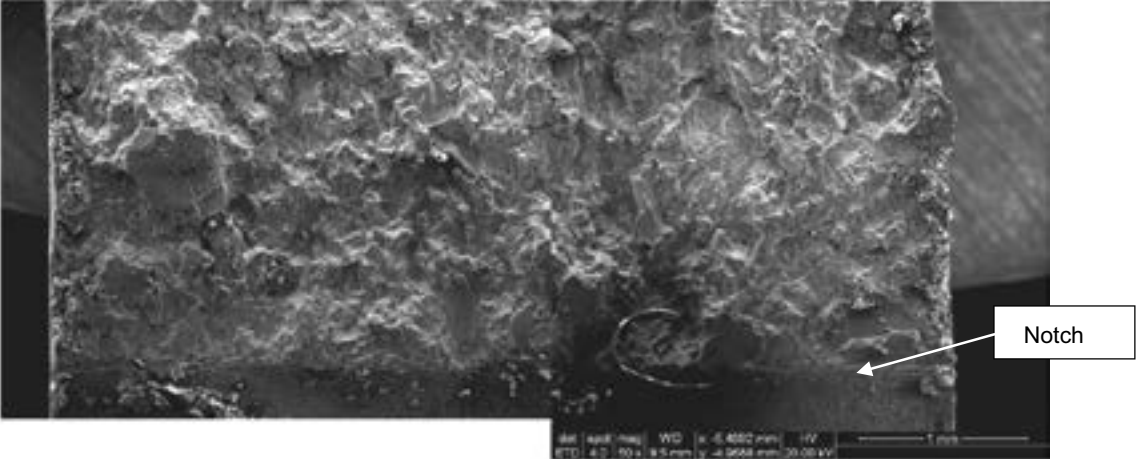
Figure 3-6 to Figure 3-9 are combined secondary electron images of each notch, pre-crack and start of fast fracture areas of WOL specimens A1, A2, B1 and B2. It is not clear on fracture faces A1 and A2 where the pre-crack area ends, but on the B1 and B2 fracture faces the pre-crack end position is shown distinctly by the change of surface morphology from rough and dark to a much smoother and lighter band (shinier). The SEM did not clearly show the pre-crack and fast fracture regions on the WOLA fracture faces but it was better defined on the fracture faces of WOL B, as labelled. Figure 3-4 shows that there is a pre-crack region, a shiny region and then a fast fracture region on the open faces of WOL B. The two lengths measured in Table 3-1 are firstly the average length of the pre-crack up to the shiny band. The second average length is the sum of the pre-crack and the shiny band.

Figure 3-6. SEM image of WOL A1 (near to cage).

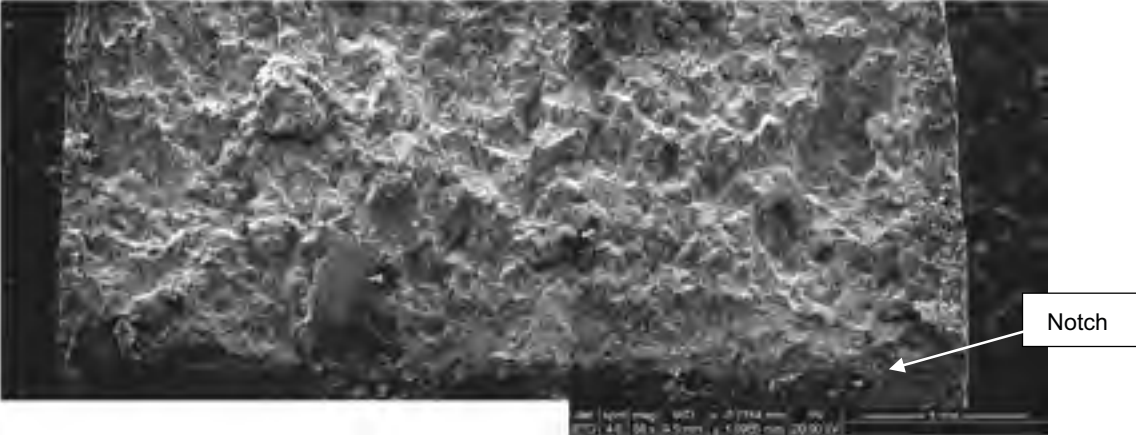
Figure 3-7. SEM image of WOL A2 (near to cage).

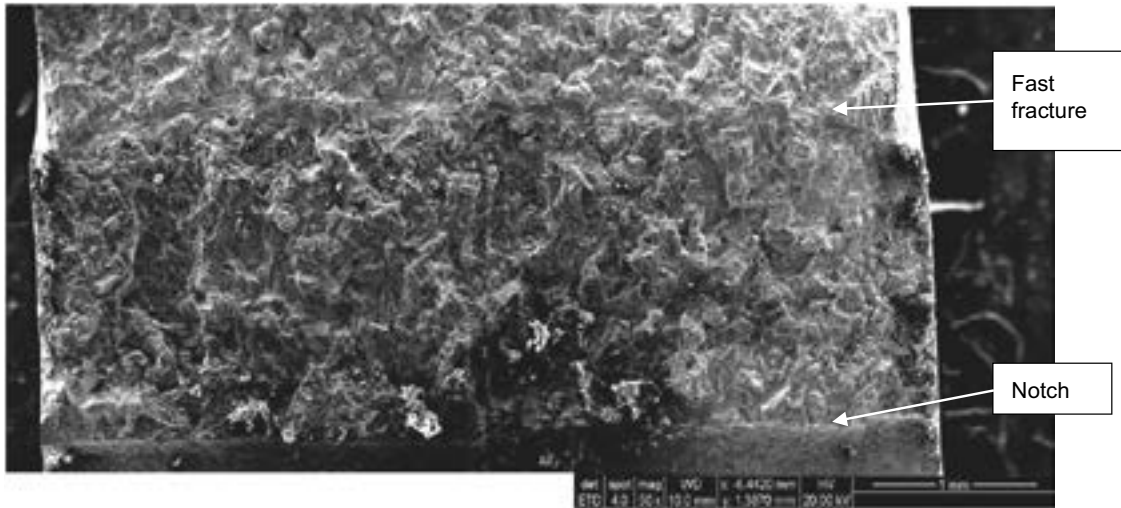
Figure 3-8. SEM image of WOL B1 (near to borehole flange).

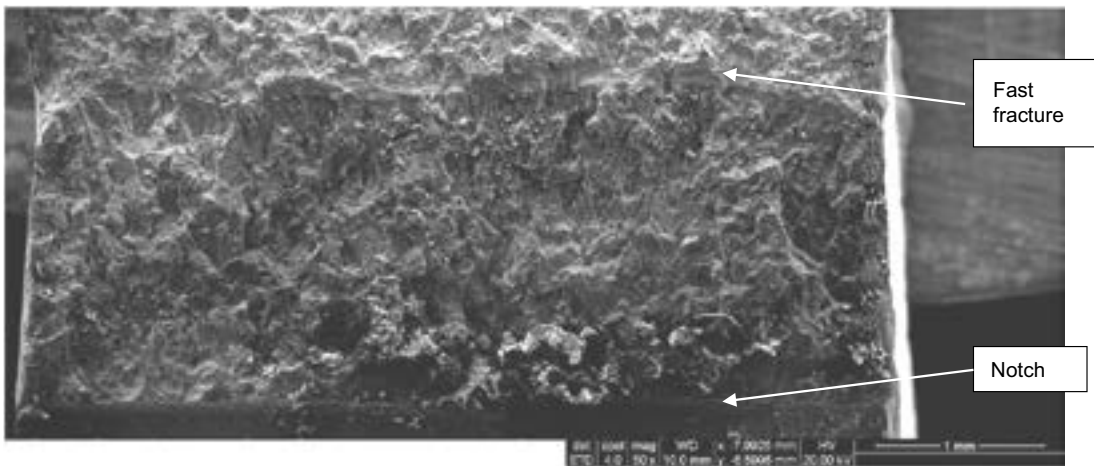
Figure 3-9. SEM image of WOL B2 (near to borehole flange).

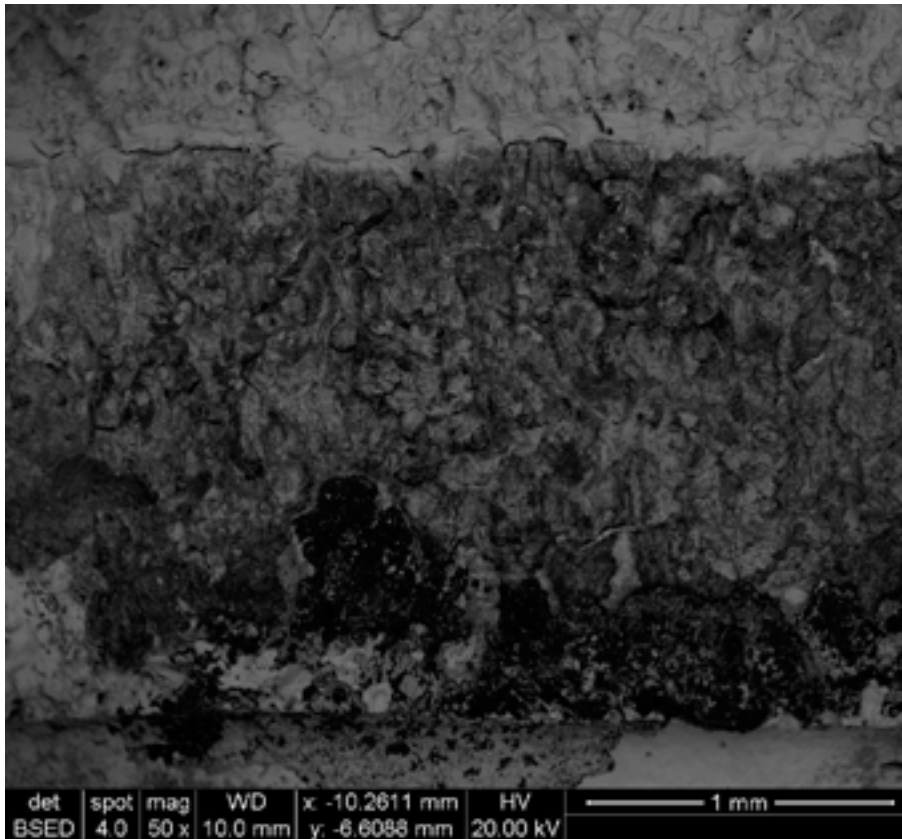
Higher magnification images (Figure 3-10 to Figure 3-12) of WOL B1 and B2 show the location of the shinier band, as seen on the Alicona images in the previous section. The shinier band consists of fatigue lines and smoothed regions, where the initial stages of pulling open the WOLs occurred. This initial smoothing of the fast fracture region is due to the technique required to open the specimens. This shinier band is an artifact that was not caused by the test conditions. There is no evidence of any crack growth that could be attributed to SCC from the pre-crack. The presence of the dark deposit on the surface of each pre-crack surface partially hindered a full analysis. EDX (energy dispersive X-ray spectroscopy) of the pre-crack and fast fracture regions as shown in Figure 3-13, Figure 3-14 and Table 3-2 show that there is evidence of an oxygen-containing deposit being present on the pre-crack area and negligible oxide being present on the fast fracture region. Table 3-2 also indicates the presence of some carbon in the deposit. Due to the limited sensitivity of the EDX technique it can only be speculated that the carbon is present as an organic deposit or as carbonate (when taking into consideration the EDX results for the U-bend specimens, Section 3.2.3). Therefore, although visual evidence of a deposit on fracture faces A1 and A2 is limited to SEM images, the EDX analysis supports the conclusion from the Alicona images of there being an oxygen-rich deposit present only on the pre-crack area and no further.

Figure 3-11. SEM image of WOL B2 (near to borehole flange), end of pre-crack, ×50 magnification.

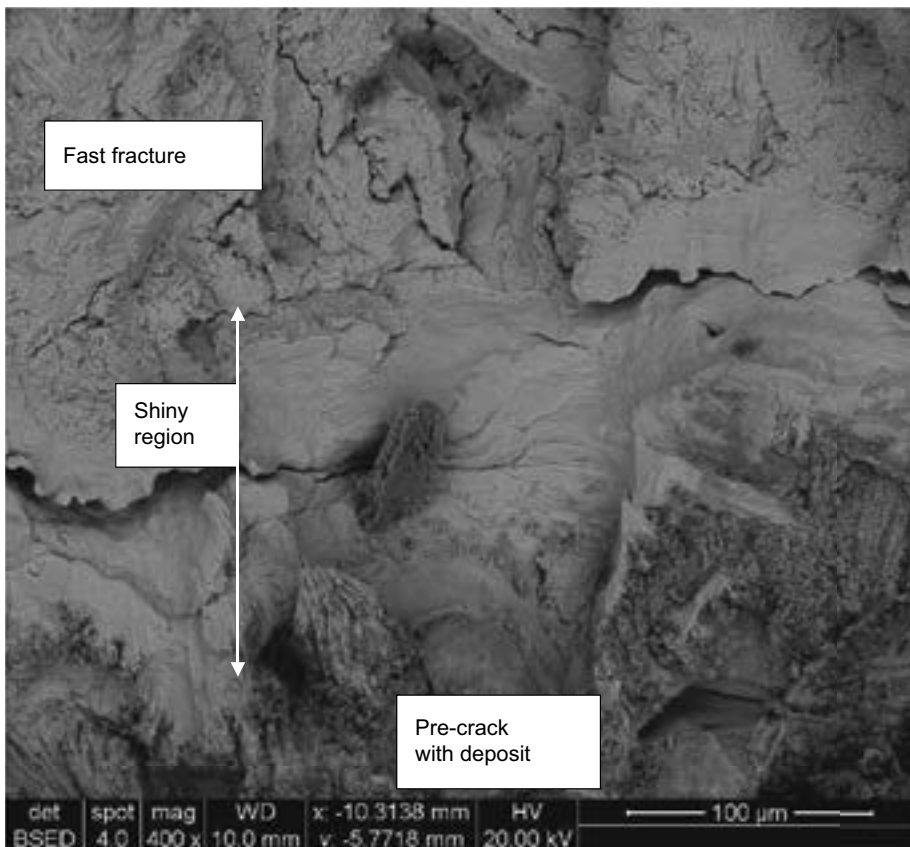
Figure 3-12. SEM image of WOL B2 (near to borehole flange), end of pre-crack, ×400 magnification.

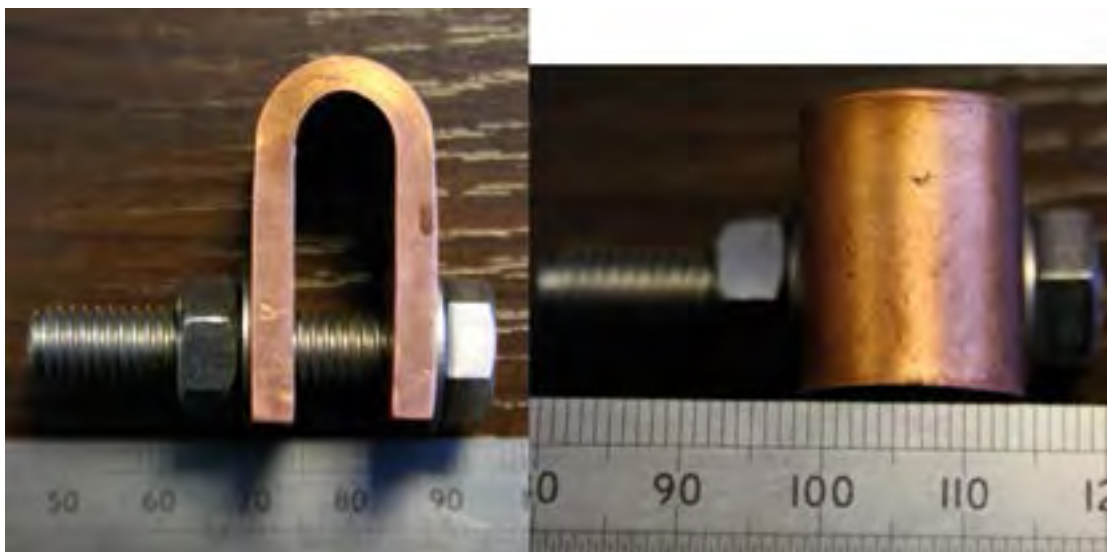
In order to determine, and possibly distinguish between, the effects of in situ exposure in the MiniCan test and the effects of mechanical stress (if any) during preparation (i.e. bending) of the U-bend specimens, a strip of copper of similar dimensions (0.5 mm thicker) was bent into a U-bend using the curvature of the tested U-bends as a template (Figure 3-15). The copper strip was bent around a former, with no external heat applied, then bolted in tension. This procedure was carried out using the same approach as that used for the U-bend specimens that had been prepared in 2006 and used in the in situ test. The aim of comparing an untested U-bend with the tested U-bends was to determine whether any surface features could be attributed to the mechanical forming of the U-bend. Although it is not clearly evident, there appears to be an “orange peel” effect on the surface of the untested U-bend (Figure 3-15). An orange peel effect is clearly visible on U-bend specimens 95UG and 94UG (Figures 3-16 and 3-17). Further evidence of the orange peel effect is presented in the following section.

Figure 3-15. Side view and top view of untested U-bend copper specimen created for comparative analysis.

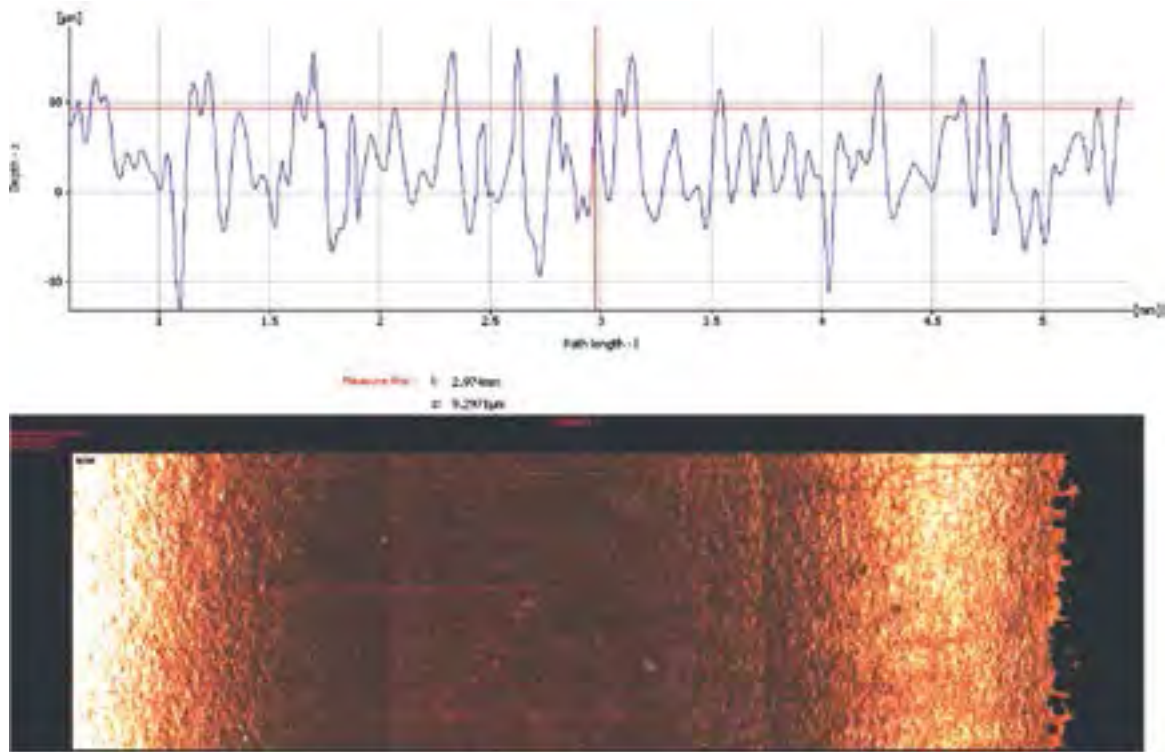
The apex values of the surface roughness of the untreated U-bend compared with the tested U-bends from the MiniCan experiment show that the surface condition had been altered by general corrosion (assuming the specimens deformed in a similar manner). This is shown by comparing the specimen slices from 94UG and 95UG with the untreated U-bend Ra values. Surface roughness values were taken across approximately the same lengths across each specimen slice and over a length of at least five repeating unit lengths, in accordance with ISO standard practice for surface roughness measurements (ISO 1302:2002, ISO 4287:1997).

Figure 3-18. Surface roughness and optical microscopy image of apex of untested U-bend.

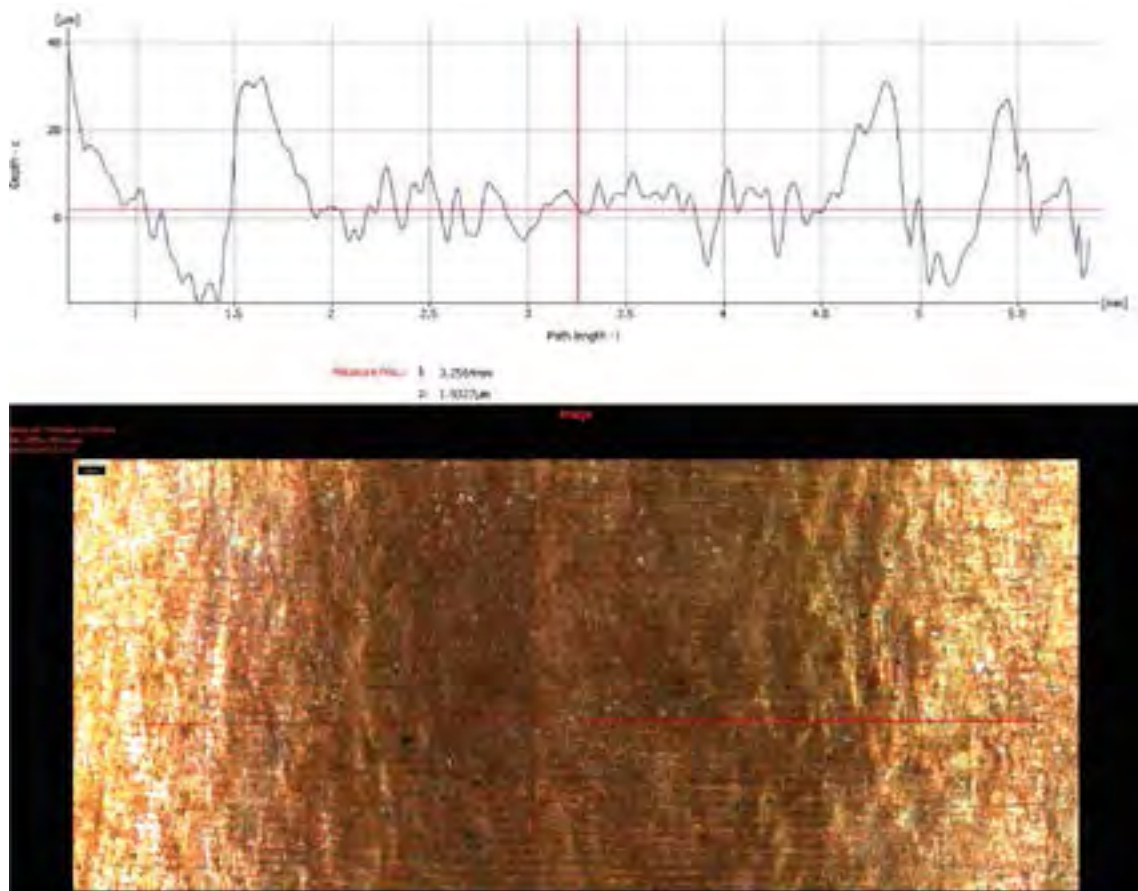
This section covers further analysis of the surface condition to determine whether exposure to the test environment had affected the overall state of the U-bends. Table 3-3 and the following images (Figure 3-18 to Figure 3-26) show that the surface condition (as stated above) had an undulating appearance resulting from straining the material when it was formed into a U-bend. This conclusion is further supported by Table 3-3, which gives the linear roughness values for each slice (see Appendix A.2 for the equation defining Ra). Linear roughness refers to the degree of roughness in the surface measured along an arbitrary straight line; the results are presented in terms of Ra, which is defined as the arithmetic average of the absolute values of roughness (ISO 1302:2002). The surface roughness of the flat ends was very low (~2 µm), whilst the average surface roughness of the U-bend sections (treated and untreated) was approximately 9 µm. The anomaly of the 95UG top slice value of 4 µm Ra can be attributed to either the presence of a smooth deposit or some residual Bakelite still being attached to the surface of this section.

Figure 3-19. Surface roughness and optical microscopy image of apex of 94UG: unmounted slice.

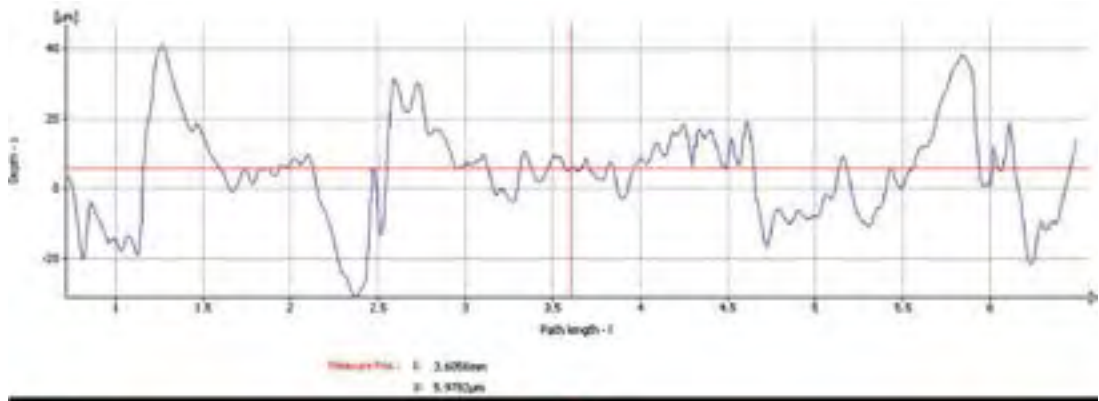
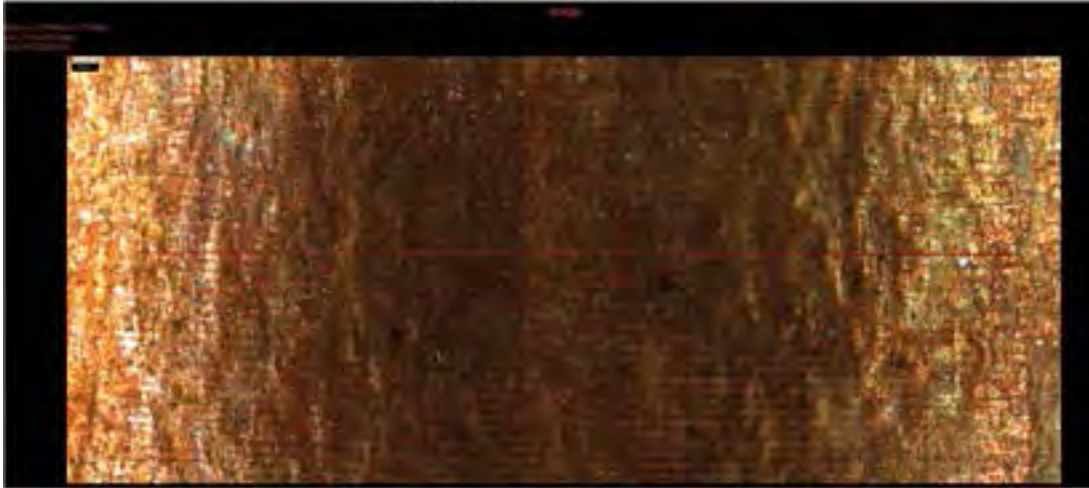
Figure 3-20. Surface roughness and optical microscopy image of apex of 94UG: bottom slice.

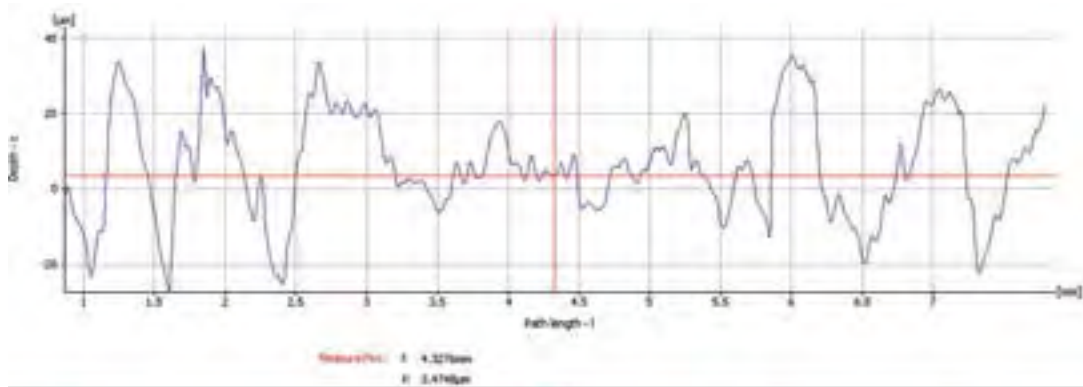
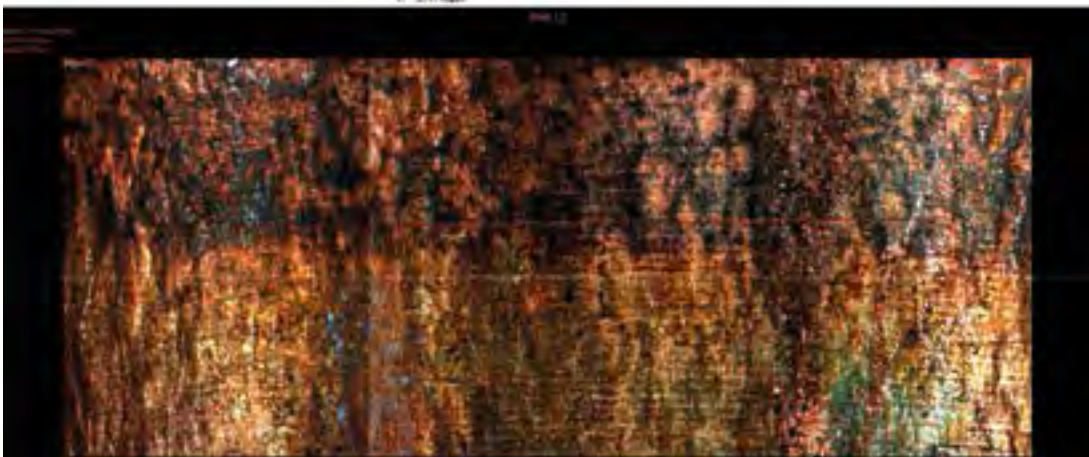
Figure 3-21. Surface roughness and optical microscopy image of apex of 94UG: top slice.

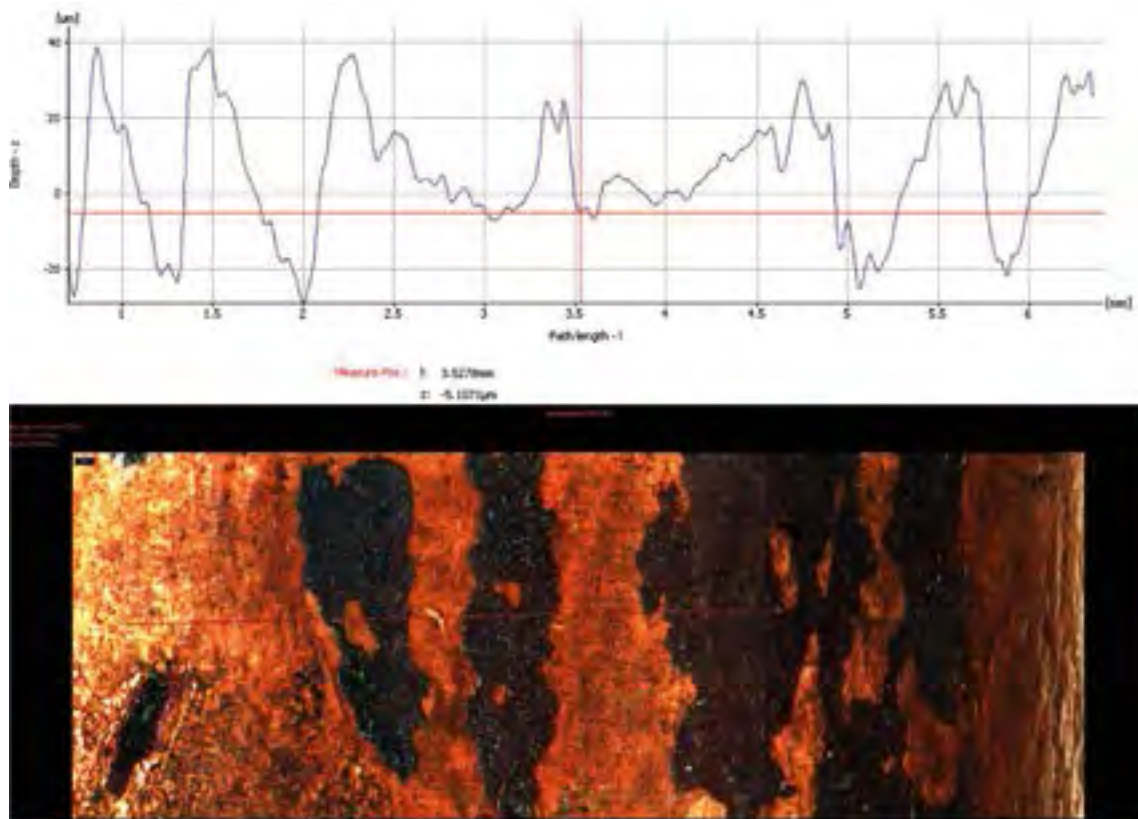
Figure 3-22. Surface roughness and optical microscopy image of apex of 95UG: unmounted slice.

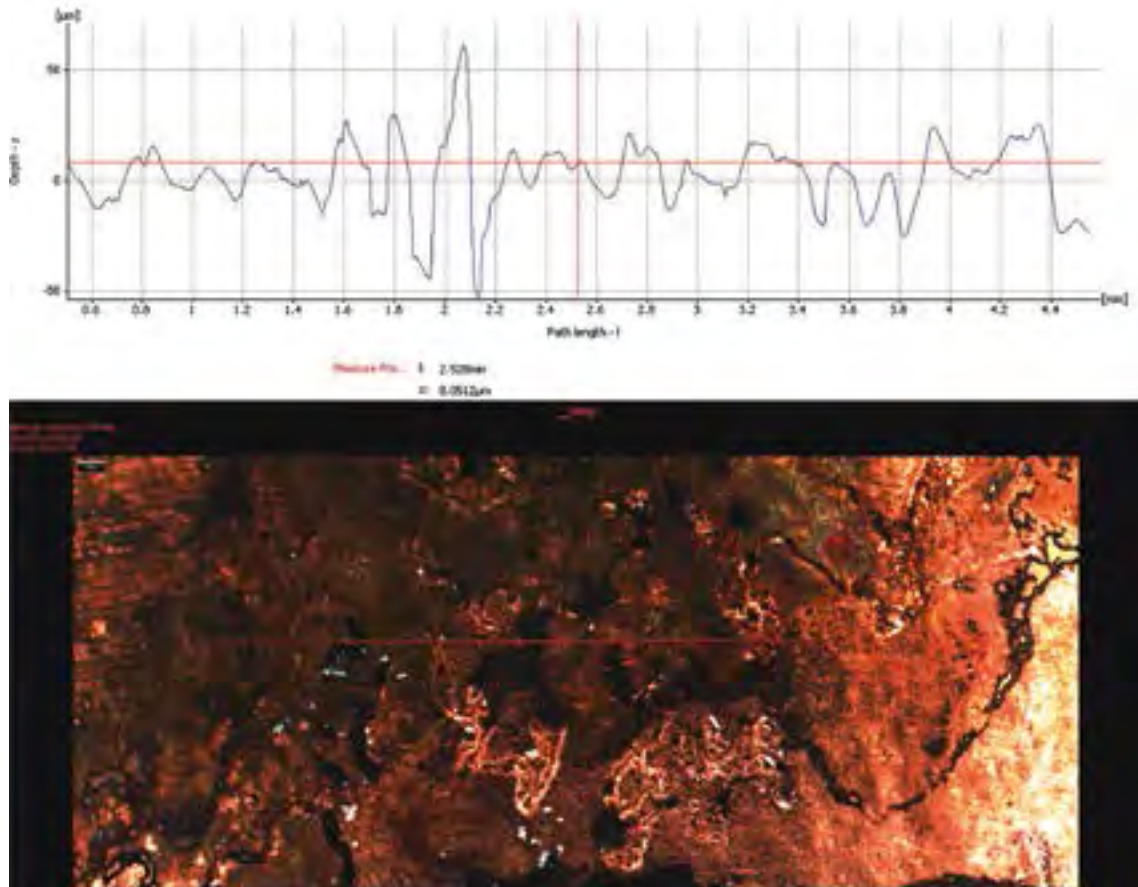
Figure 3-23. Surface roughness and optical microscopy image of apex of 95UG: bottom slice.

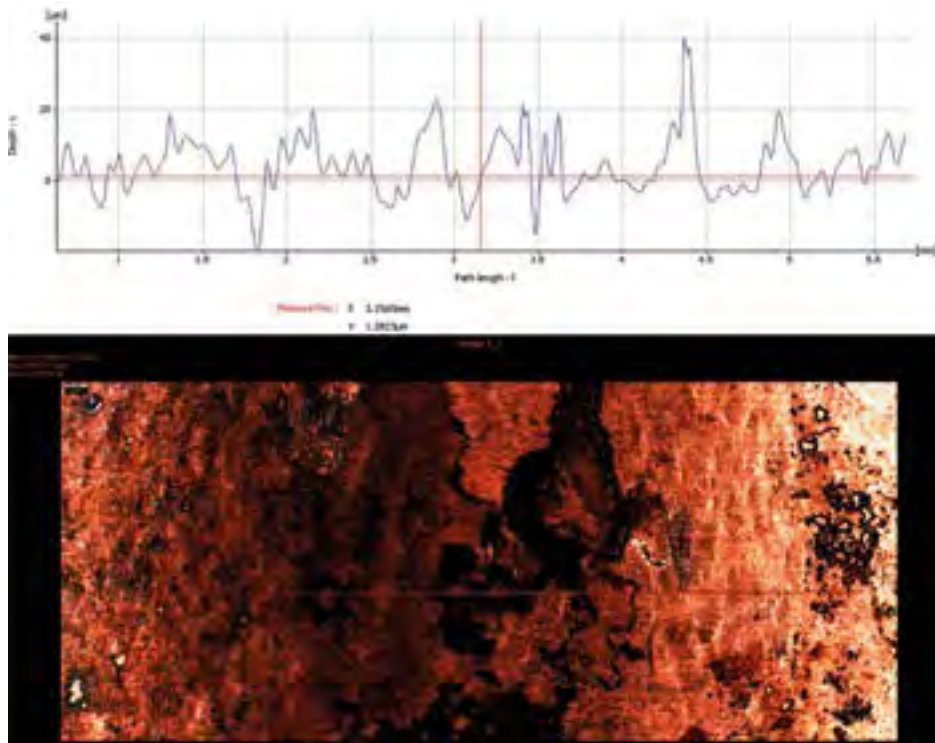
Figure 3-24. Surface roughness and optical microscopy image of apex of 95UG: top slice.

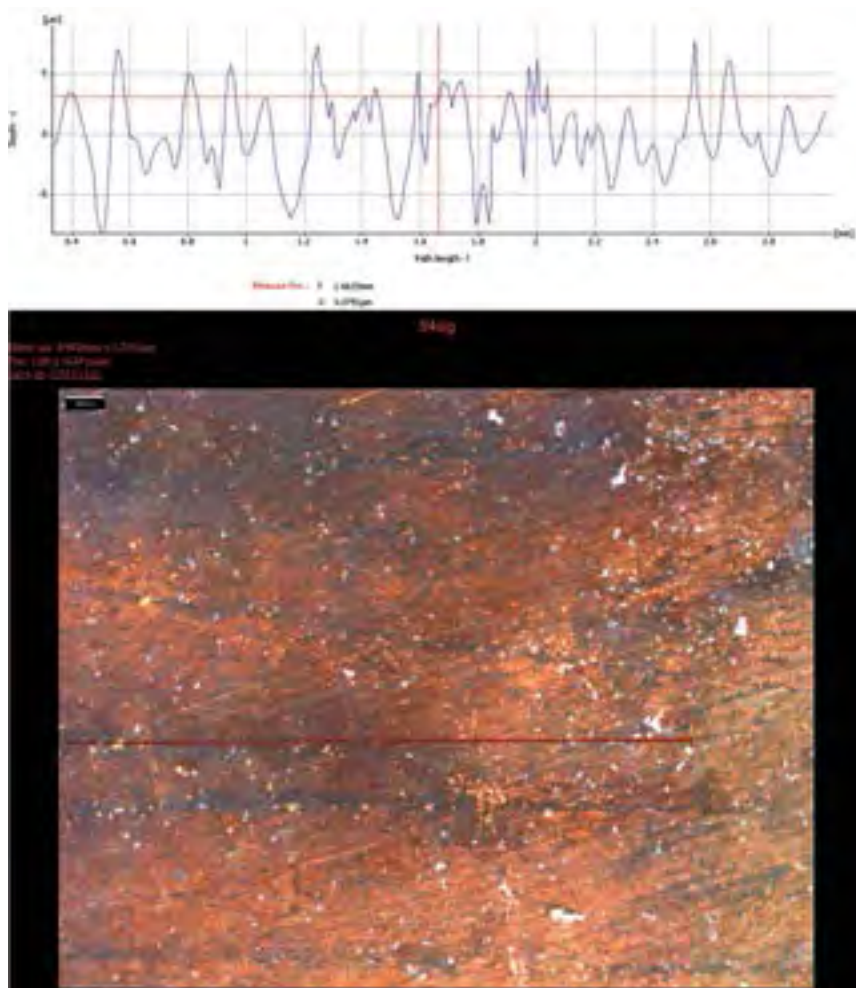
Figure 3-25. Surface roughness and optical microscopy image of 94UG: flat end of U bend.

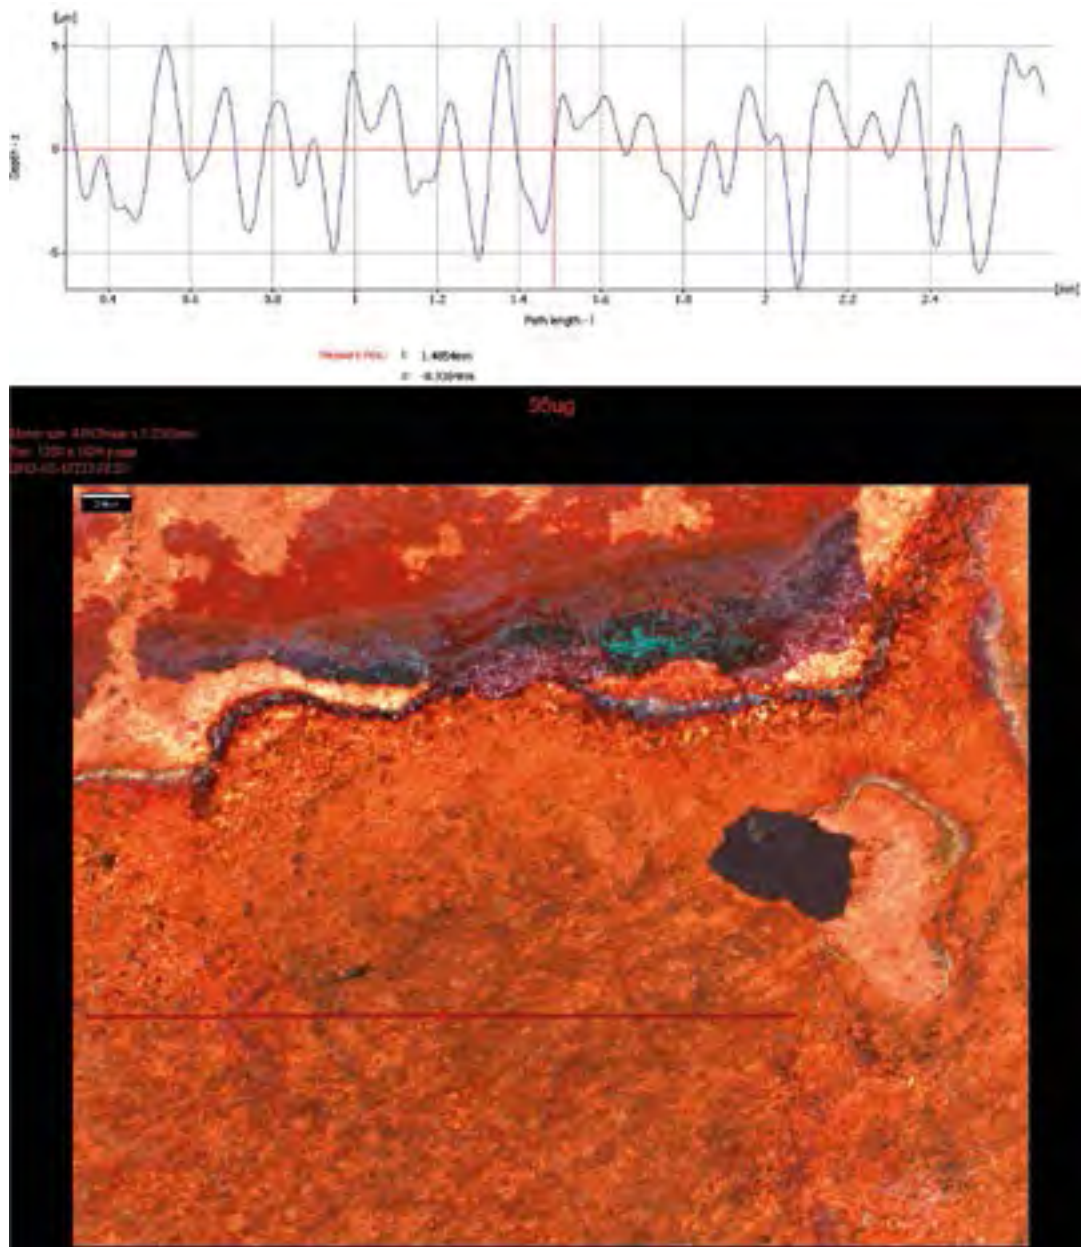
Figure 3-26. Surface roughness and optical microscopy image of 95UG: flat end of U-bend.

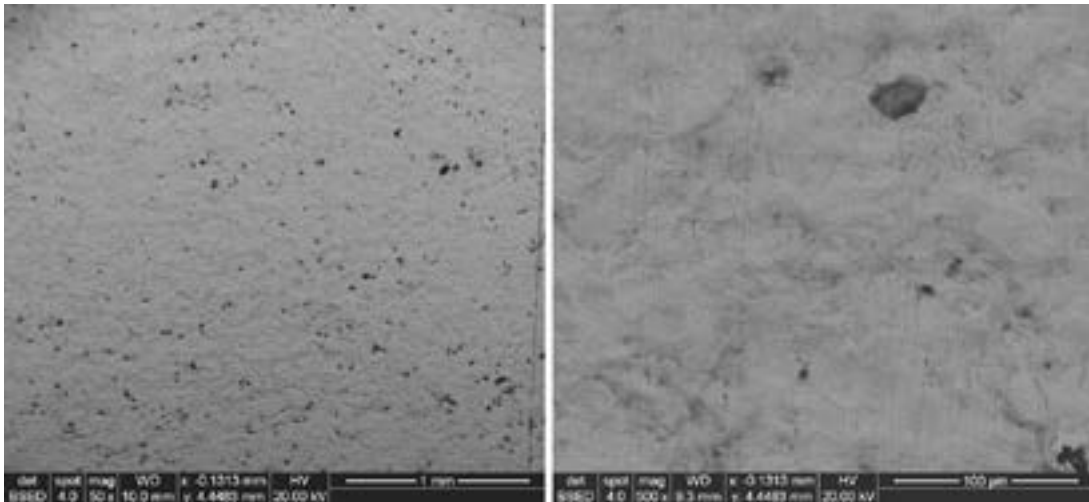
Figure 3-27 and Figure 3-28 show increasing magnification micrographs of the untested U-bend surface condition. It can be clearly seen in the higher magnification images that there are strain-directional striations and non-uniform surface features. These images are in agreement with the images above, showing non-uniform mechanical deformation of the apex of the U-bends.

Figure 3-27. SEM images at $\times 50$ and $\times 500$ of untested U-bend.

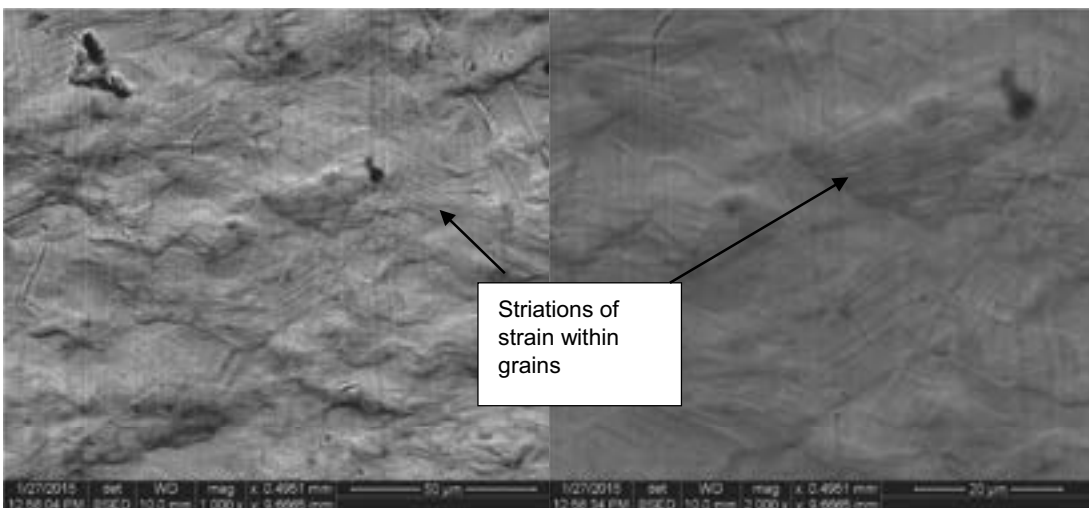
Figure 3-28. $\times 1000$ and $\times 2000$ magnification backscattered electron detector (BSED) images of untested U-bend with curvature from top of image to bottom.

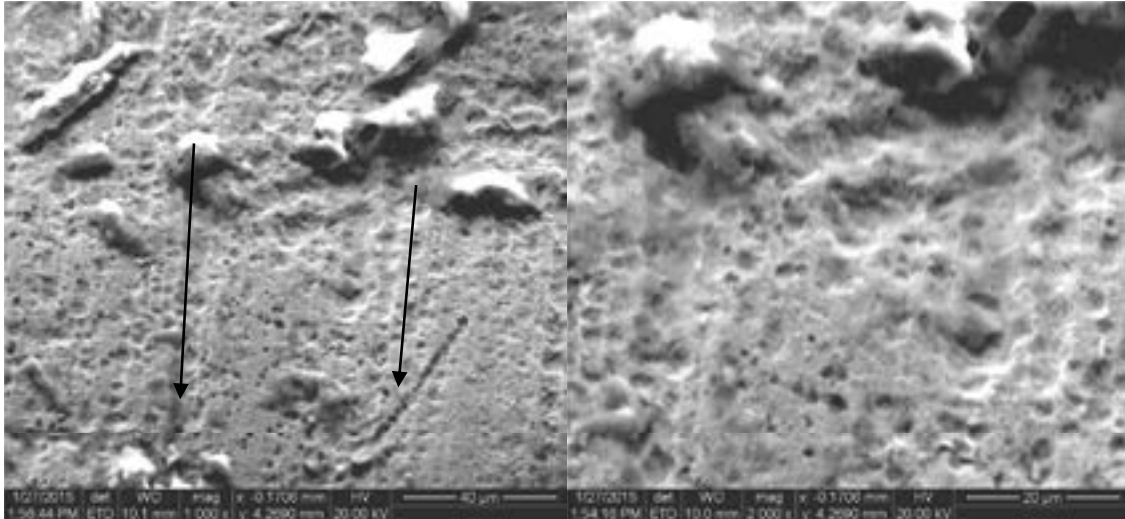
Figure 3-30. $\times 1000$ and $\times 2000$ magnification SEM images of 94UG unmounted section U-bend with curvature from top of image to bottom. Arrows denote tool mark directions.

When compared with the untested U-bend, Specimen 94 UG shows evidence of pitting on the surface of the material. There appear to be striations of pits (i.e. selective attack), along the machine tool marks, as well as generally dispersed pits not associated with any machine tool marks. No significant difference in the EDX analysis of the pits was noted between the two types of corrosion (i.e. general corrosion and selective corrosion).

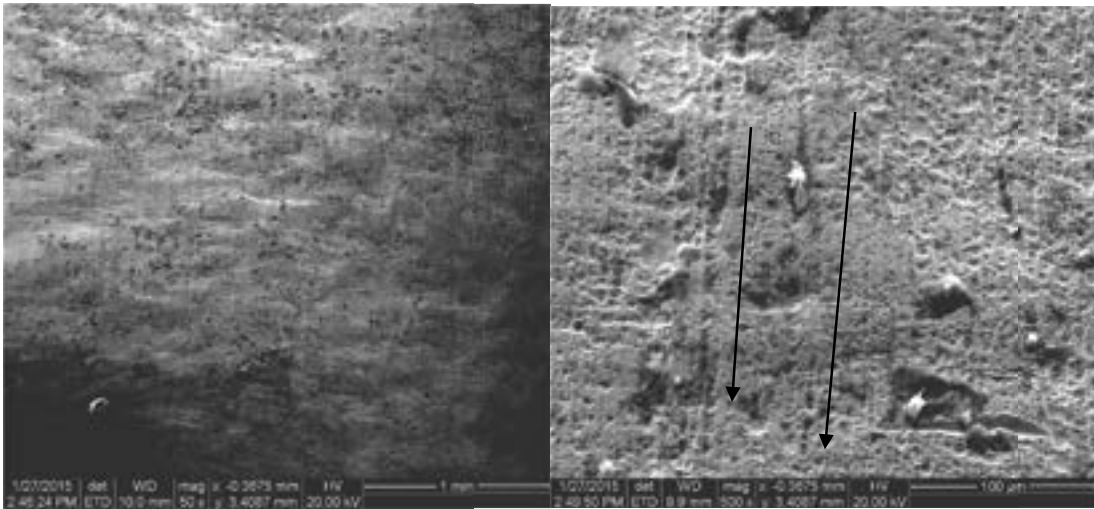
Figure 3-32. $\times 50$ and $\times 500$ magnification SEM images of 94UG top slice with curvature of U bend from top of image to bottom. Arrows denote machine tool directions.

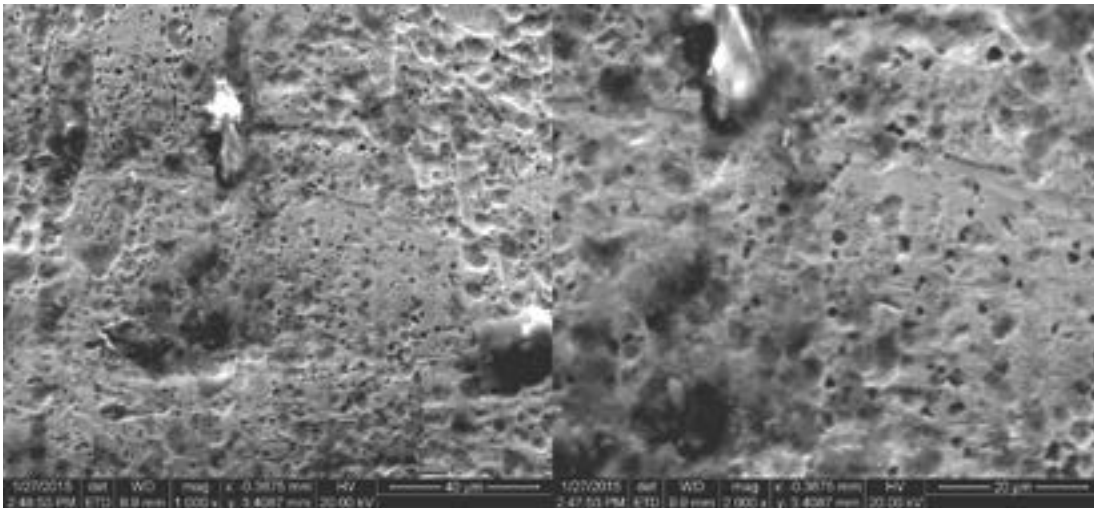
Figure 3-33. $\times 1000$ and $\times 2000$ magnification SEM images of 94UG top slice U bend with curvature from top of image to bottom.

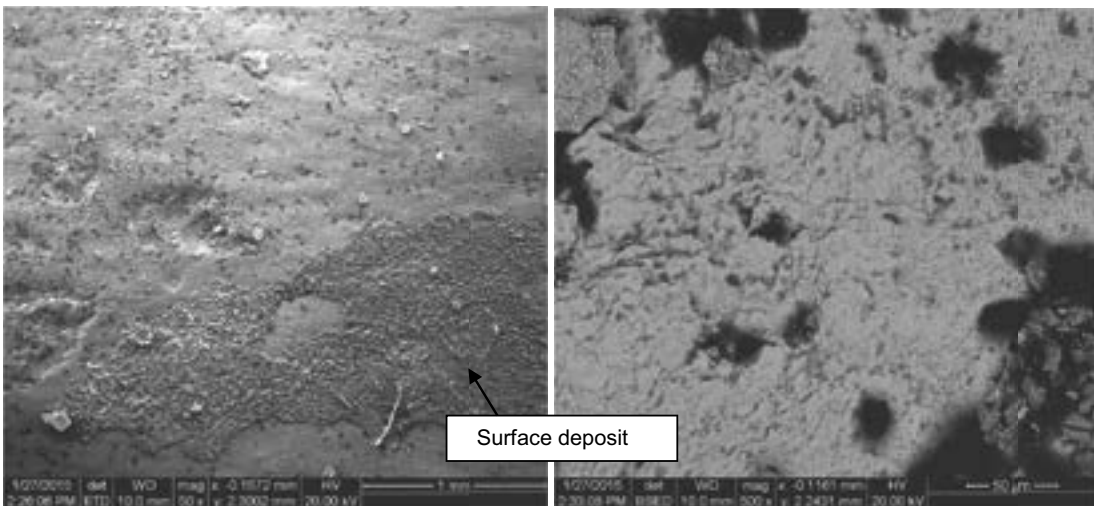
Figure 3-34. $\times 50$ and $\times 500$ magnification SEM images of 95UG unmounted slice with curvature of U bend from top of image to bottom.

When comparing the surface condition of specimen 95UG with the untested U-bend, there was no evidence of pitting on the surface of the U-bend 95UG. This suggests that either the position of the U-bend in the MiniCan experiment is a variable to consider (unlikely) or that there had been general surface corrosion of one of the U-bends (94UG) when in storage after test and not for the other (95UG). A photograph of specimen 94UG immediately after it was removed from the experiment (Figure 3-39) does not show the presence of any significant corrosion, suggesting that corrosion occurred after the test during the storage period, when the specimens were stored in groundwater from Äspö. Although the containers were sealed in plastic boxes under inert gas and sealed in a secondary plastic bag, the possibility of oxygen ingress during storage over a period of approximately 18 months before they were analysed cannot be excluded (a green tint to the specimens was noted when the specimens were stored in groundwater, suggesting the possible formation of copper carbonate, malachite). XPS analysis of the surface of one leg of this specimen (Smart et al. 2012) showed that the surface film was predominantly composed of copper, oxygen and carbon, with a trace of sulphur.

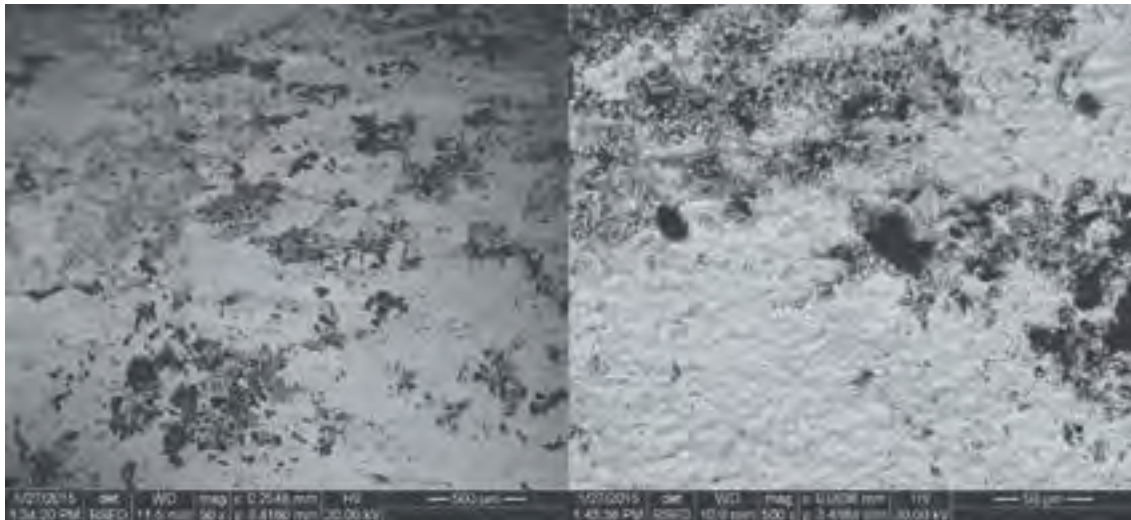
Figure 3-37. $\times 50$ and $\times 500$ magnification SEM images of 95UG top slice with curvature of U-bend from top of image to bottom.

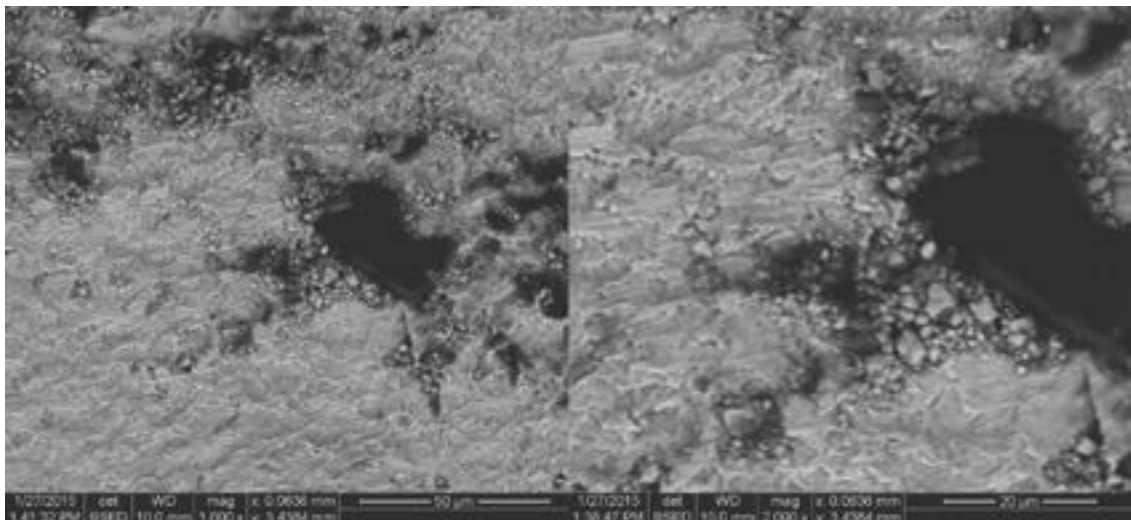
Figure 3-38. $\times 1000$ and $\times 2000$ magnification SEM images of 95UG top slice U bend with curvature from top of image to bottom.
