Febex Project Post-mortem Analysis: Corrosion Study

V. Madina, I. Azkarate
INASMET

AITEMIN requested the INASMET Foundation to carry out the tasks laid down in quotation Ref. 73.1707.2, consisting of a study of the corrosion suffered by different components of the “in situ” test of the FEBEX Project being carried out by AITEMIN in Grimsel (Switzerland).

The test began in July 1996 and, after approximately six years, one of the heaters, a section of guide tube (liner), samples and four sensors were extracted in June 2002. These elements were the object of the study, the aim of which was to evaluate the behaviour of the above-mentioned elements in relation to the corrosion phenomena suffered in the same conditions as those predicted for deep geological disposal in a granitic formation.

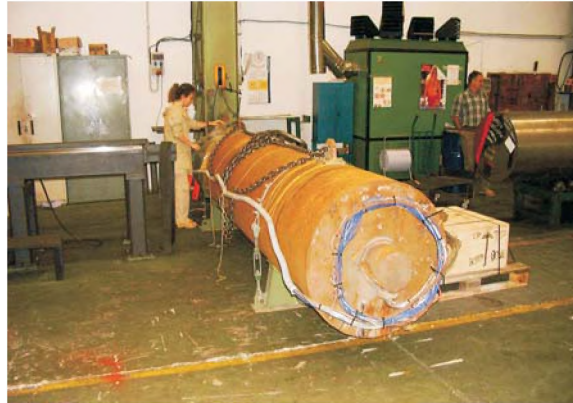
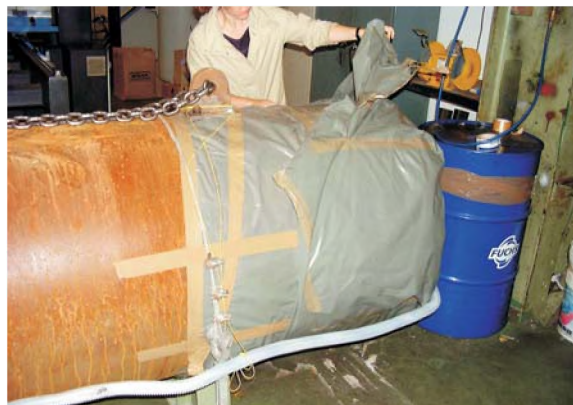
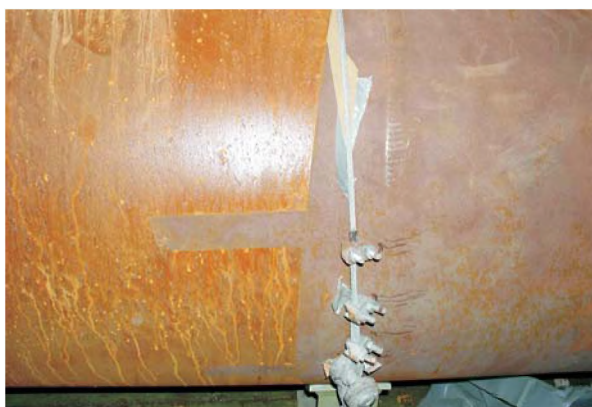
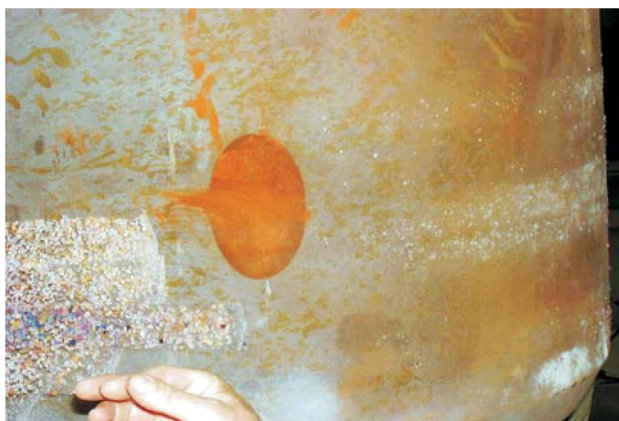
Figure 1: Macrograph on reception.

Figures 1 to 6 show different views of the heater on the Thyssen premises. The lid area was protected during transport from Grimsel by a plastic wrapping with silica gel as the drying agent, meaning that corrosion in this area is less than that seen on the surface freely exposed to the external environment during storage after extraction and transport to the Thyssen Ibérica premises. Examination of the heater showed very slight and apparently uniform overall corrosion of the surface of the container. No pitting or any other signs of localised corrosion were detected.

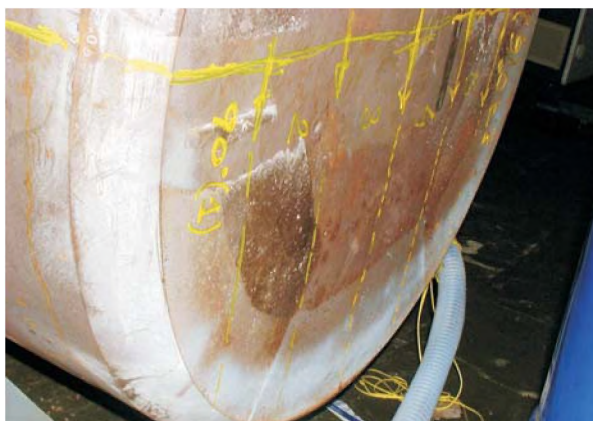
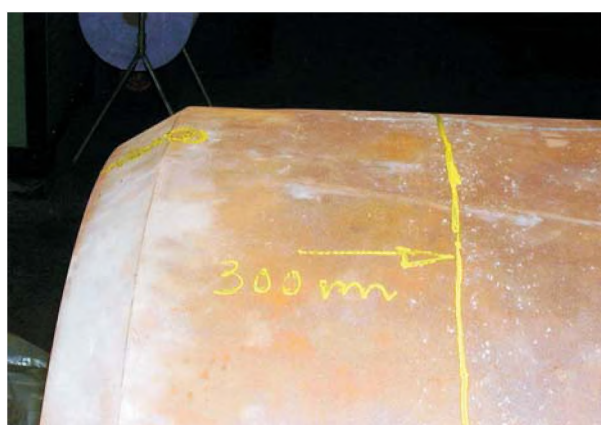
Figure 5: Macrograph on reception.

Figures 5 and 6 show the cuts made in the heater, including the lid, welded joint and body. The different parts obtained, on which the location of the welded joint was marked, can be seen in Figures 7 and 8, now on the INASMET premises. The test pieces used to carry out the study were extracted from these parts.

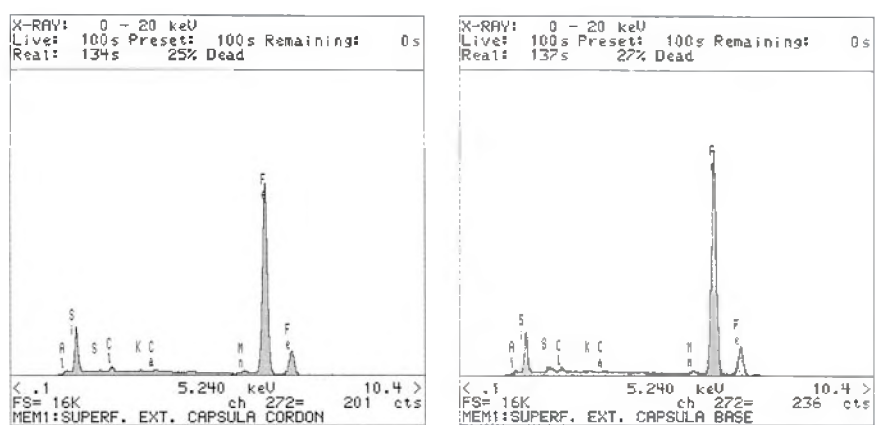
The test pieces extracted from the lid and body underwent energy dispersive spectrometry (EDS) microanalysis of the corrosion products generated on the corroded surface. The EDS spectra in Figure 9 show, for both samples, a majority presence of iron, together with those elements typical of bentonite, such as silicon, calcium and aluminium. Chlorine and sulphur were detected in lesser quantities. The corroded surface was analysed using X-Ray Diffraction (XRD) in order to identify the corrosion products generated. The spectrum, shown in Figure 10, detects iron hydroxide with a molecular formula of $\text{Fe}(\text{OH})_3$, as well as some SiO_2 , possibly as a mineral proceeding from the bentonite. It is important to point out, that it is difficult to obtain data using XRD, with

Figure 9: EDS spectra of a) the surface of the welded joint and b) cylinder.

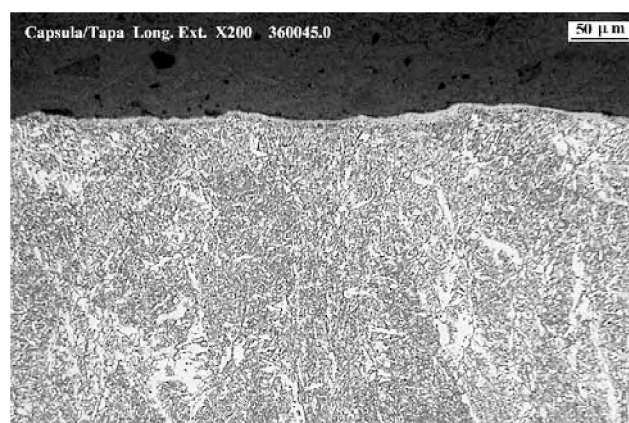
The optical micrograph in Figure 11 shows the outer surface of the heater in a welded area. A thin layer of oxide, with a thickness less than $15\text{ }\mu\text{m}$, can be seen.

Figure 11: External surface of the welded joint.

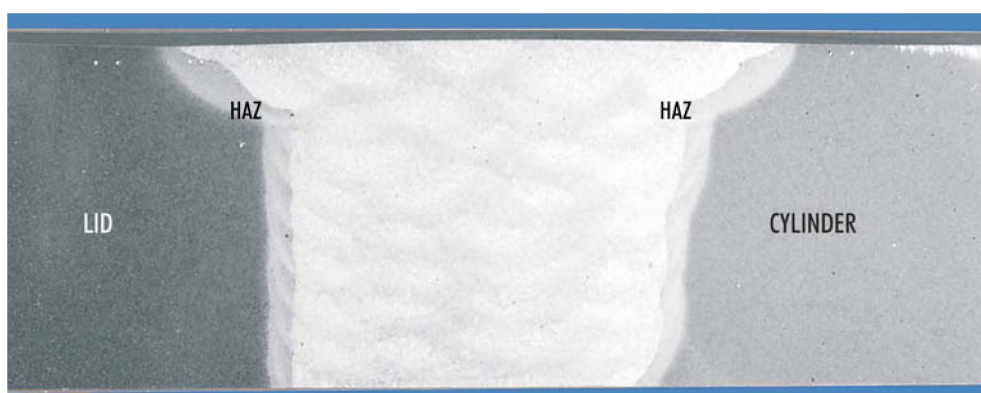
The macrograph in Figure 12 shows one of the cross-sections including a welded joint. Study of the base material making up the lid shows, Figure 13, a ferritic microstructure with areas of pearlite-bainite. The cylinder, in Figure 14, also shows a ferrite-pearlite structure with a smaller ferritic grain size. The microstructure of the heat affected zone (HAZ) of the welded joint, basically bainitic, is shown in Figures 15 and 16.

Figure 12: Macrograph of the lid-cylinder welded joint test piece.

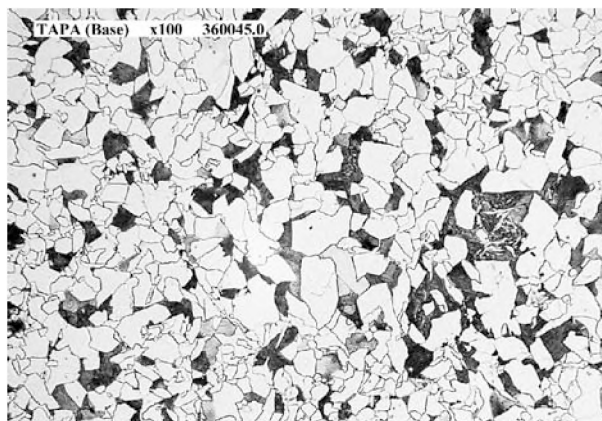
Figure 13: Optical micrograph of the lid structure (Unaffected base metal).

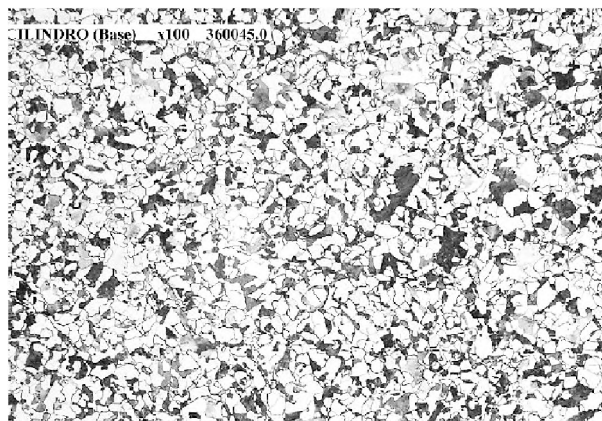
Figure 14: Optical micrograph of cylinder microstructure (Unaffected base metal).

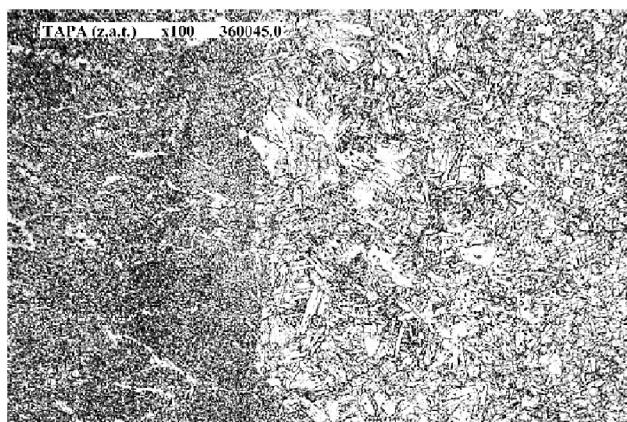
Figure 15: Optical micrograph of the HAZ in the lid joint.

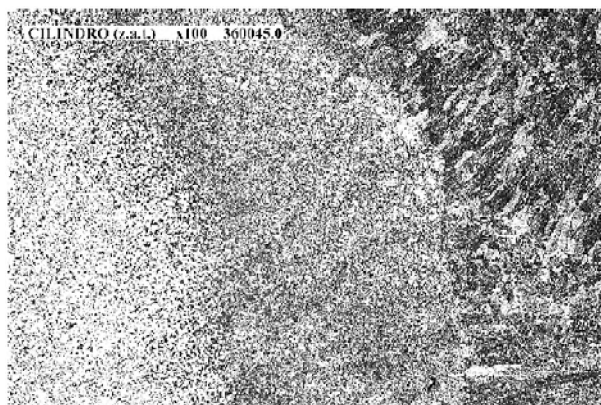
Figure 16: Optical micrograph of the HAZ in the cylinder joint.

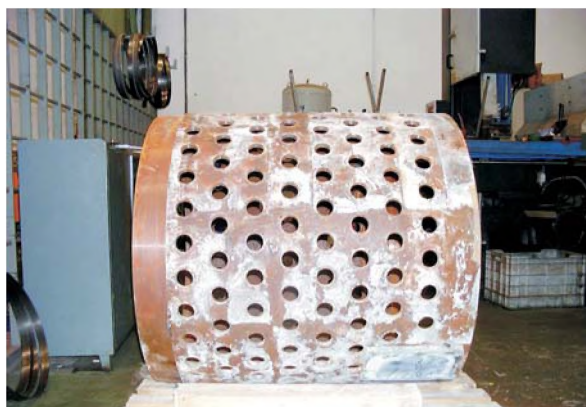
The photographs in Figures 17 to 20 show different views of the liner segment studied. There is observed generalised corrosion of the whole external surface of

Figure 17: Liner segment studied.

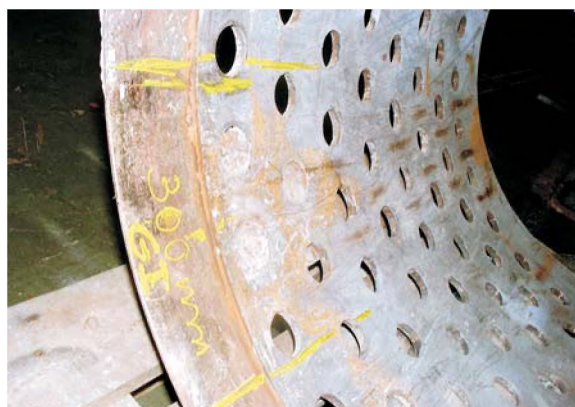
the component, with the formation of brownish-red corrosion products and remains of the bentonite that surrounded it, [Figure 20](#), and which still remained lodged inside some of the perforations of the component, [Figure 18](#). The technical staff at INASMET marked the lower (GI) and upper (GS) generatrix.

Figure 18: Internal surface (G1 lower generatrix).

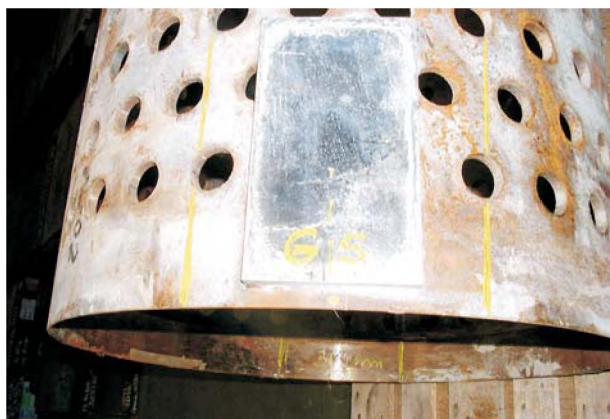
Figure 19: External surface (GS upper generatrix).

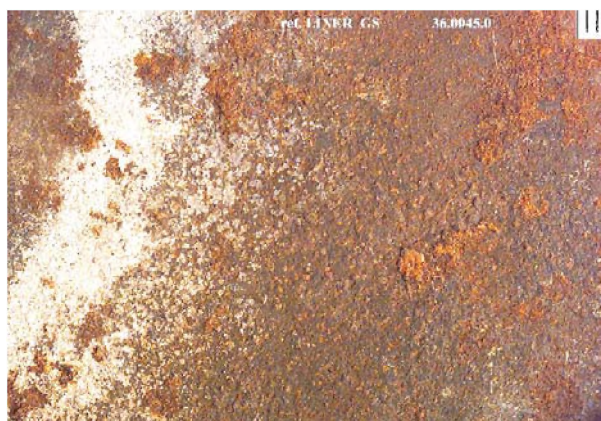
Figure 20: Detail of the external surface.

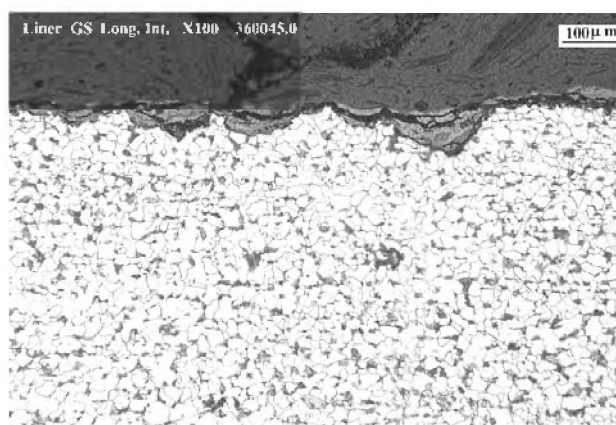
Different sections extracted from the liner were prepared for metallographic study, by embedding them in resin and polishing, to be studied using an optical microscope. The optical micrographs in [Figures 23](#) to [26](#) show the external and internal surfaces of the liner in sections taken from the upper and lower generatrix. The morphology of the corrosion seen is of the type generalised non-uniform, with maximum values of corrosion penetration of approximately 130 microns on the external surface of the two generatrix. The internal surface of the lower generatrix showed a maximum penetration of up to 200 microns. With the lower generatrix, corrosion penetration was less, with values not exceeding 100 microns. Metallographic development of the material making up the liner shows a ferrite-pearlite microstructure typical of carbon steels.

Figure 24: Internal surface of the upper generatrix liner.

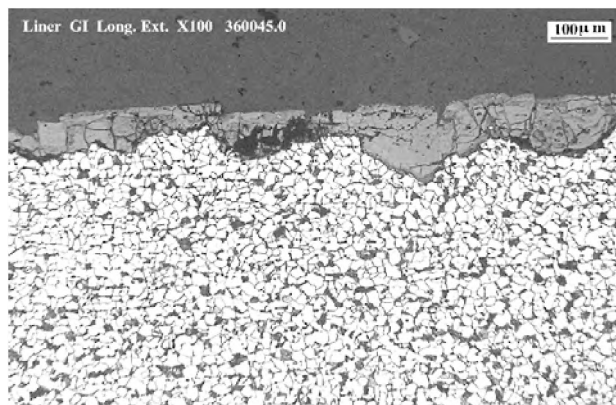
Figure 25: External surface of the lower generatrix liner.

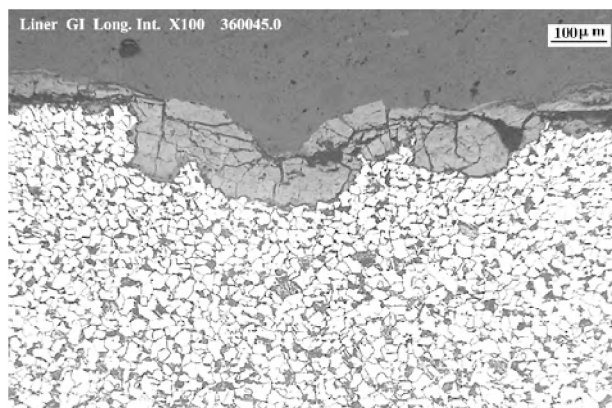
Figure 26: Internal surface of the lower generatrix liner.

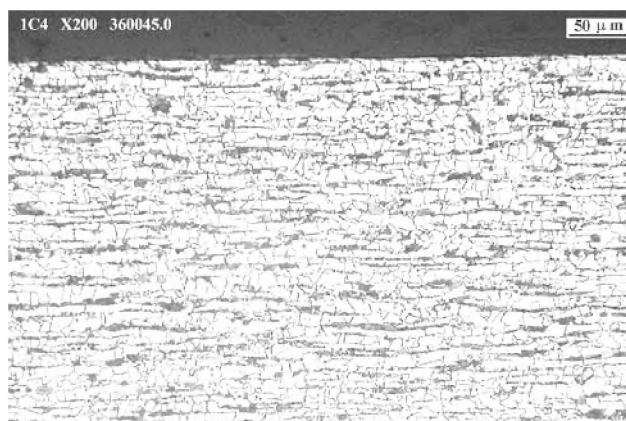
Metallographic study of tested coupons shows little penetration of the corrosion, with no differences in the extent of the corrosion being noted between the base and welded materials, [Figures 33 and 34](#). Scanning electron microscope (SEM) analysis of the surface of these coupons reveals a poorly adherent and discontinuous layer of oxide, [Figure 35](#). EDS analysis of this oxide, [Figure 36](#), reveals the majority presence of iron and oxygen, with a small amount of chlorine. The XRD spectrum of the sample only detects the substrate (Fe), given the lack of thickness of the oxide layer generated on the surface of the test sample.

Figure 34: Base material, coupon Ref. R1C4.

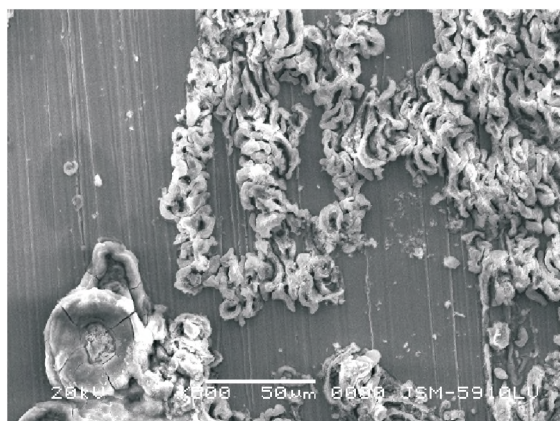
Figure 35: SEM micrograph of the surface of coupon Ref. R1C3.

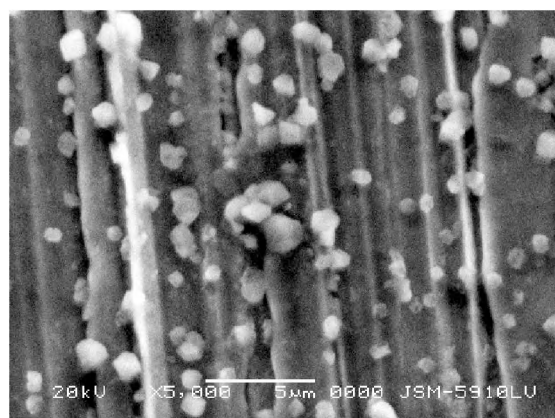
Figure 57: SEM micrograph, surface of Ref. R4C5 (Cu30Ni).

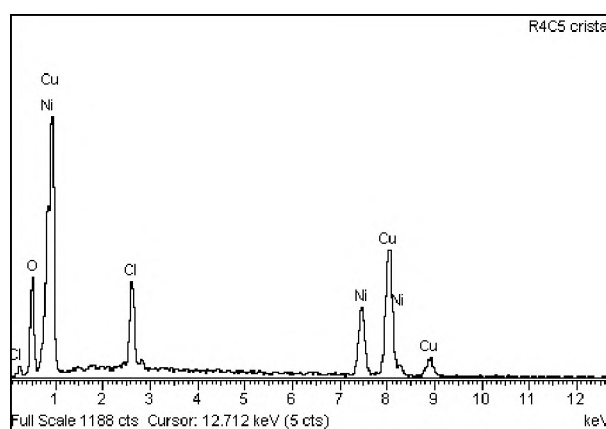
Figure 59: EDS spectrum of corrosion products of Ref. R4C5.

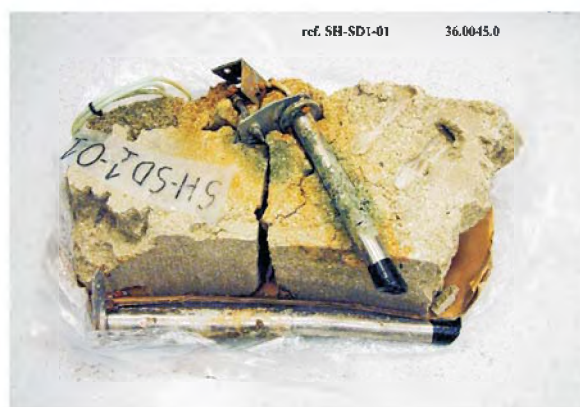
The macrograph in [Figure 62](#) shows the bentonite block containing the SH-SD1-01 sensor split into two during operations to extract the components. Diffusion of corrosion products proceeding from the sensor can be seen in the bentonite surrounding it. The overall appearance of the sensor studied is shown in the macrograph in [Figure 63.b](#). Two areas of damage were identified and given the references of 1 (close to the rock) and 2 (close to the liner). These zones coincide with the zones of greatest diffusion of corrosion products, as can be seen in the photograph showing the on-site test of the sensor, [Figure 63.a](#).

Bentonites ref. BS-24-2 and BS-24-3 were not significantly different to the naked eye insofar as colour, degree of compaction, etc. However, these bentonites differed from that with reference SH-SD1-01, [Figure 129](#), which had a much higher degree of humidity. In this latter block (see [Figure 62](#)), diffusion of green and red corrosion products proceeding from corrosion of the metal sensor was observed.

Figure 62: Reception of sensor SH-SD1-01 in block of bentonite.

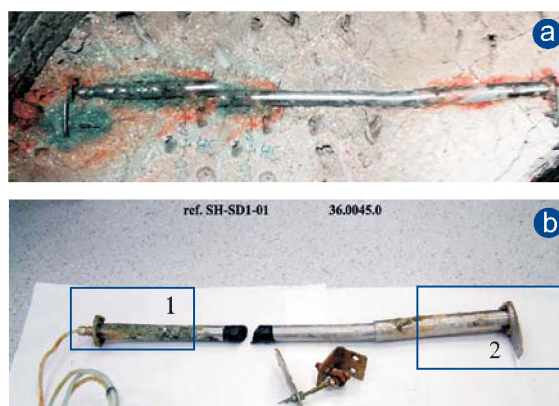
Figure 63: a) On-site (19/06/02), b) reception at INASMET.

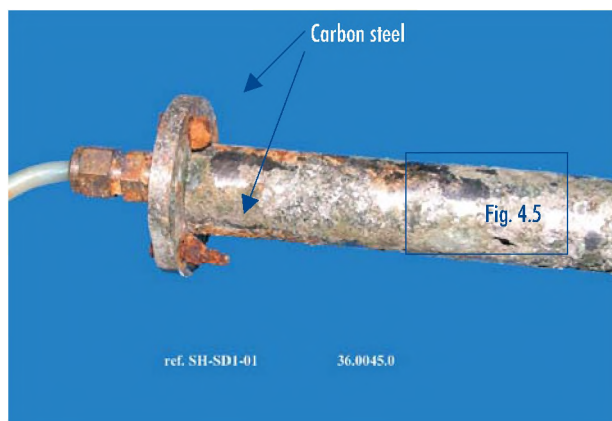
Macrographs 64 and 65 correspond to zone 1 close to the rock. The corrosion damage is manifested as pitting, sometimes large, on the surface, advancing from the outer to the inner periphery, occasionally perforating the tube wall. The corrosion products generated in this zone are deep green. The morphology of the corrosion observed in zone 2 close to the liner, [Figures 66 to 68](#), is characterised by pitting, also extensive on the surface, sometimes developing beneath pustules or deposits mainly made up of remains of bentonite and corrosion products. The corrosion products generated in this zone are mainly brown-black.

Figure 64: Detail of the sensor in zone 1, close to the rock.

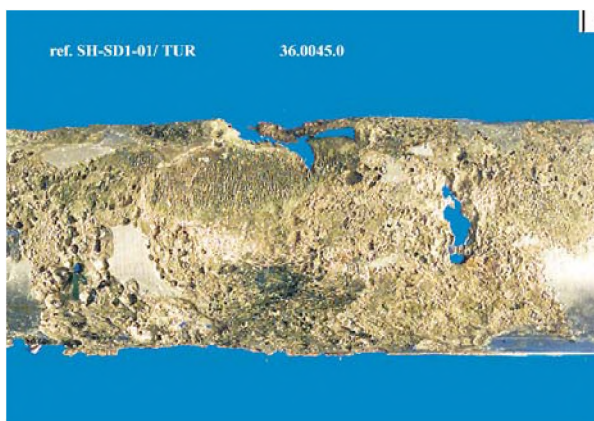
Figure 65: Macrograph detail of 64.

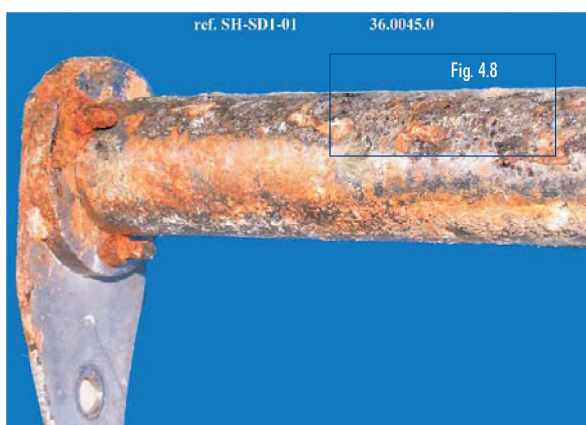
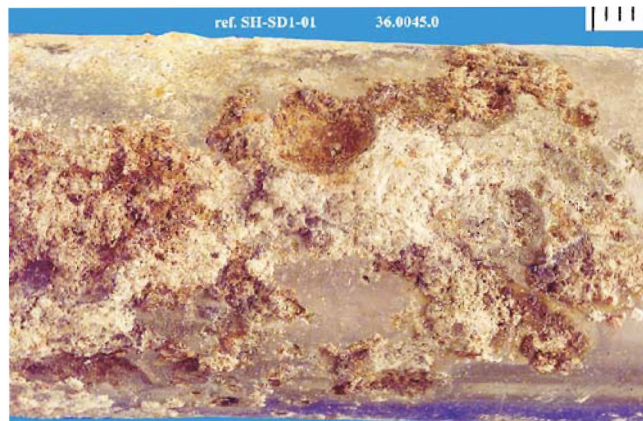
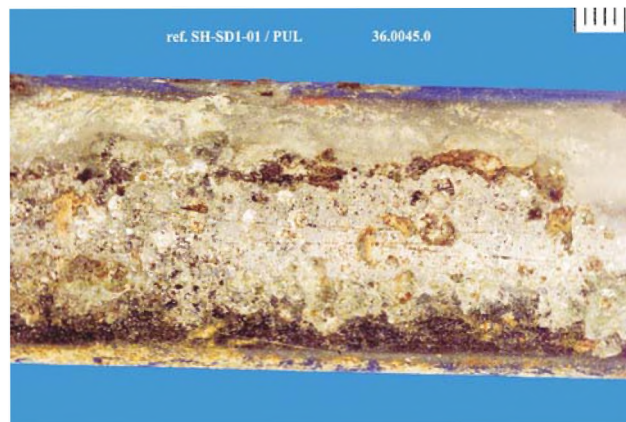
Figure 66: Detail of sensor in zone 2, close to the liner.

Figure 67: Macrograph detail of 66.

Figure 68: Macrograph detail of 66.

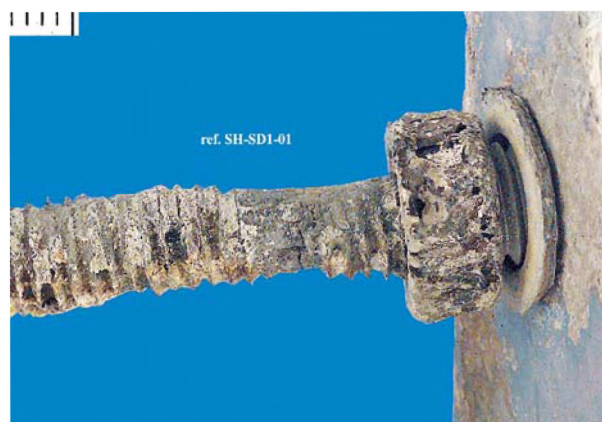
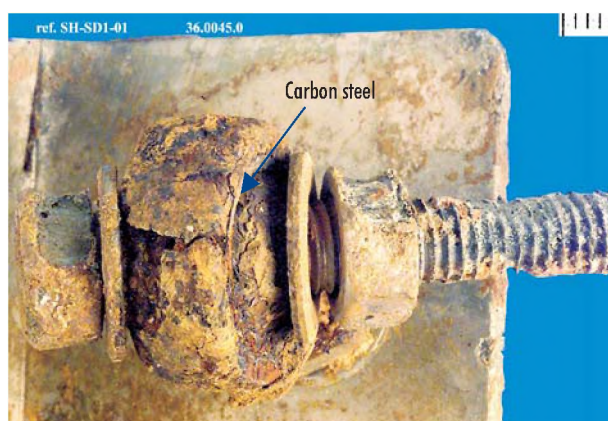
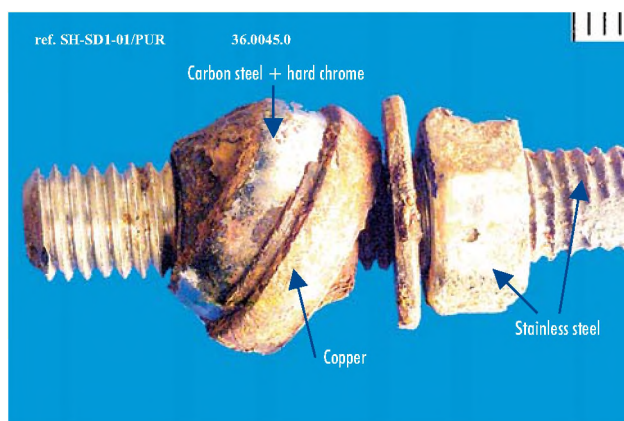
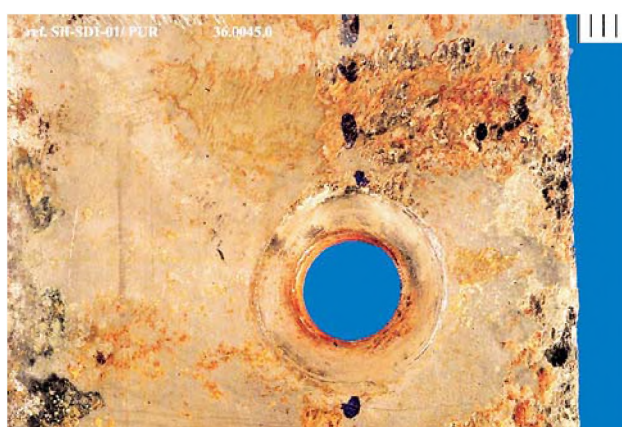
The macrographs in [Figures 69 to 72](#) show details of the device for attaching the sensor to the rock. Significant corrosion damage can be seen on the plates, bolts, screws and other items making up this anchoring device. The corrosion products generated in this area are mostly greenish, except for those components made from carbon steel, which are brown-red. [Figures 70 and 71](#) show the composition of some of the component parts of the anchoring device, determined by the semi-quantitative EDS analysis shown in [Figure 95](#). Analysis of the screws fixing the sensor to the plate ([Figure 64](#)) showed that they were made from carbon steel.

Figure 69: Detail of rock-sensor joint SH-SD1-01.

Figure 70: Detail of rock-sensor joint SH-SD1-01.

Figure 71: Detail of rock-sensor joint SH-SD1-01.

Figure 72: Detail of rock-sensor joint SH-SD1-01.

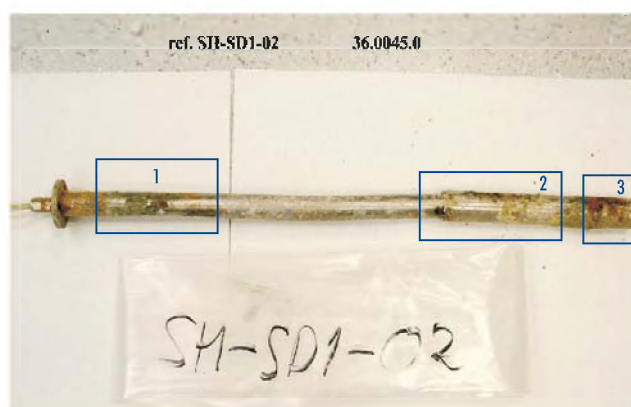
The corrosion damage observed on sensor Ref. SH-SD1-02, a view of which can be seen in macrograph 4.13, coincides in many ways with that on sensor Ref. SH-SD1-02. The corrosion damage was defined in three zones. Zone 1 close to the rock shows extensive surface pitting that perforates the tube. Bright green corrosion products predominate in this zone, [Figure 74](#). In zone 2, [Figures 75 and 76](#), there is observed pitting development beneath the pustules and/or deposits. The corrosion products in this area are dark brown. In zone 3, close to the liner, [Figures 77 and 78](#), there is detected cracking and pitting of the tube.

Figure 73: Reception of sensor SH-SD1-02.

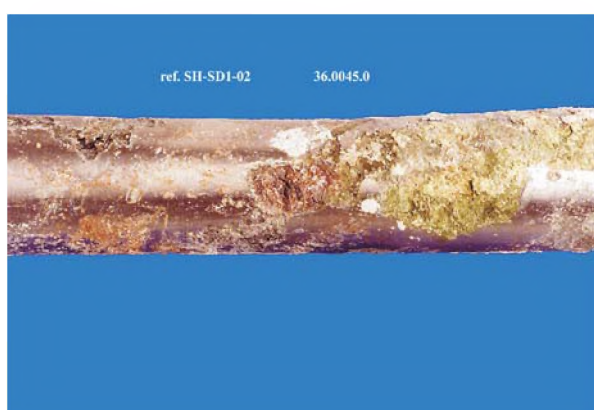
Figure 74: Detail of sensor in zone 1, close to the rock.

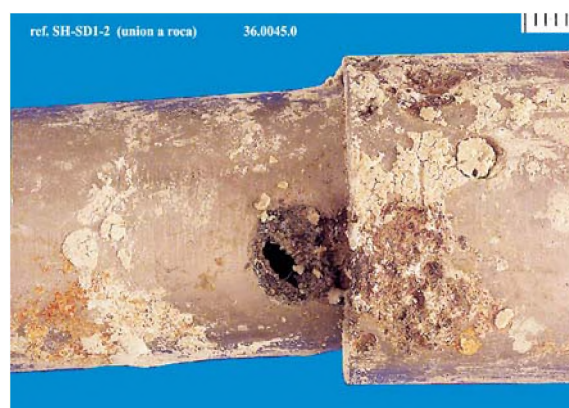
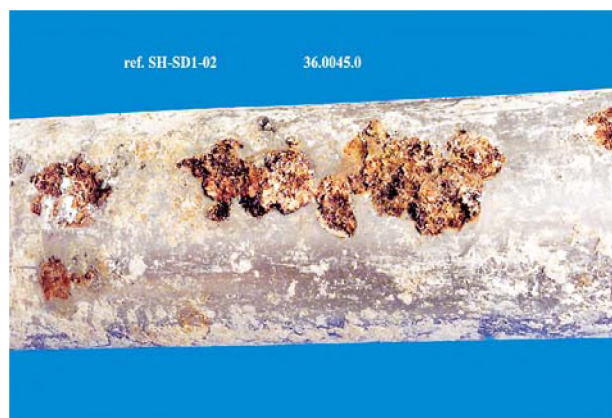
Figure 75: Detail of sensor in zone 3.

Figure 76: Detail of sensor in zone 3.

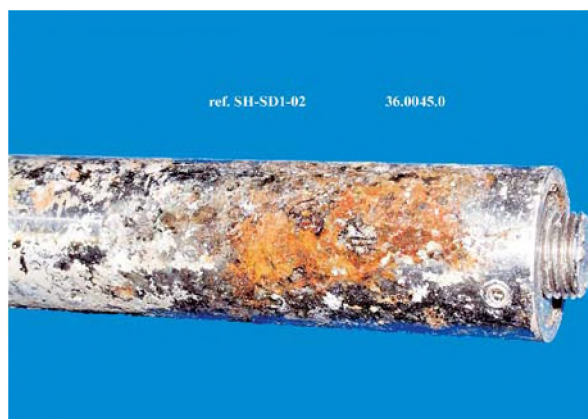
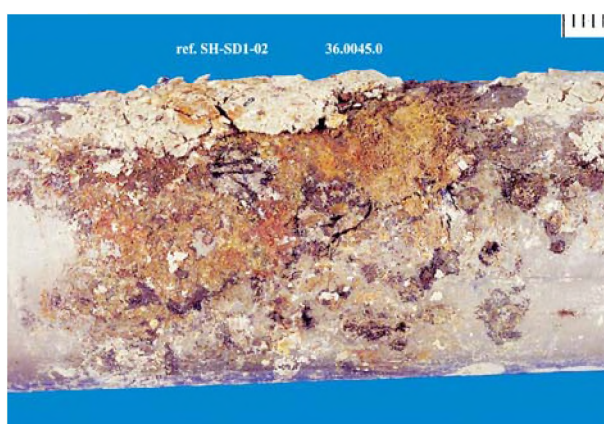
Figure 77: Detail of sensor in zone 3, close to the liner.

Figure 78: Detail of Figure 77.

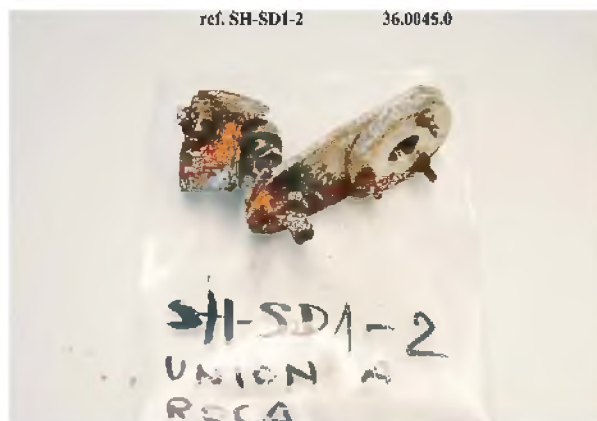
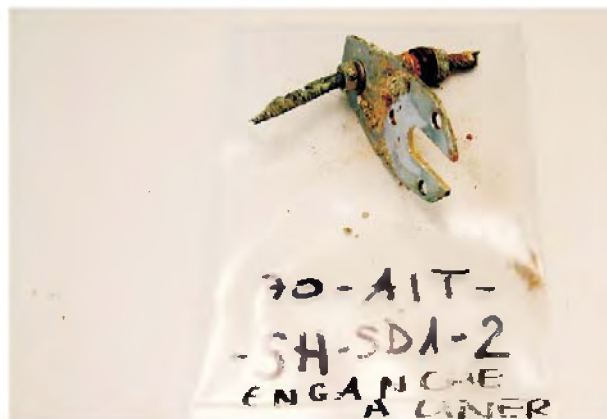
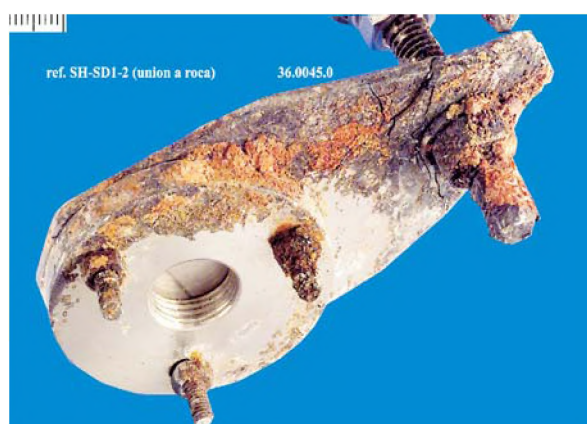
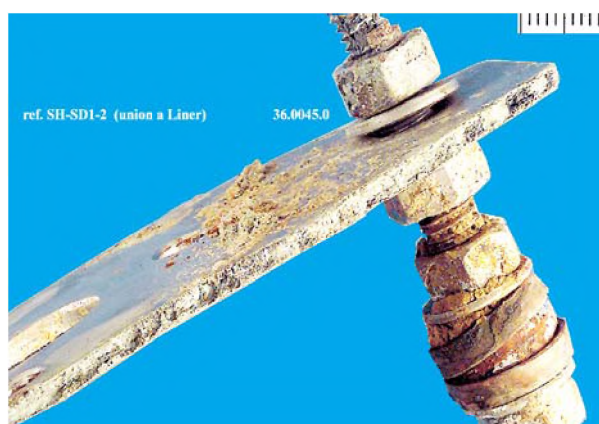
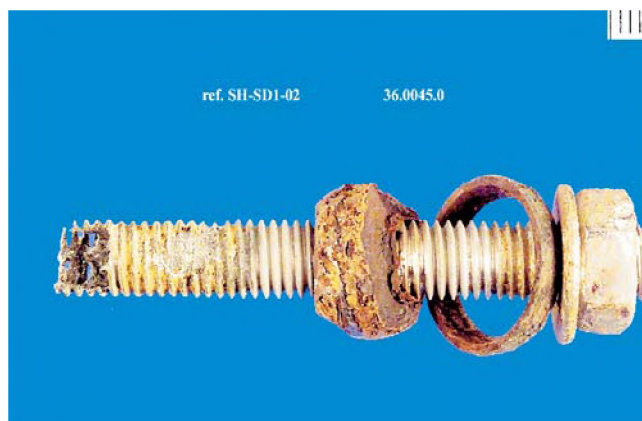
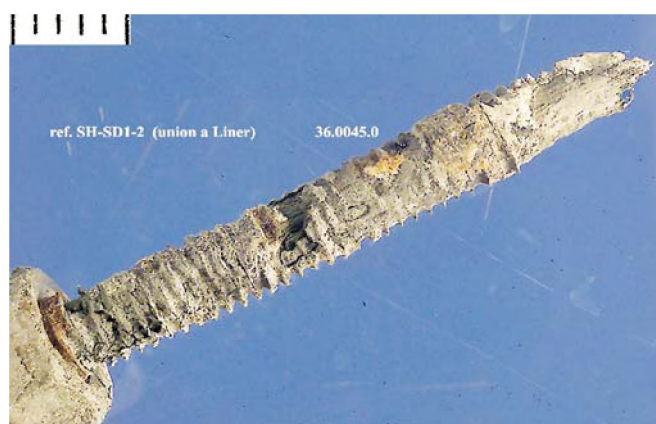
The corrosion damage observed on the devices for anchoring the sensor to the rock and the liner, is shown in [Figures 79 to 84](#). The plates where it is joined to the rock show significant cracking, and significant generation of reddish corrosion products. The corrosion products generated on the fixing devices are green (when the substrate is stainless steel) and red, when the component is made from carbon steel.

Figure 79: Detail of rock-sensor joint SH-SD1-02.

Figure 80: Detail of liner-sensor joint SH-SD1-02.

Figure 81: Detail of rock-sensor joint SH-SD1-02.

Figure 82: Detail of liner-sensor joint SH-SD1-02.

Figure 83: Detail of liner-sensor joint SH-SD1-01.

Figure 84: Detail of liner-sensor joint SH-SD1-01.

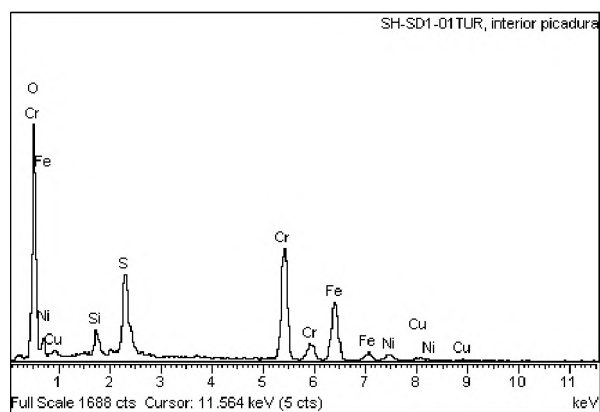
Figure 86: EDS spectrum of corrosion products inside the pitting on sensor SH-SD1-01, close to the rock.

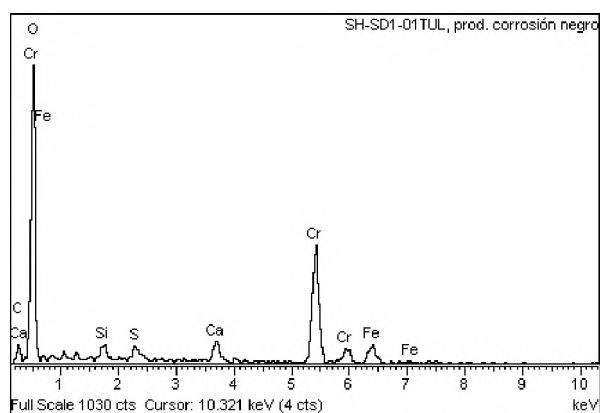
Figure 87: EDS spectrum of black corrosion products on sensor SH-SD1-01, close to the liner.

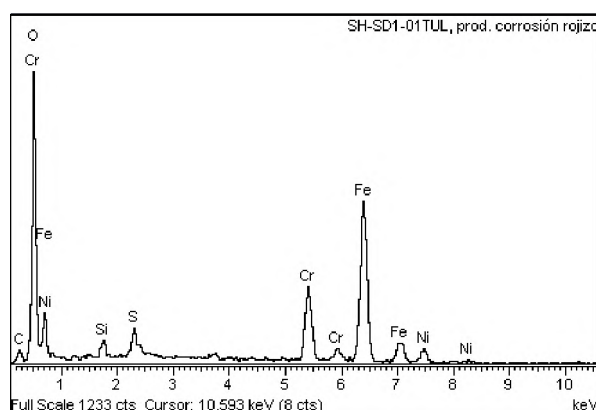
The EDS analyses carried out on the green corrosion products show the presence of sulphur, sometimes predominant, [Figures 85, 89 and 92](#). Analysis of the reddish corrosion products shows them to be enriched with the element iron, [Figures 88 and 93](#). A significant fact is that analysis of the corrosion products beneath pustules shows calcium enrichment as well as sulphur, [Figure 90](#).

Figure 88: EDS spectrum of red corrosion products on sensor SH-SD1-01, close to the liner.

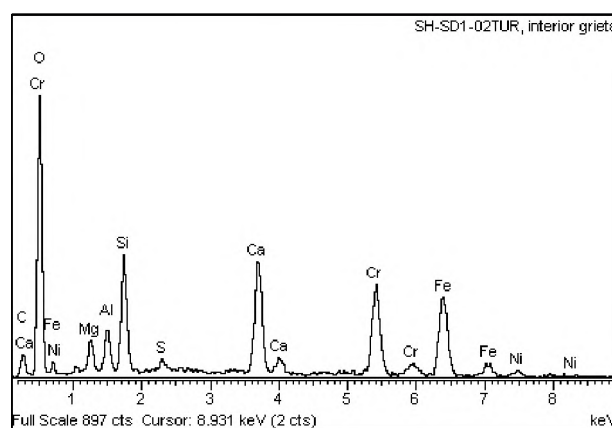
Figure 91: EDS spectrum of corrosion products inside crack on sensor SH-SD1-02, close to the liner.

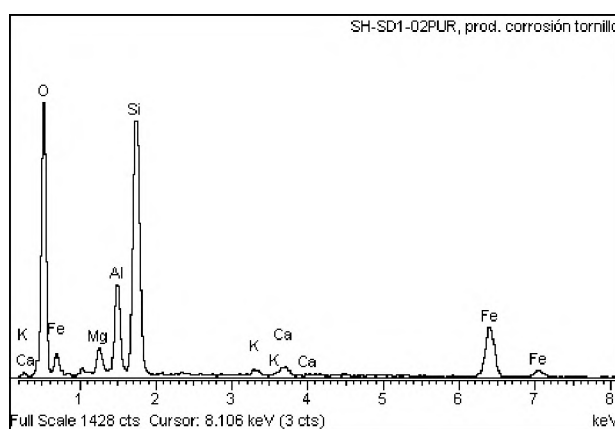
Figure 93: EDS spectrum of red corrosion products on the plate fixing sensor SH-SD1-02 to the rock.

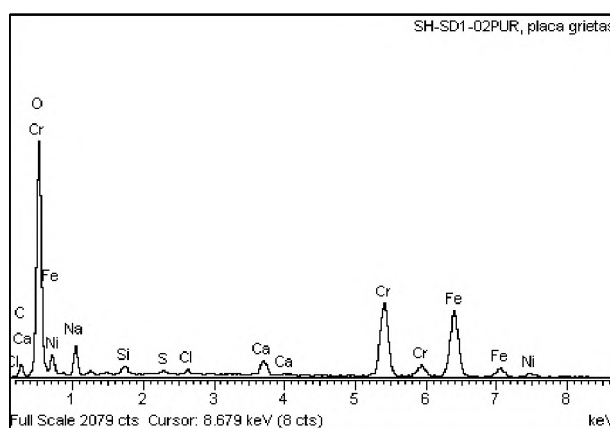
Figure 94: EDS spectrum inside crack on the plate fixing sensor SH-SD1-02 to the rock.

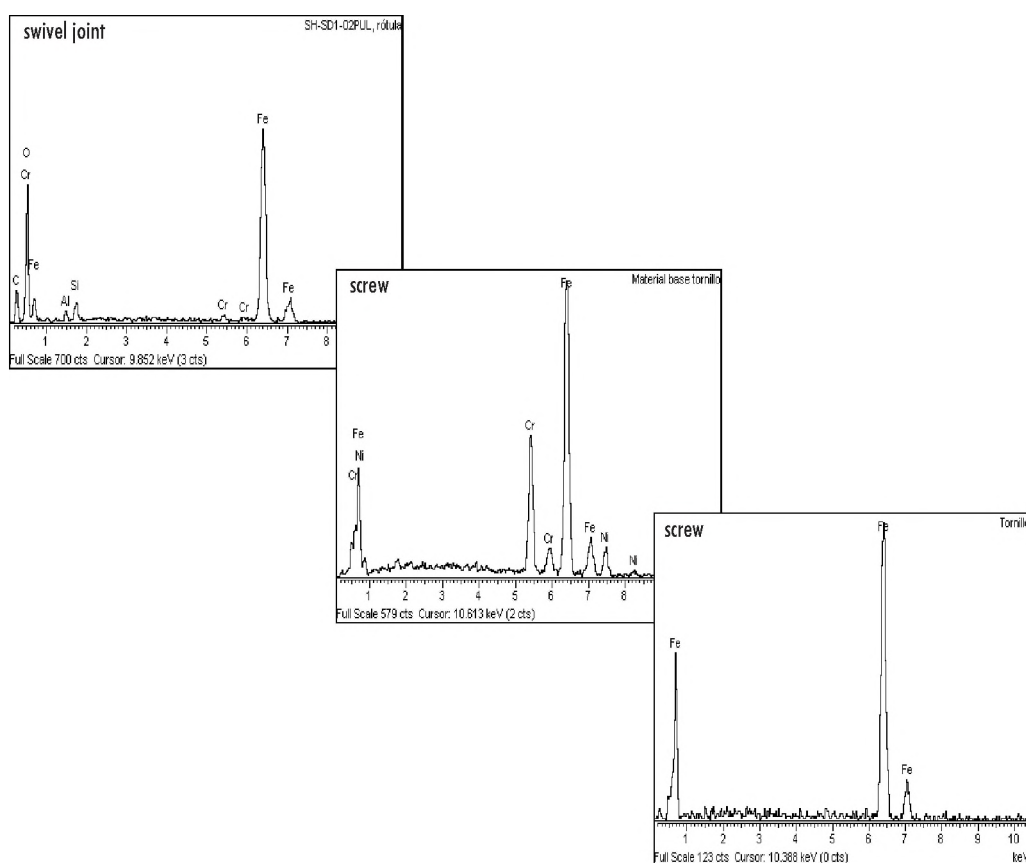
Figure 95: EDS spectra of the swivel joint and screw (austenitic) of the liner fixing plate, and of the screw fixing the sensor to the plate (Figure 64) Component: Sensors: SH-SD1-01.

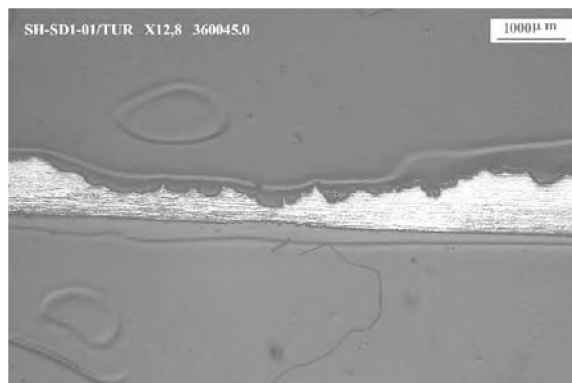
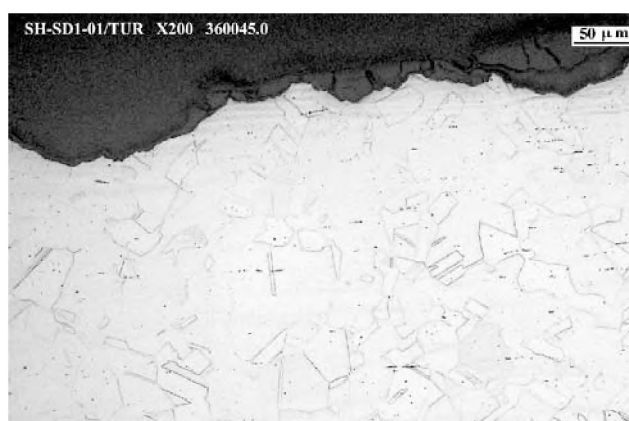
The optical micrographs in Figures 98 to 108 show different sections extracted from the two sensors being studied. The samples show significant corrosion penetration of the material, with a clear advance from the outer to the internal periphery. The steel making up the external tube of both sensors shows a non-sensitised austenitic microstructure, with a certain degree of intergranular advance of the corrosion, especially in zones of the tube close to the liner, Figures 100 and 101.

Figure 98: Longitudinal section, zone 1.

Figure 99: Detail of Figure 98.

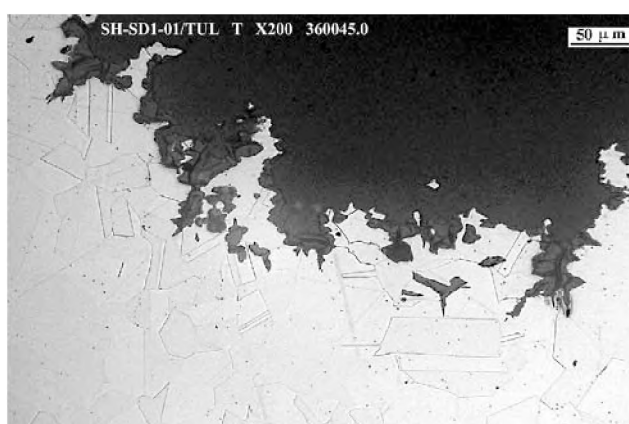
Figure 101: Detail of Figure 100.

The optical micrographs in Figures 109 to 113 show different aspects of the morphology of the damage observed in the anchor points of the two sensors to the liner and the rock. Figures 100 and 111 show the cracking detected in fitting securing sensor SH-SD1-02 to the rock. The optical micrograph in Figure 112 shows the corrosion damage produced in one of the carbon steel parts.

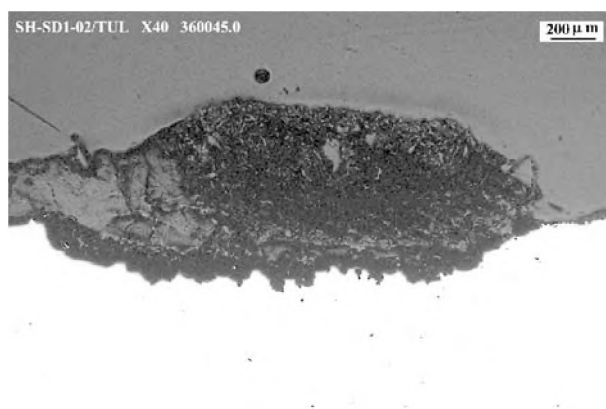
Figure 104 Transversal section of pustule in zone 2.

EDS analysis of the pustules, with their characteristic dark brown deposits, identifies significant amounts of calcium, sulphur and iron. The XRD spectrum only detects calcite, CaCO_3 , given the amorphous nature of the iron sulphides. The formation of crystallised calcite (Figure 104) is usually attributed to chemical transformations of the deposits or pustules, which are usually accompanied by the precipitation of calcite. These deposits normally reflect SRB corrosion that is no longer active.

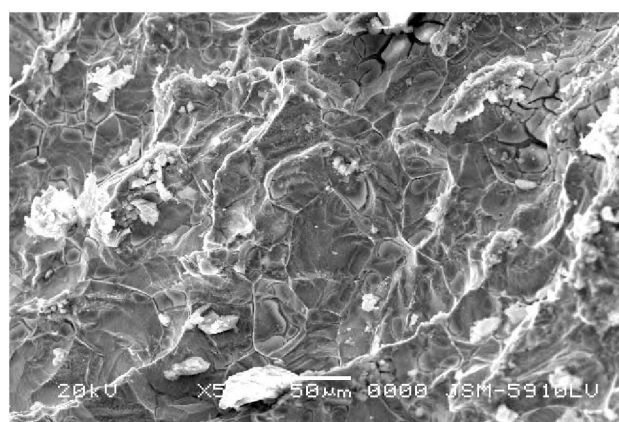
Finally the electron micrograph in Figure 113 shows the surface morphology of one of the pits on the sensors being studied. This pit has a shiny (or active) surface and shows a certain intergranular progression of the corrosion.

Figure 113: SEM of pitting in zone 2 of sensor SH-SD1-01.

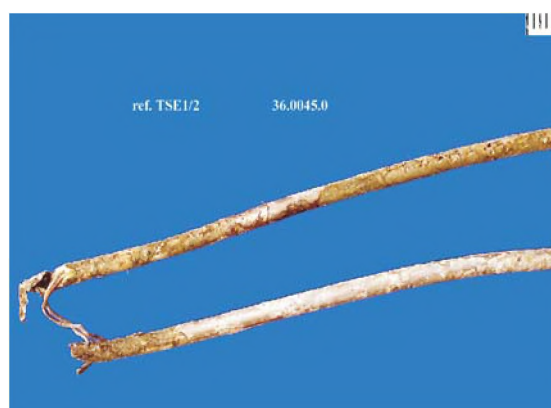
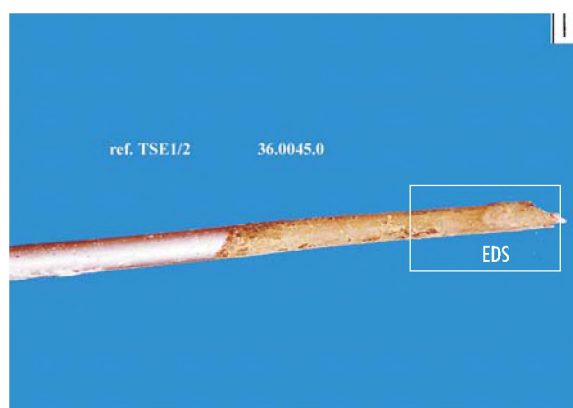
Both thermocouples showed zones of damage characterised by generalised corrosion of their surface, Figures 116 and 117, with the formation of a layer or "film" of green corrosion products. In other zones,

Figure 116: Detail of sensor TSE1-2.

Figure 117: Detail of sensor TSE1-2.

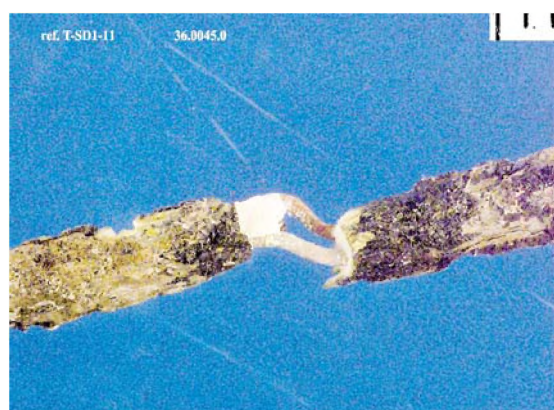
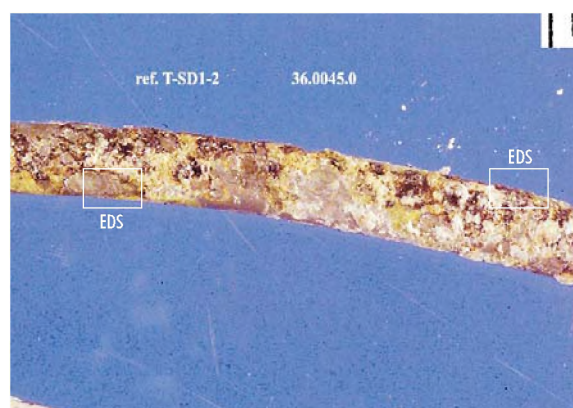
the corrosion damage was characterised by a more localised corrosion morphology, in the form of more or less extensive superficial pitting, with generation of green, yellow and black corrosion products, [Figures 118 and 119](#). Shiny or active areas of corrosion were also observed. The corrosion has advanced from the outer to the internal periphery, to perforate the wall of the tube or sheath covering the sensors, leaving the insulation or magnesia open to view, together with the two wires making up the thermocouple.

Figure 118: Detail of sensor TSD1-11.

Figure 119: Detail of sensor TSD1-11.

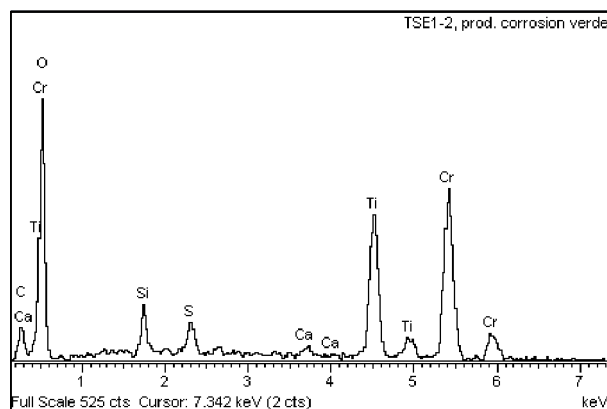
[Figures 120 to 124](#) show the EDS spectra obtained. Sulphur was detected in the green and black corrosion products analysed, [Figures 120 to 122](#). The analyses of the yellow corrosion products showed a significant presence of chlorine and nickel, [Figure 123](#).

Figure 120: EDS spectrum of green corrosion products on thermocouple TSE1-2.

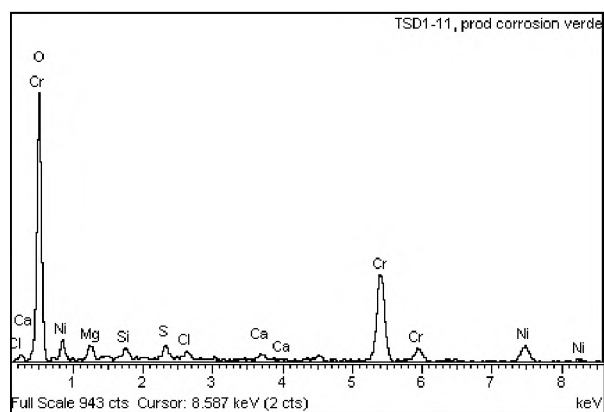
Figure 121: EDS spectrum of green corrosion products on thermocouple TSD1-11.

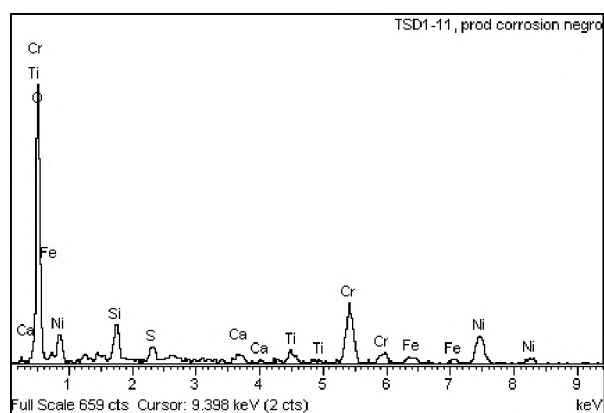
Figure 122: EDS spectrum of black corrosion products on thermocouple TSD1-11.

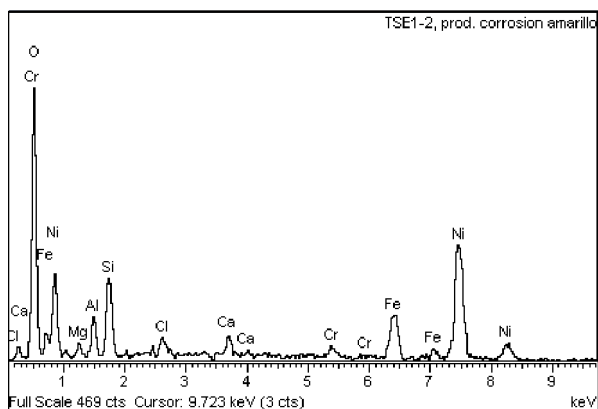
Figure 123: EDS spectrum of yellow corrosion products on thermocouple TSE1-2.

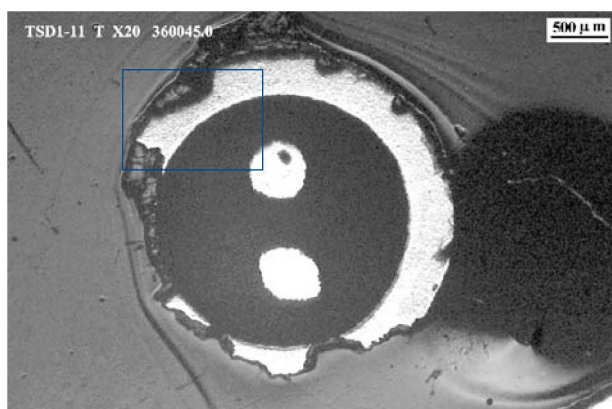
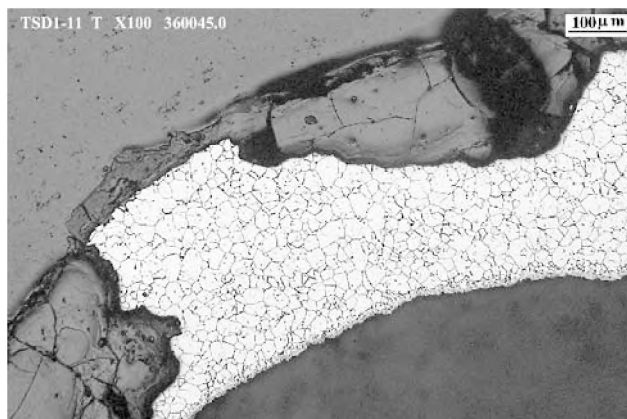
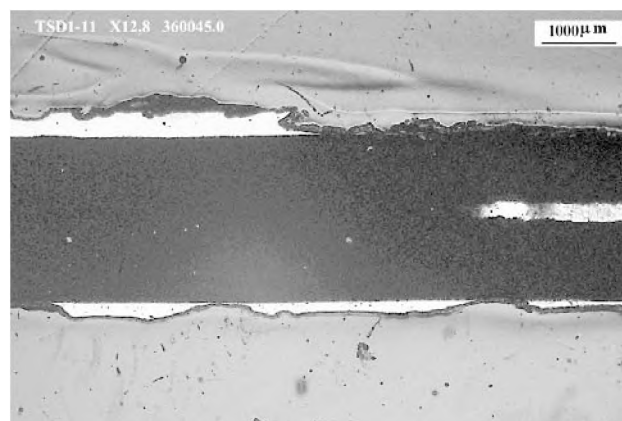
The optical micrographs in [Figures 125 to 127](#) show different sections extracted from the thermocouples being studied. The samples show significant corrosion penetration of the material, which has perforated and practically dissolved the outer tube in some sections. The alloy making up the tube or

Figure 125: Transversal section of thermocouple TSD1-11.

Figure 127: Longitudinal section of thermocouple TSD1-11.
