Febex Project Post-mortem Analysis: Corrosion Study

V. Madina, I. Azkarate
INASMET

AITEMIN requested the INASMET Foundation to carry out the tasks laid down in quotation Ref. 73.1707.2, consisting of a study of the corrosion suffered by different components of the “in situ” test of the FEBEX Project being carried out by AITEMIN in Grimsel (Switzerland).

The test began in July 1996 and, after approximately six years, one of the heaters, a section of guide tube (liner), samples and four sensors were extracted in June 2002. These elements were the object of the study, the aim of which was to evaluate the behaviour of the above-mentioned elements in relation to the corrosion phenomena suffered in the same conditions as those predicted for deep geological disposal in a granitic formation.

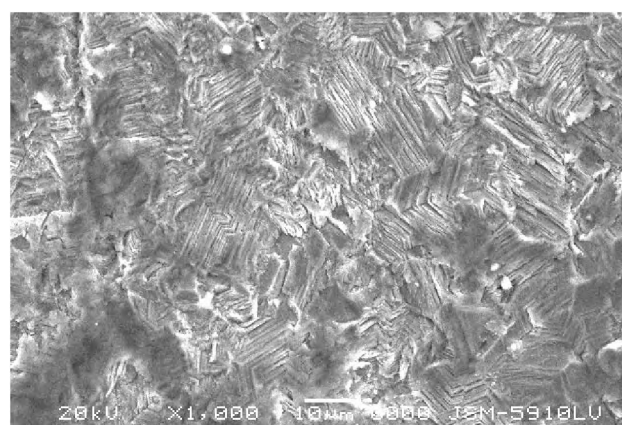
The SEM micrograph in [Figure 128](#) shows an “active” or shiny surface on one of the thermocouples. A certain degree of intergranular progression of the corrosion can be appreciated.

Figure 128: SEM of active surface on thermocouple TSD1-11.

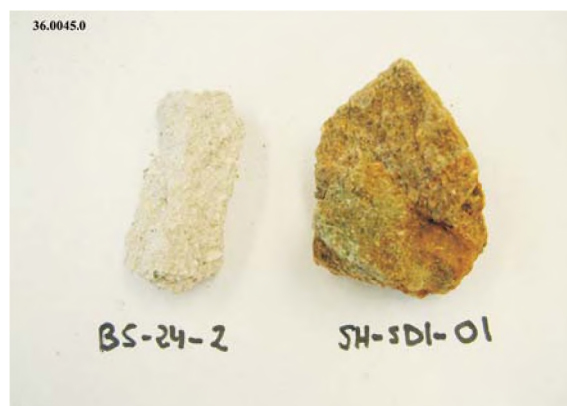
Figure 129: Samples from blocks BS-24-2 and SH-SD1-01.

Bentonites ref. BS-24-2 and BS-24-3 were not significantly different to the naked eye insofar as colour, degree of compaction, etc. However, these bentonites differed from that with reference SH-SD1-01, [Figure 129](#), which had a much higher degree of humidity. In this latter block (see [Figure 62](#)), diffusion of green and red corrosion products proceeding from corrosion of the metal sensor was observed.

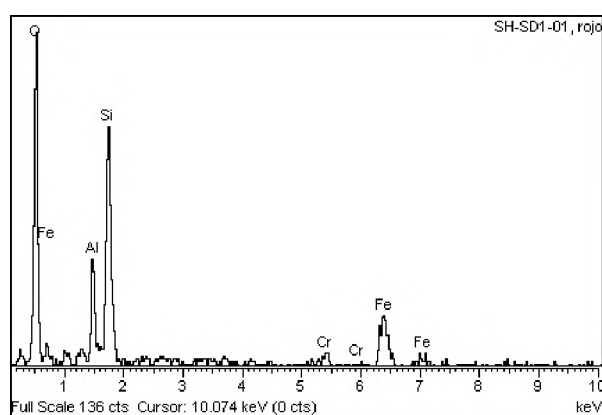
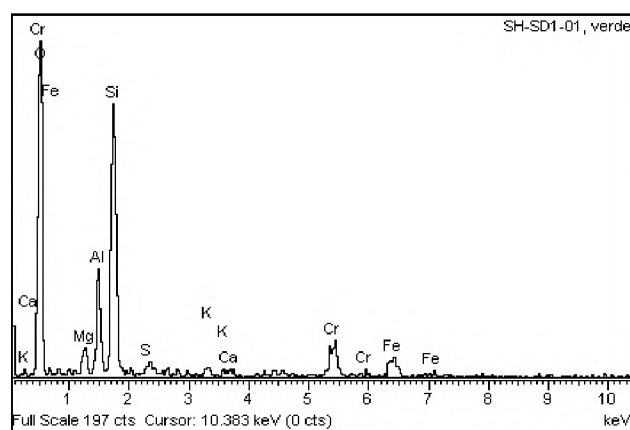
Figures 130, 131 and 132 show the EDS spectra obtained for bentonites ref. BS24-2, and SH-SD1-01. The bentonite sample of block SH-SD1-01 was obtained far from the zone of diffusion of the corrosion products proceeding from the sensor. The three analyses detected elements typical of bentonite, such as silicon, aluminium, magnesium and calcium, in similar percentage. Analysis of bentonite sample SH-SD1-01, taken from a zone with diffusion of reddish corrosion products, showed, as well as the above-mentioned elements, a significant percentage of iron, Figure 131. When the sample analysed was that taken from a zone close to the sensor, with the diffusion of greenish corrosion products, a significant peak of chrome and some sulphur was detected in addition to the iron, Figure 132.

Figure 131: EDS spectrum of sample Ref. SH-SD1-01, in the zone of diffusion of reddish corrosion products.

Figure 132: EDS spectrum of sample Ref. SH-SD1-01, in the zone of diffusion of greenish corrosion products.
