## Review meeting LOT experiments (ii)

- (i) Management system & project management
- (ii) **Retrieval, sampling, handling of samples & analyses**
- (iii) Interpretation of results.

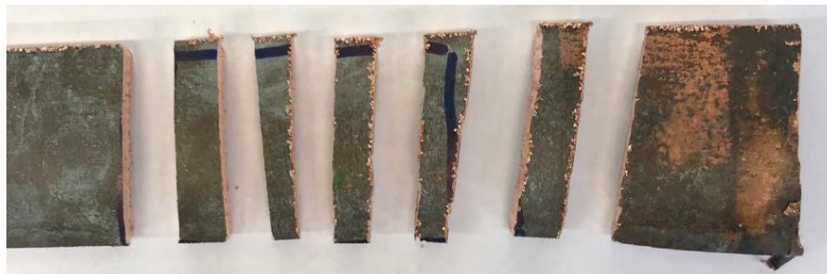
It was decided to sample “type-areas” based on their visual appearance, for example light (Cu coloured), dark/black, and with grey deposits (could be bentonite and/or gypsum). This is shown in figures G1-G5 in TR-20-14. As exemplified for area 1 for the pipe sample from A3, several cross-sections were examined for each area.

Tube samples were chosen for SEM cross-section analysis based on visual appearance (Section 2.3). What criteria were used to judge the area to select?
