Notes; Quality assurance - LOT meeting 2

Retrieval, sampling, handling of samples and analysis

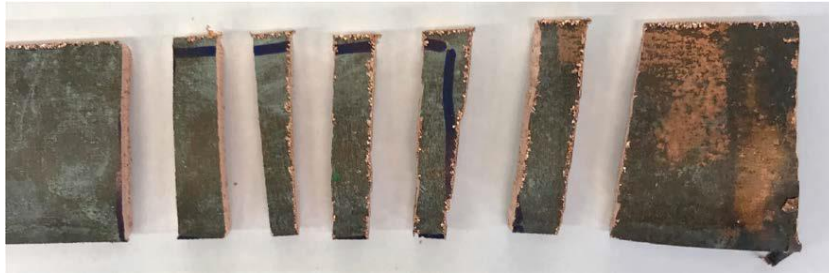
SKB's reply/comment: It was decided to sample "type-areas" based on their visual appearance, for example light (Cu coloured), dark/black, and with grey deposits (could be bentonite and/or gypsum). This is shown in figures G1-G5 in TR-20-14. As exemplified for area 1 for the pipe sample from A3, several cross-sections were examined for each area (Fig G6 in TR-20-14).

Discussion: SKB believes that sampling “type-areas” was an appropriate way to choose samples for the analysis. It should be noted that the darkest parts are not necessarily the most corroded, since corrosion products may in some cases adhere to the bentonite surface in contact with the pipe.
