Corrosion of copper after 20 years exposure in the bentonite field tests LOT S2 and A3

SVENSK KÄRNBRÄNSLEHANTERING AB

SKB TR-20-14

September 2020

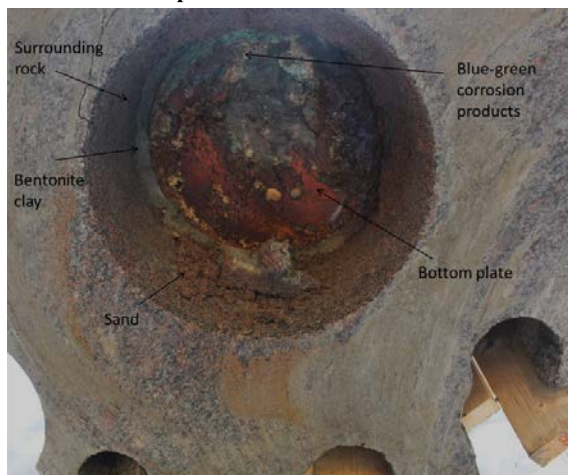
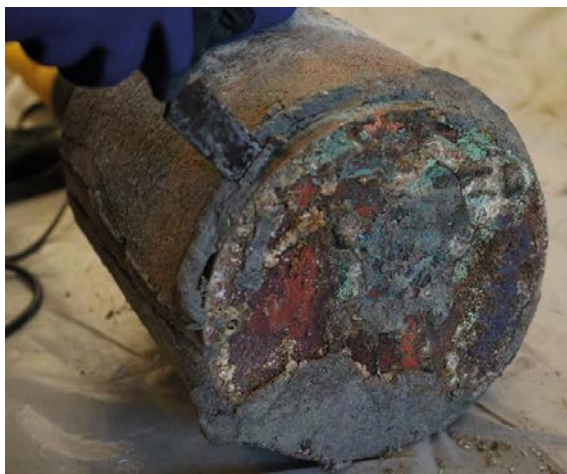
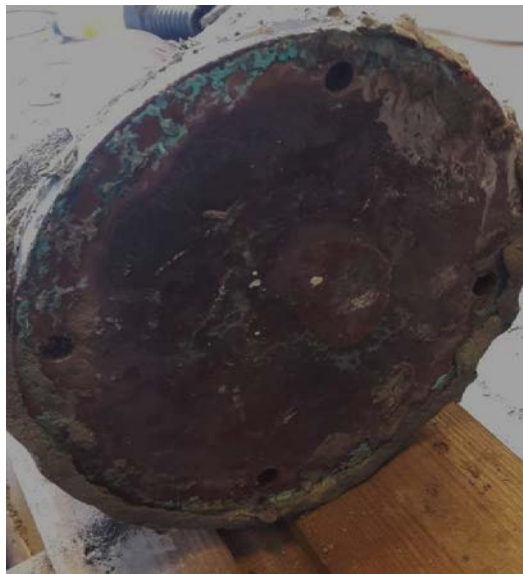
The first copper surfaces that became visible during the retrieval were the bottom plates welded to the central copper pipes (Figure 3-1). As indicated in Figure 1-2, the bore holes below the experimental test parcels were filled with sand, i.e. there was no bentonite clay in contact with the bottom plates. The upper left photo in Figure 3-1 shows the bottom plate of A3 when the test parcel was still surrounded by rock. Some of the sand which filled up the hole below the test parcel is still present and some bentonite is visible on the side of the bottom plate. It may be noted in Figures 3-1 and 3-2 that blue-green deposits had formed under the bottom plates in both test parcels, as well as on the side of the bottom plate in A3. Although not apparent in the photographs, the mid part of the S2 bottom plate also had a slightly blue-green appearance. A sample of the blue-green deposit was later analysed with SEM-EDS and XRD (Appendix I). The EDS analysis indicated high levels of chlorine and the XRD showed good agreement with the diffraction pattern of $\text{Cu}_2(\text{OH})_3\text{Cl}$, an expected corrosion product of copper in the presence of O_2 and chloride (Karnland et al. 2009).

Figure 3-1. Appearance of the bottom plates immediately after retrieval. Note the blue-green deposits. Upper left: Bottom plate of A3 when it was still surrounded by rock. Lower left: Bottom plate of A3 when the pipe was still embedded in the bentonite. Right: Bottom plate of S2.

The only surface adherent Cu²⁺ corrosion products detected in S2 and A3 were the blue-green deposits under the bottom plates, verified by XRD to contain Cu₂(OH)₃Cl (paratacamite), a compound found on the coupons in the previously retrieved LOT A2, as well as in other intermediate or large-scale field tests (Karnland et al. 2009, Wersin and Kober 2017) and laboratory experiments (Huttunen-Saarivirta et al. 2017). A circumstance that could have affected the formation of Cu²⁺ corrosion products under the bottom plates, is that one of the Ti-tubes (Tube 7 in Figure 1-2) extended into the sand filled space just below the bottom plate, and since the Ti-tubes were open for about four months after installation of the test parcels, the bottom plates may have experienced atmospheric O₂ pressure during this period (and thereby a higher electrochemical potential than other parts of the copper pipe or the coupons). Furthermore, the bottom plate may have been exposed to O₂ for an extended period also after closing the Ti-tubes, since the sand filled hole below the test parcel may still have contained air. A possible explanation for the adherence of Cu₂(OH)₃Cl under the bottom plate could be that there was no interaction between Cu²⁺ and bentonite at this part of the copper surface.

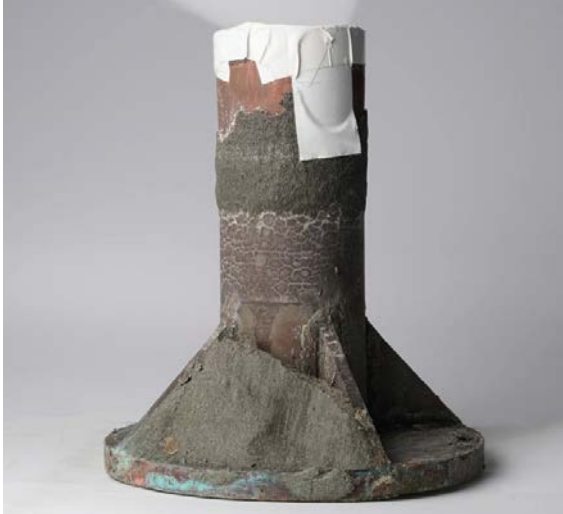
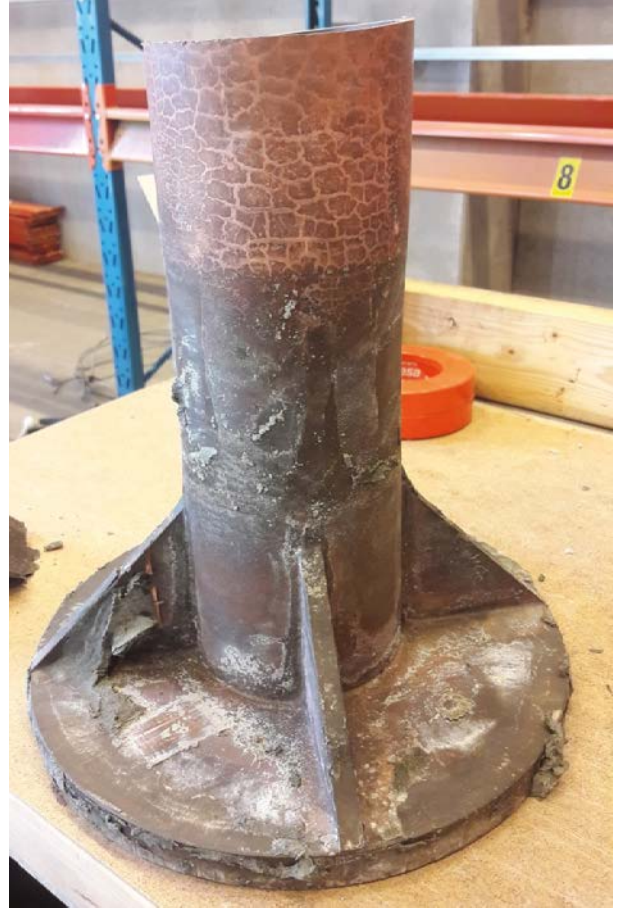
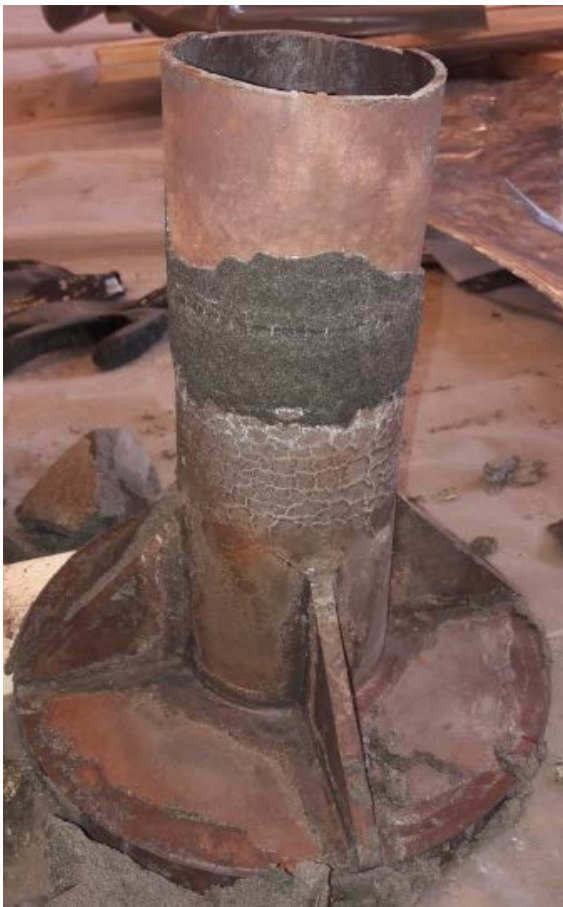
Figure 3-2. *Appearance of the lower part of the copper pipes immediately after retrieval.*

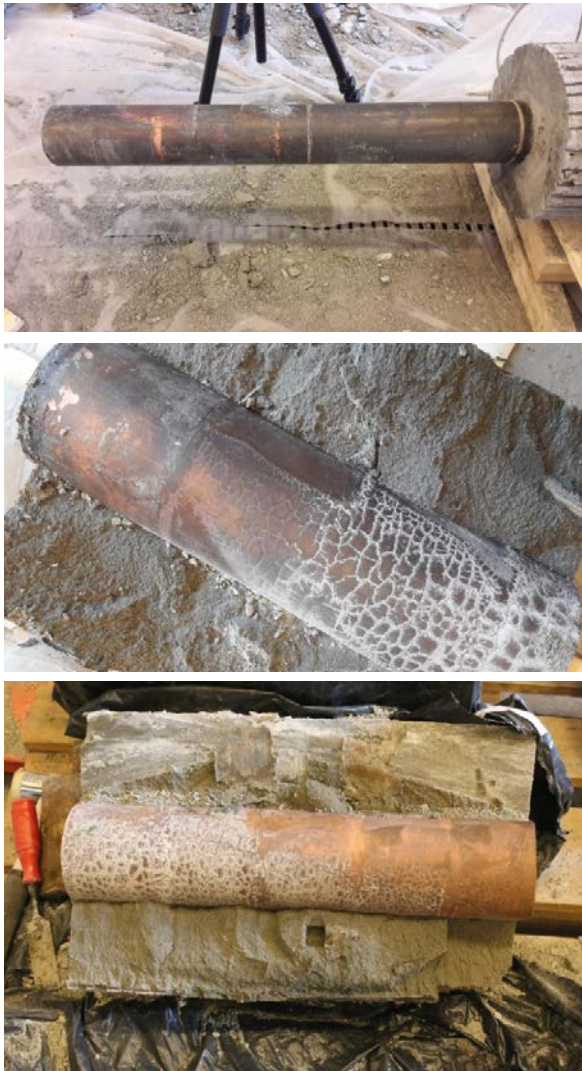
A3 pipe sections

The copper pipes became visible after the test parcels had been segmented by breaking off the rock masses, removing the Ti-tubes and cables to the thermo-elements, and finally cutting the clay and pipe assembly using a saw. The appearance of the copper pipes in the two test parcels were similar (Figure 3-3). Both pipes had areas with dark brown to nearly black appearances, as well as areas with a lighter copper-like appearance. The pipe from A3 appeared to have slightly larger dark areas than the pipe from S2, although areas of both types were found on both pipes. The dark staining of the copper pipes in LOT S2 and A3 was similar to the appearance of the pipe in LOT A2, see Figures A2-2, A8-4 and A8-6 in Karnland et al. (2009). There were also areas where a thin layer of bentonite clay was still adherent to the surface, and areas with a white deposit forming a reticulated pattern (see for example the mid left photo in Figure 3-3). The latter was very similar with observations made in both LOT S1 and A0, see e.g. Figure 4-13 in Karnland et al. (2000), and has been identified as precipitates of CaSO_4 (see further Section 3.6).

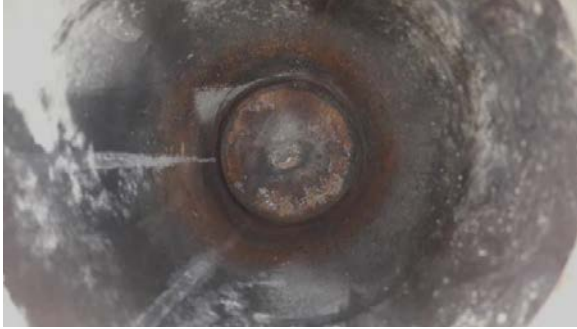
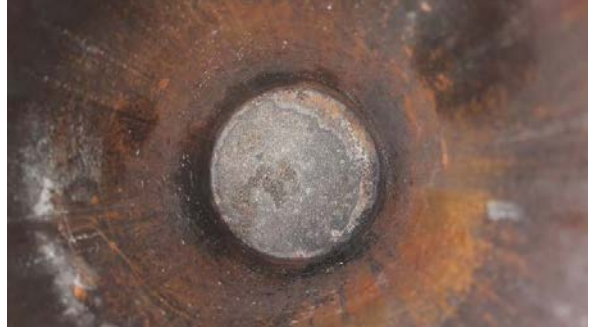
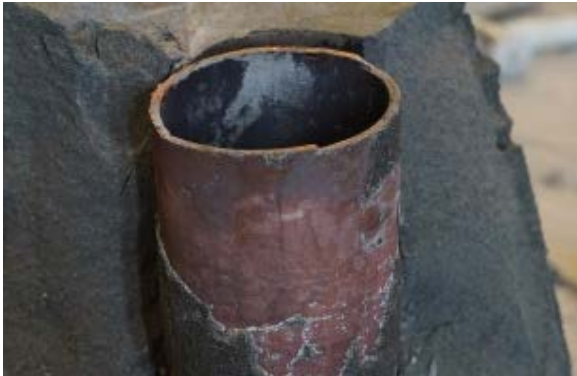
As discussed in the introduction, the copper pipes were open to the Äspö tunnel during the whole experiment. The exposure of the inner pipe surface to air and humidity was clearly visible on some parts and especially the lower parts of the pipe showed signs of corrosion (Figure 3-4). Further examination of cross-sectioned samples of the copper pipes inner surfaces in SEM revealed a thin corrosion film ($< 1 \mu\text{m}$ thick), and pits of about a few μm deep (Appendix F).

Figure 3-4. *Appearance of the interior of the copper pipes in LOT A3 and S2 immediately after retrieval.*

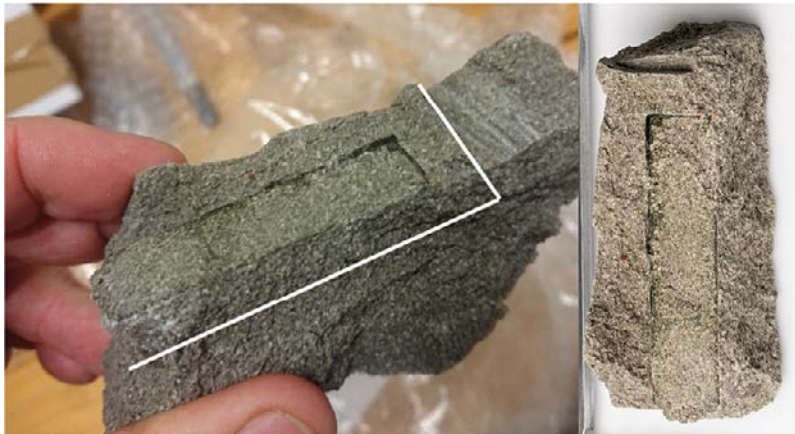
The first sample (Block 30; Cu K N) was sampled using the 0 – 10 mm interval (Figure 3-25). The resulting bulk sample obtained after grinding and compaction of the sample showed a copper concentration below detection limit. Hence it was decided to sample a smaller interval of 0 – 5 mm for the remaining samples (Figure 3-26). This means bulk samples were produced by milling all the bentonite that were within a 5 mm distance from the copper coupon. The 21 – 23 N Cu I sample was trimmed a little bit further after the photo was taken (on its right side).

Figure 3-25. Sample “30 Cu K N” from block 30 of LOT A3, before and after trimming. All bentonite at 10 mm distance from the copper coupon was included in the final sample.

The sample “30 Cu K N” from block 30 of LOT A3, included all bentonite within a 10 mm distance from the copper coupon (Figure 3-25), and the resulting “CuO” content was 0.008 wt% (Table 3-8), which is not a reliable quantification due to the very low concentration. This is not considered to be usable. Therefore, the other samples were instead trimmed using a 5 mm distance (Figure 3-26, Table 3-9). This resulted in higher “CuO” levels in the range of 0.03 – 0.05 wt% (Table 3-8). The repeatability of the measurements was rather high (standard deviation SD was low, Table 3-8).

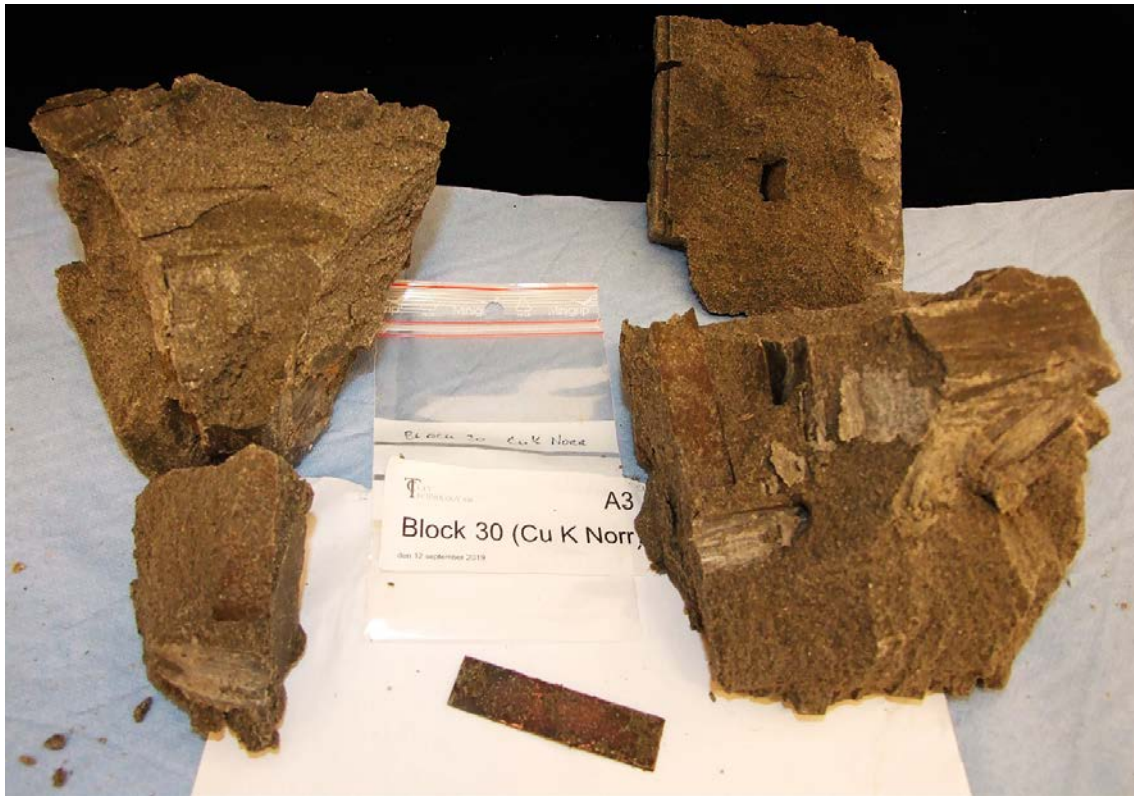
Figure A-4. Corrosion coupon A3/K with surrounding bentonite clay.

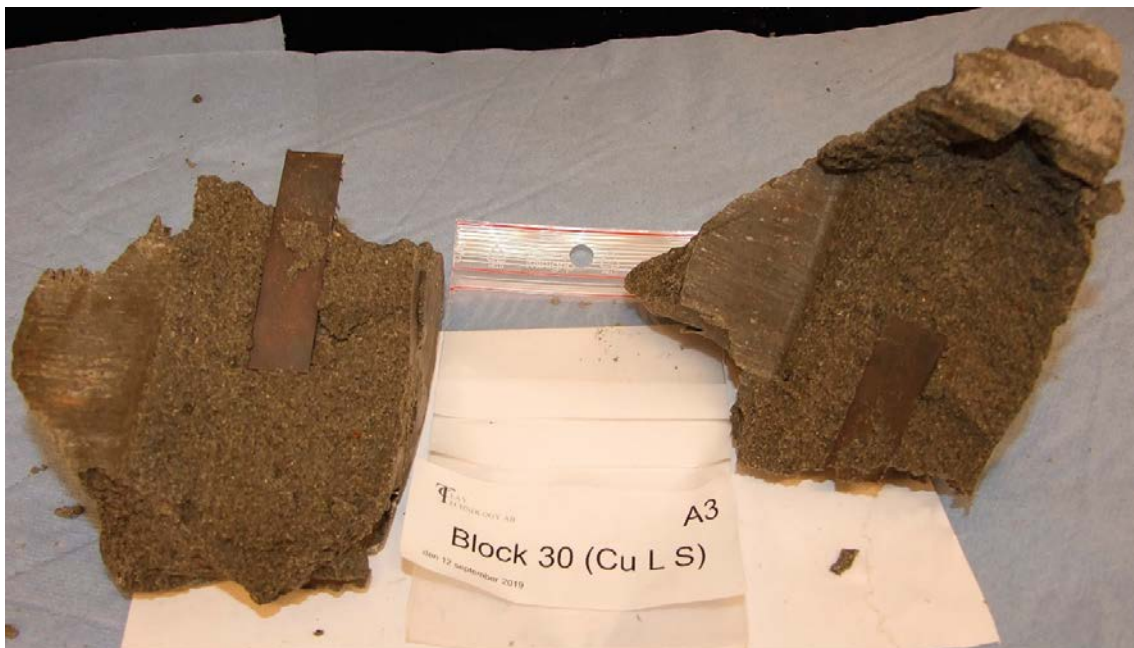
Figure A-5. Corrosion coupon A3/L with surrounding bentonite clay.

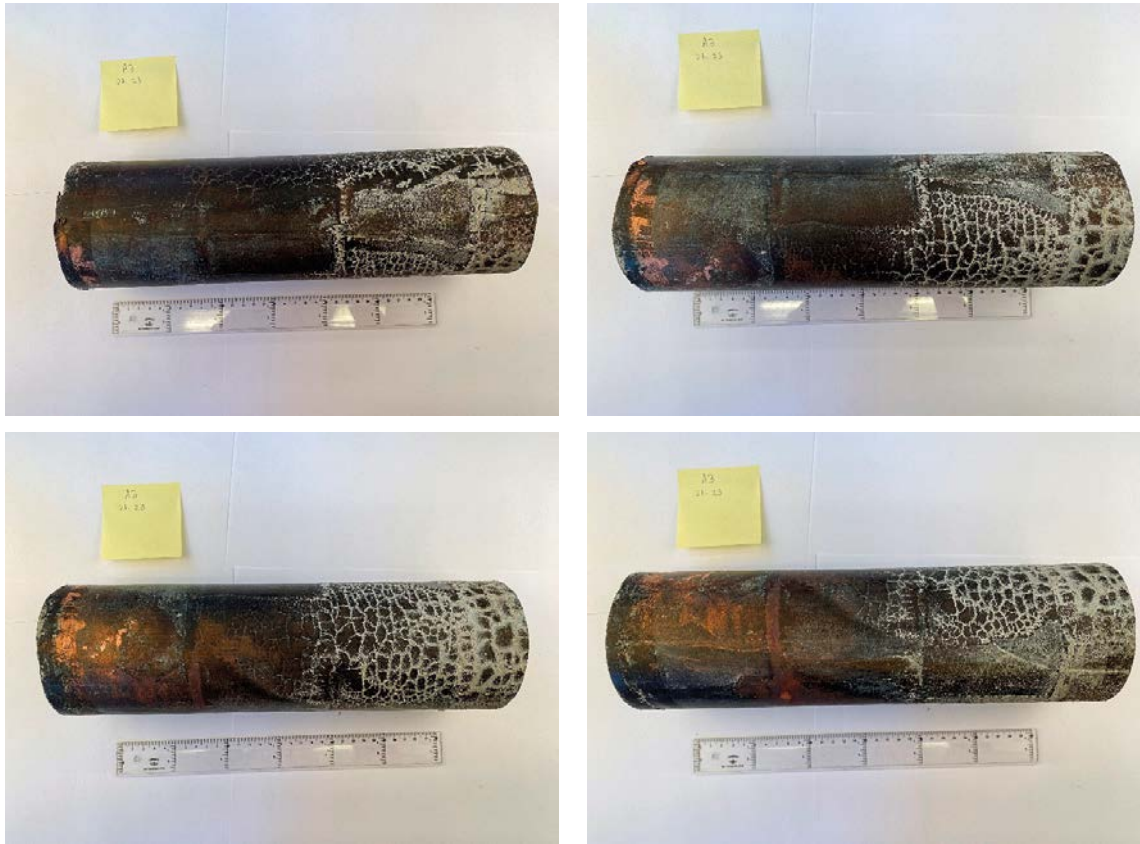
Figure A-12. Pipe sample A3 as-received, photographed at 0°, 90°, 180°, 270° rotation.

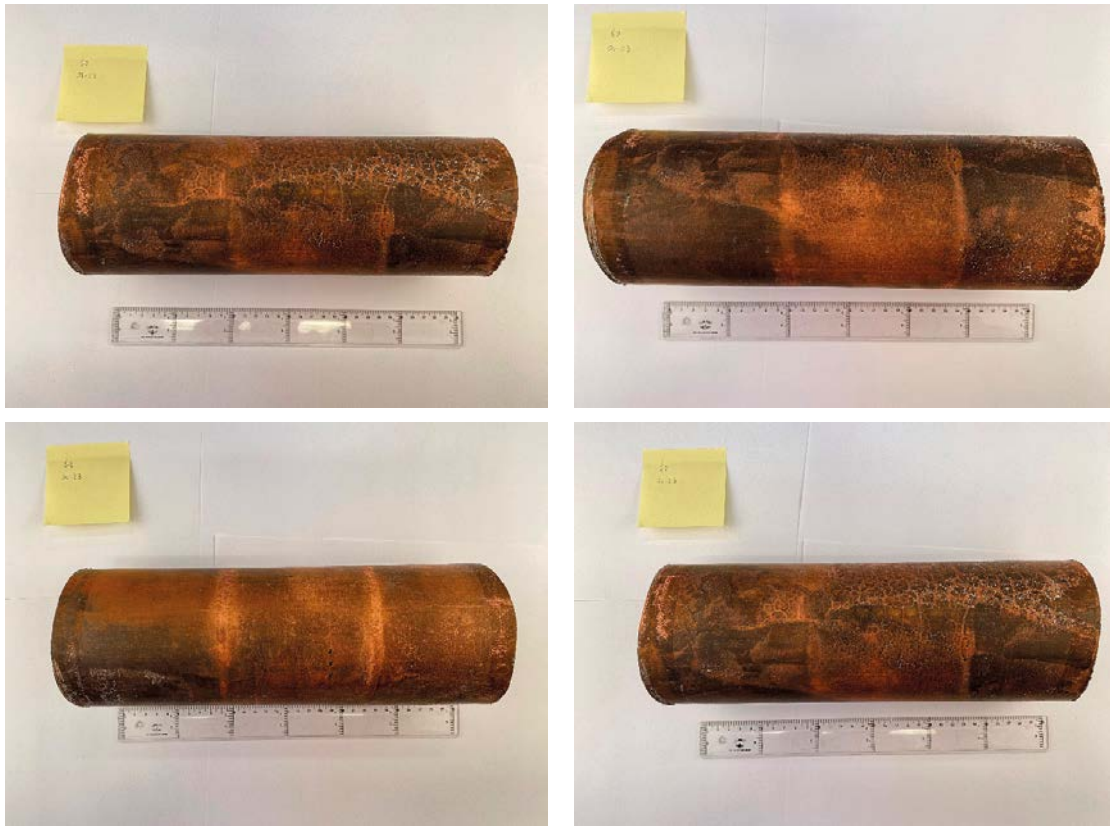
Figure A-14. Pipe sample S2 as-received, photographed at 0°, 90°, 180°, 270° rotation.

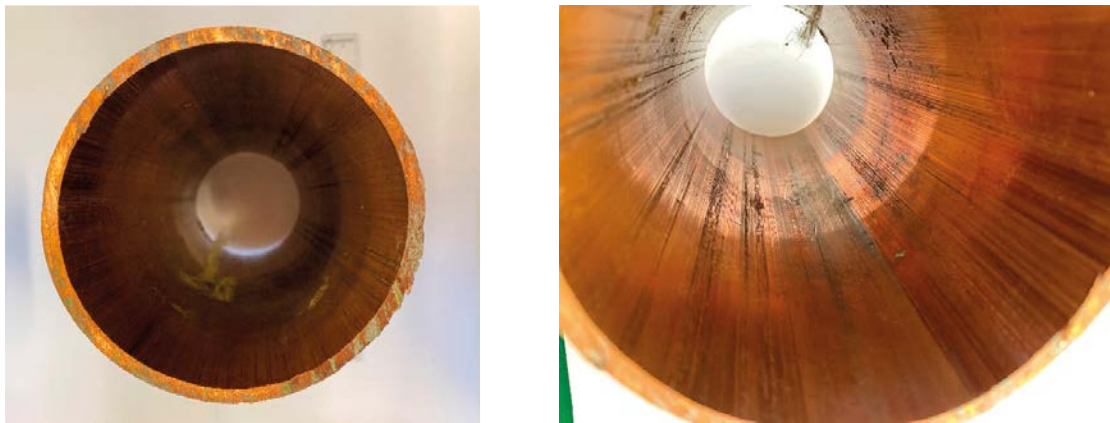
Figure A-15. Pipe sample S2 inner surfaces as-received.

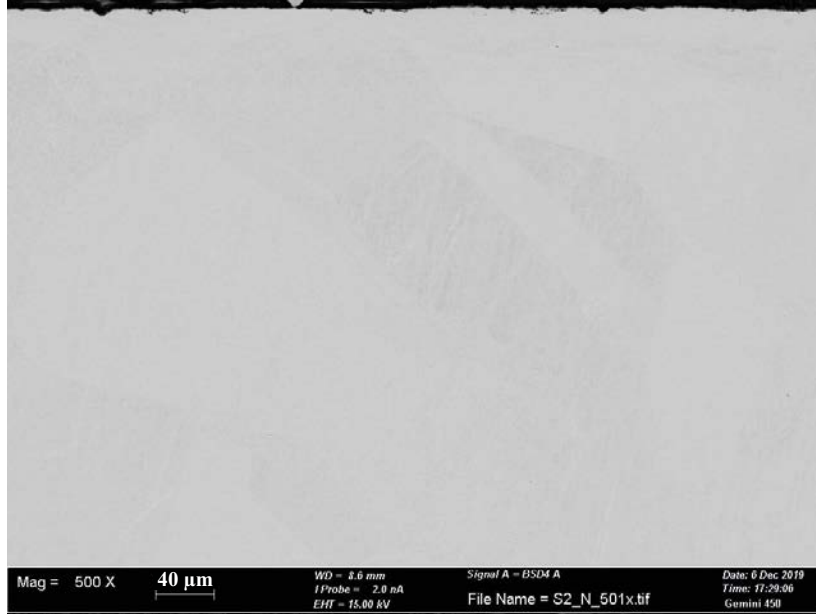
S2/N – cross section 2

Figure B-39.
Cross-section
SEM image
of coupon S2/N.

Figure B-40.
Cross-section
SEM image
of coupon S2/N.

Figure B-41.
Cross-section
SEM image
of coupon S2/N.

Figure B-42.
Cross-section
SEM image
of coupon S2/N.

Figure B-43.
Cross-section
SEM image
of coupon S2/N.

Figure B-44.
Cross-section
SEM image
of coupon S2/N.

Figure B-45.
 Cross-section
 SEM image
 of coupon S2/N.

Figure B-46.
 Cross-section
 SEM image
 of coupon S2/N.

Figure B-47.
 Cross-section
 SEM image
 of coupon S2/N.

Figure B-48.
*Cross-section
SEM image
of coupon S2/N.*
